Landslide Disaster around Baguio City caused by Typhoon Pepeng in 2009

Takashi INOKUCHI*, Tadashi NAKASU**, and Teruko SATO***

Key words: Landslide disaster, Typhoon Pepeng, Philippine, Baguio City

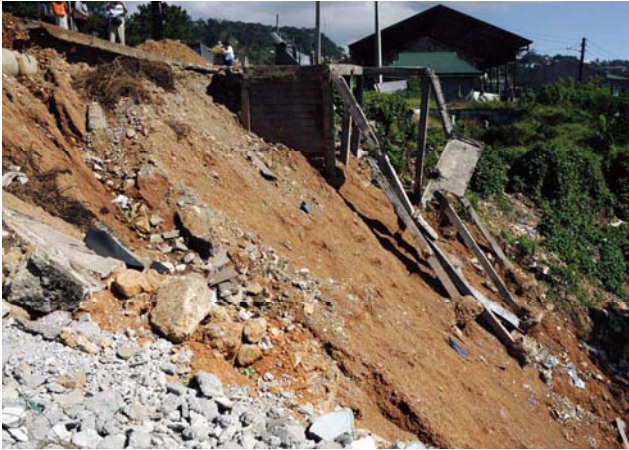
Almost nothing was left of the buildings on the central part of the landslide, where weathered soil was left exposed (**Photo 1**). Adjacent buildings had nothing but their foundations remaining. Based on interviews with some people at a nearby shop, the landslide occurred at around 1 am on Oct. 9. We believe that this was triggered by the record rainfall of 685 mm that fell the previous day in Baguio.

However, the landslide occurred in an area below a paved road surface where water infiltration was not expected to happen and where there is no water catchment surface. We found sewage pipes and tiles apparently made of concrete

Photo 1 Landslide in Kitma. The house in this photo collapsed down into the slope.

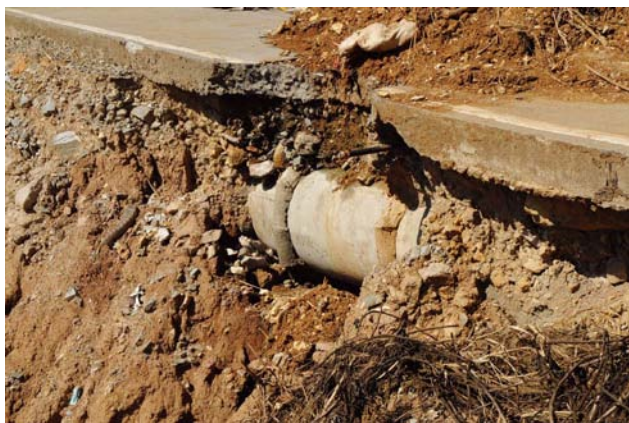
buried under the soil beneath the fault scarp below the road shoulder (**Photo 2**).

However, we did not have time to find out how the rainwater that falls on the road surface is drained. In the absence of other probable factors, we believe that it was possible that there was water leakage from the sewage pipes buried under the road. Even though we did not have information about the state of the buildings before the damage, it seemed that they were improperly built. Thus, we believe that the loosening of the soil due to the rains caused the unstable buildings to fall down with the land.

Photo 2 Sewage pipes found buried under the upper portion of the landslide in Kitma.

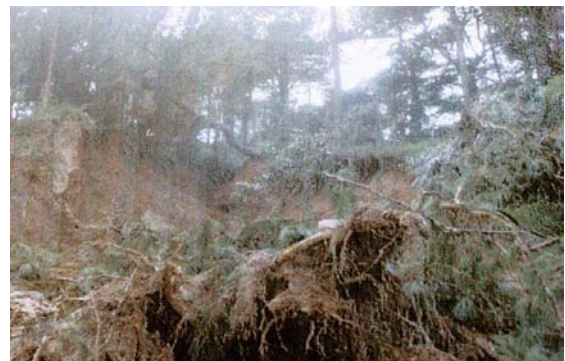
with grass, so at first it did not appear as if there had been a landslide. **Photo 3** shows a picture of the area provided by the city government that was taken right after the landslide. It was a small-scale landslide that occurred on a 20-degree gentle slope, 10 m wide and 10 m deep. We inferred from **Photo 3** that the area was naturally sloped and composed of a thick layer of weathered soil, and although it has the features of a valley-type slope, the water catchment surface is not very large.

Although we did not obtain detailed information about how the area was developed, we believe that the major factors that caused the damage were the unregulated building of houses and the lack of consideration to building safety on mountain slopes, where there is a danger of landslides occurring after heavy rainfall.

Photo 3 PNB Ville site right after the landslide (Provided by the Baguio City Government).

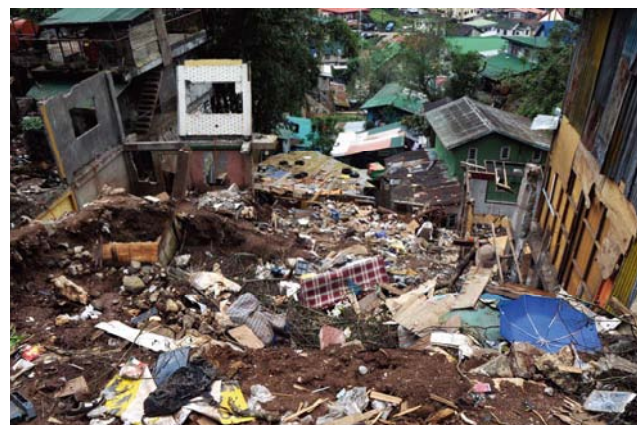
The landslide damage was similar to the first area we visited at Kitma, where a mudslide occurred below the road shoulder (Cover **Photo 2**). In this area, the houses were built in tiers along the slope so that all the houses located 30 to 40 m down from the portion that collapsed were damaged by the land and houses that fell down from above (**Photo 4**). Twenty-three people were killed in the landslide.

Photo 4 Damage of houses along the slope due to the landslide in Cresencia Village.

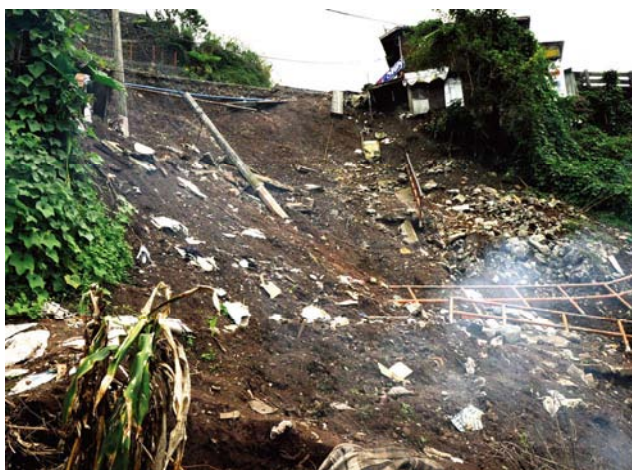
The area was an elevated residential one near the center of the city and located only around 500 m from the City Hall, with a nice view from the road. The area that collapsed was a steeply sloped area beneath the road shoulder that had a maximum width of 20 m, a slope length of 25 m, and a tilt of 30 degrees (**Photo 5**). Judging from the conditions of the surrounding area and from the topographical maps we obtained, we believe that the area was originally the uppermost part of the valley, a portion of which was probably filled during construction of the road. The side of the road where the slope collapsed did not have gutters or drainage systems, so it was possible that the rainwater flowed along the tilted road surface into the slope below it.

We believe that one major factor that contributed to the landslide that claimed many lives is the building of houses in a valley-like topographical area, which has a high risk for landslide damage, without proper land modification.

Photo 5 Condition of the slope where landslide occurred in Cresencia Village.

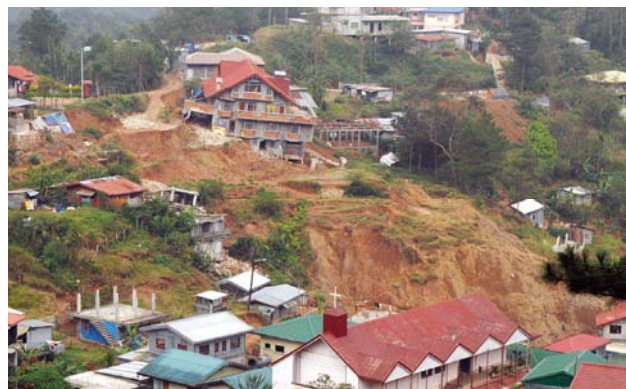
Photo 6 shows the landslide that occurred in Pinsao Proper, where earth movement occurred on a gentle slope that had a thick layer of advanced weathering-stage soil. This landslide area had the deepest slip plane among those we have mentioned so far, and the houses built over the landslip became greatly tilted. Since we were viewing the area from a distance, we could not accurately estimate the dimensions of the damage, so we estimated it to be approximately 100 m wide and 100 m long. The slope also did not have a significant water catchment surface area behind the landslide.

Photo 6 Landslide in Pinsao Proper.

We believe that groundwater levels rose due to an infiltration of rainfall that reached a total of 1,000 mm over the sloped area. There were reports of two fatalities in this area, but we were not able to determine the actual location where this happened.

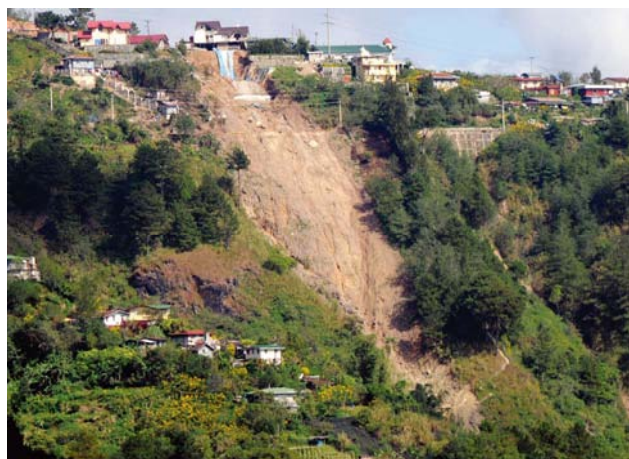
Photo 7 Landslide in Yapdue area.

Photo 7 is a far-view picture of the landslide that occurred on a steep slope in the Yapdue area. From the picture, it would seem that the amount of collapsed land is minimal, but due to the collapse of the upper region of the slope, a wide area was laid bare. We were not able to determine the extent of damage for this area. There were other landslides having a similar type of damage in some other places within Baguio City. In this particular area, there were no houses beneath the collapsed portion, but there were several houses in the slope right next to it. Thus, if the landslide had occurred in a slightly offset point, it could have resulted in human casualties. Landslides of varying scales were also observed in many other areas.

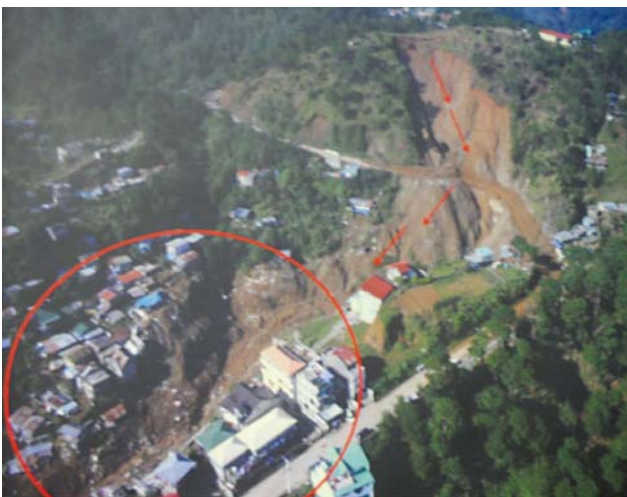
Photo 8 Landslide in Little Kibungan.

along the valley, resulting in enormous damage that left 85 people dead (area encircled in **Photo 8**).

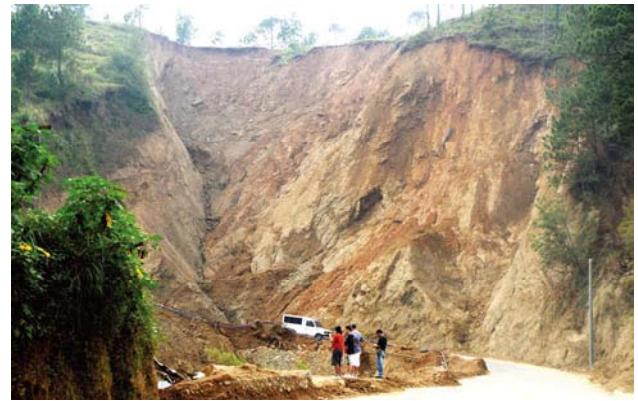
Photo 9 Origin of landslide in Little Kibungan.

The landslide occurred on a steep, 25-m-high slope that was directly above the road (**Photo 9**). It collapsed as if the land from the part near the ridge of the smooth-topped, hill-like peak was gouged. The landslide was around 30 m wide and 35 m in height. The fault plane that cuts the slope diagonally served as the boundary of the cliff on the right side of the landslide area, causing the land to collapse in a wedge-shaped pattern. The upper part of the landslide almost reached the ridgeline, and there was no significant water catchment area behind the landslide. As such, we believe that the infiltration of rainfall into the collapsed portion of the slope caused the landslide. It is possible that the rainwater that infiltrated the soil was blocked by the fault plane and accumulated on the area.

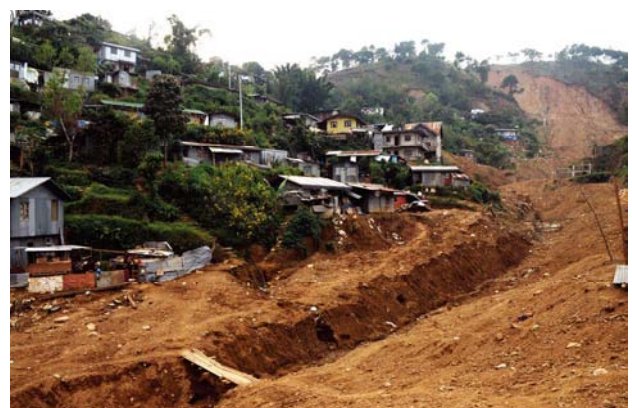
A massive amount of material flowed down at a rapid speed into the valley over a distance of 100 m, resulting in considerable damage. Houses lined both sides of the valley, and those that were along the path of the debris flow were either washed out or completely destroyed. Restoration work was already under way at the time of the inspection, so we could not see the actual damage, but the location of the houses in relation to the path of the debris flow can be seen in **Photo 10**.

Photo 10 Damage in houses built along the valley where landslide occurred in Little Kibungan.

It is difficult to predict precisely where landslides might occur in slopes that have complex and heterogeneous soil conditions, but needless to say, houses should not be built in areas near the valley flow path because of its inherently high topographical risk. We can learn from this disaster that proper risk assessment is an essential component in land use planning.

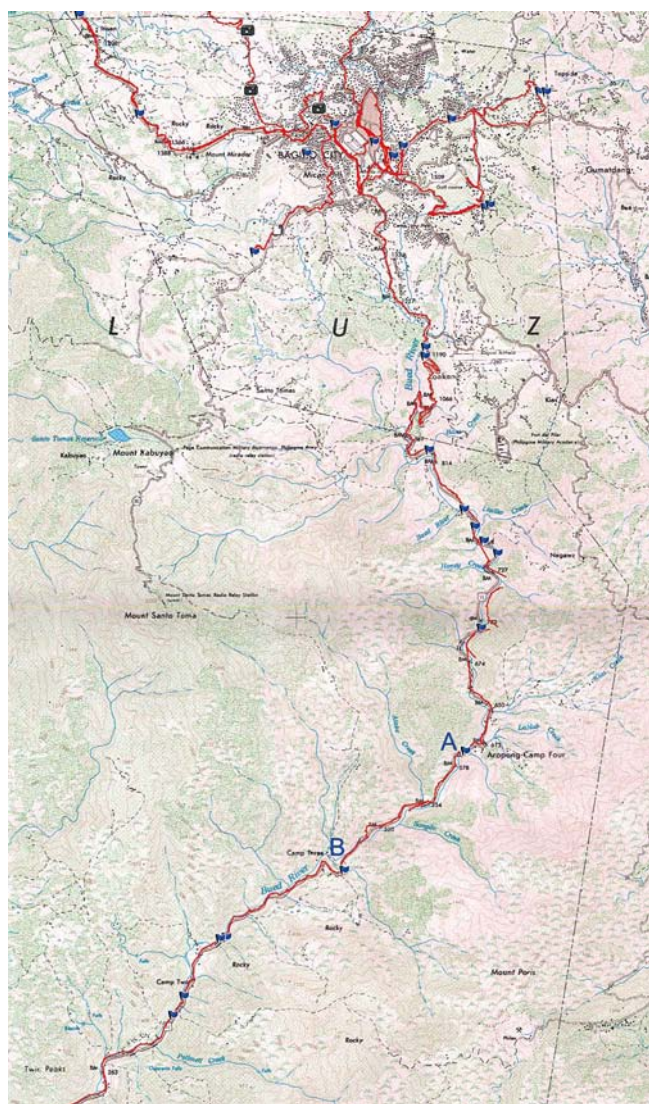
Fig. 2 Distribution of landslides along Kennon Road.

On the way, we tried to stop and take pictures of several portions of the road where there had been landslides. Although there were not many places where we were able to actually stop and take a look, by using GPS, we also recorded the landslide locations and other areas where there were fallen rocks and debris scattered along the road. **Fig. 2** shows the results of our quick survey of landslide occurrences along Kennon Road.

Cover **Photo 7** shows an area damaged by the flow of rock and debris from the collapsed upper portion of the slope (**Fig. 2-A**). Debris that included giant boulders a few meters big had been moved away to the roadside, indicating that the road must have been impassable for a long period. At the time of the photo, the road was being repaired as an emergency measure, and alternating traffic caused congestion. To prevent future disasters, a bridge high enough to accommodate possible rock and debris flow from above must be built on the portion where the road traverses the river. Otherwise, roads must be constructed on both sides of the river so that even when one side is damaged, traffic can still pass along the road on the other side.

Cover **Photo 8** shows rocky slopes along Kennon Road that had collapsed (**Fig. 2-B**). In addition to rainfall infiltrating the fissures on the rocky slope, we believe that the river below had been eroding the base of the slope, making it unstable and eventually causing the rock flow.

Although it is difficult to predict rockslides in places like this, it is possible in this case that minor deformations had already occurred along the fissures that eventually became the slip plane for the rockslide. Since the area had been covered by vegetation, it would have been difficult to detect these early warning signs, so a regular inspection system must be employed to prevent disaster as part of proper road management practice.
