2015年4月ネパール地震 (Gorkha地震) における 地震の概要と建物被害に関する情報収集調査報告

Investigation of Damage in and Around Kathmandu Valley Related to the 2015 Gorkha, Nepal Earthquake

防災科学技術研究所研究資料

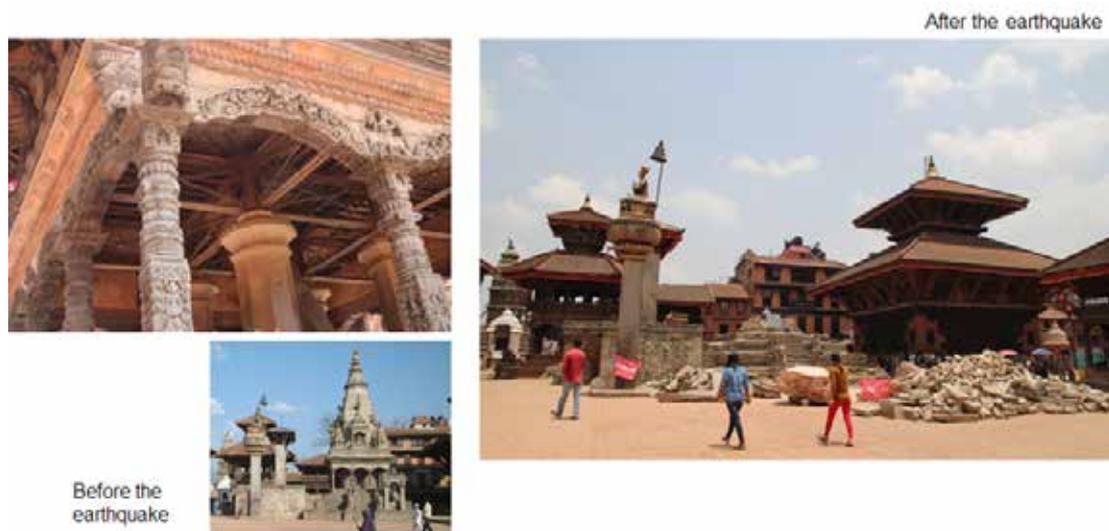
Many of Sikhara in Bhaktapur’s Durbar Square were severely damaged. The steel frame reinforced Chayslin duga temple (left) (Fig. 3.2). This temple was no damaged. During the 1934 Earthquake Chyasilin Mandap was completely destroyed. Architects Götz Hagemüller and Niels Gutschow set about rebuilding this temple due to the metal reinforcements by GTZ fund. The Vatsala temple (center), which is Newar style temple, ca.1690, but destroyed. Yaksheshvara temple (right) survived.

Fig. 3.2 Reinforced Chayslin duga temple (left) by steel frame, Vatsala temple (center) was destroyed and Yaksheshvara temple (right) survived (photo by T. Ohsumi).

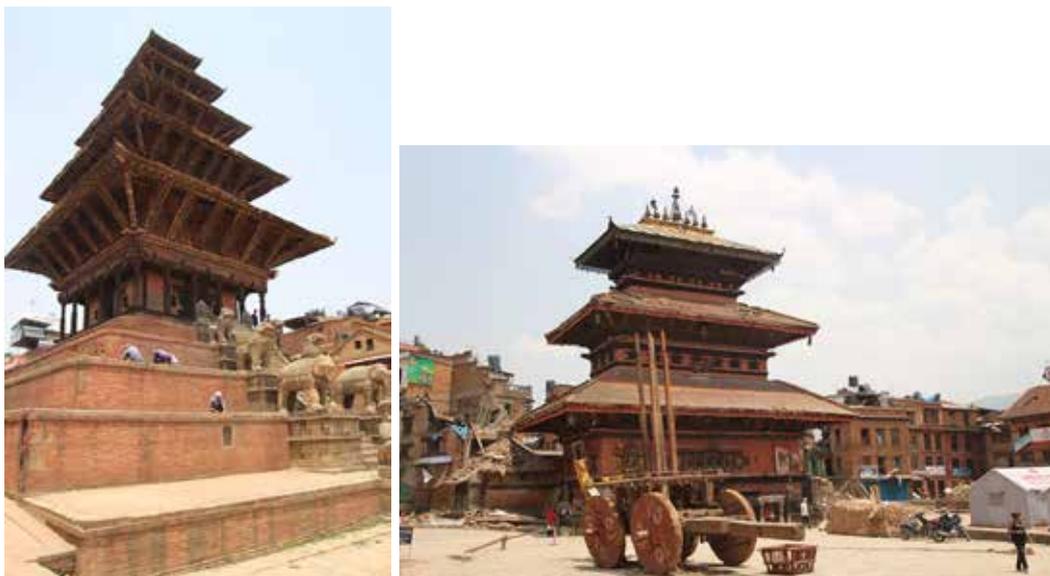
workmanship. This temple survived in an earthquake in 1934. This temple remained with a minimum of damage, the reliability of the building technology is being evaluated. The Bhairavnath temple was destroyed by an earthquake in 1934 and subsequently rebuilt.

Fig. 3.6 Nyatapola temple (left) and Bhairavnath temple (right) are no damage (photo by T. Ohsumi).

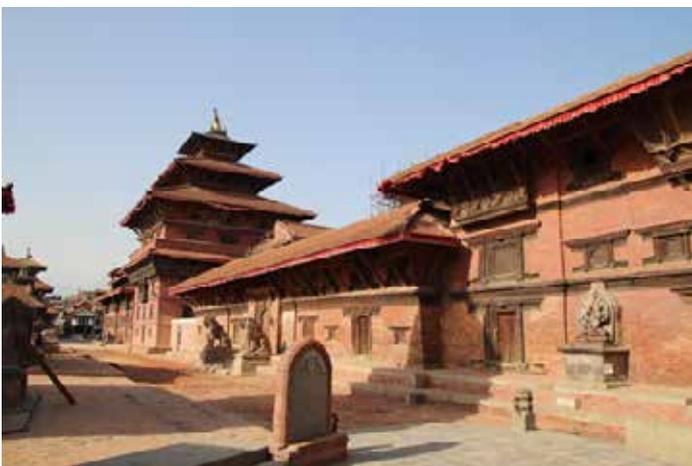
Thus, in Patan, 2015, after the earthquake, this place had only partial damage at Gajur and Baymvah (**Fig. 3.9-11**).

Fig. 3.10 Patan 2015, after the earthquake, this place had partial damage at Gajur and Baymvah (right) (photo by T. Ohsumi).

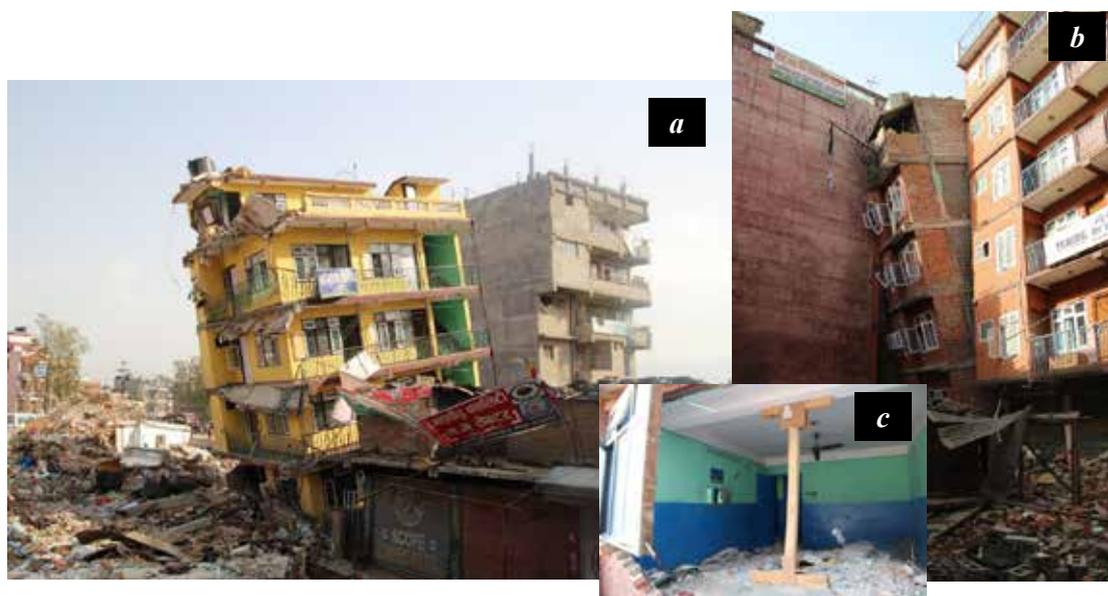
Fig. 3.15 At Gongabu, RC frame buildings were tilted (a,b). A shear crack in the first floor (c) (photo by T. Ohsumi).

four to seven story structures. The damage was sometimes greater at locations with soft ground such as deltaic deposit near river branches (**Fig. 3.15**); however, some damage was also likely to have been caused by inappropriate construction methods. At Sitapaila, west of the Ring Road, some RC building collapsed at locations where the ground conditions on terraces were a bit stiff. At Balkhu, southwest of the Ring Road, RC frame buildings were tilted. This is near the confluence of the Bagmati and Balkhu rivers, where collapsed buildings fell onto and destroyed a neighboring building (**Fig. 3.16**). The ground conditions in Balkhu were soft because of the presence of riverbed sediments.

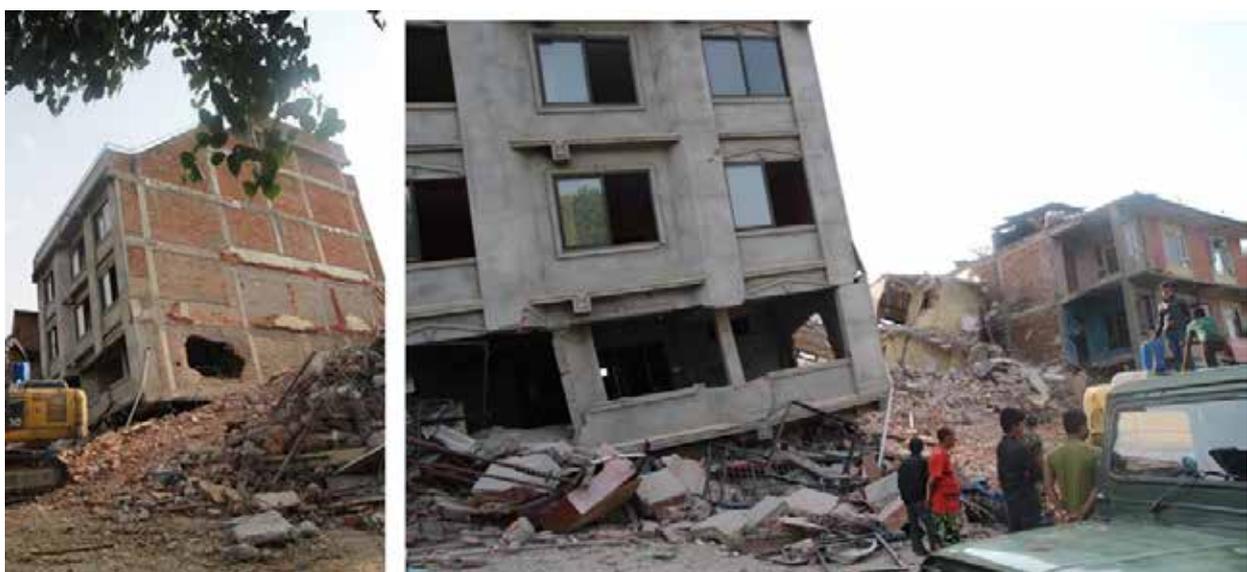
Fig. 3.16 At west side of the Ring Road in Kathmandu, RC frame buildings were tilted (photo by T. Ohsumi).

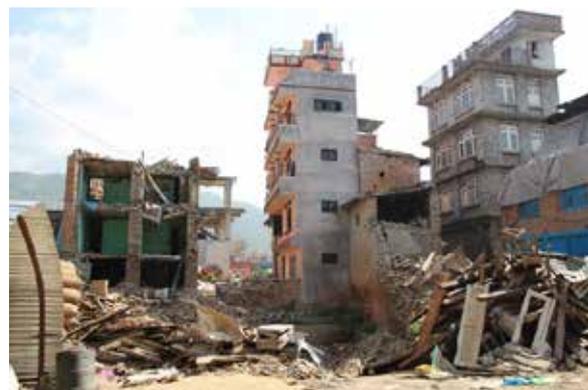
Fig. 3.20 RC buildings were partially damaged, the difference appears remarkable in Sankhu (photo by T. Ohsumi).

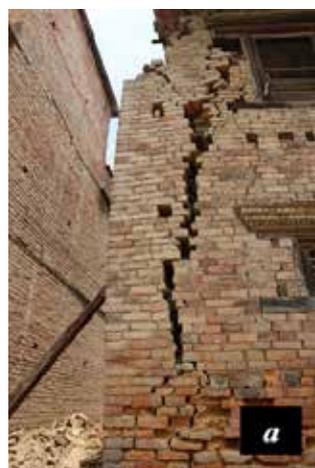
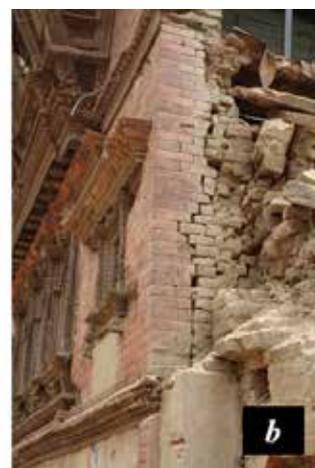
Fig. 3.21 A vertical crack in a brick masonry wall was generated from the corner (a). Structures having no RC columns on the corner (b) (photo by T. Ohsumi).

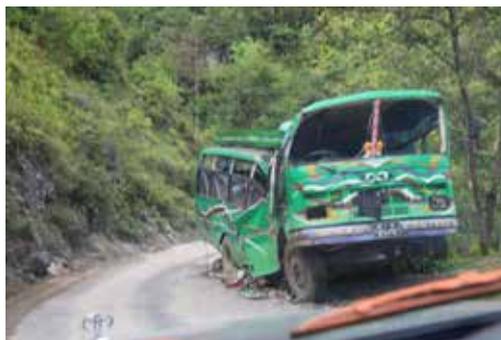
Fig. 4.1 Bus was hit in falling rocks in Dhikure, on Baglung Rajmara High way (photo by T. Ohsumi).

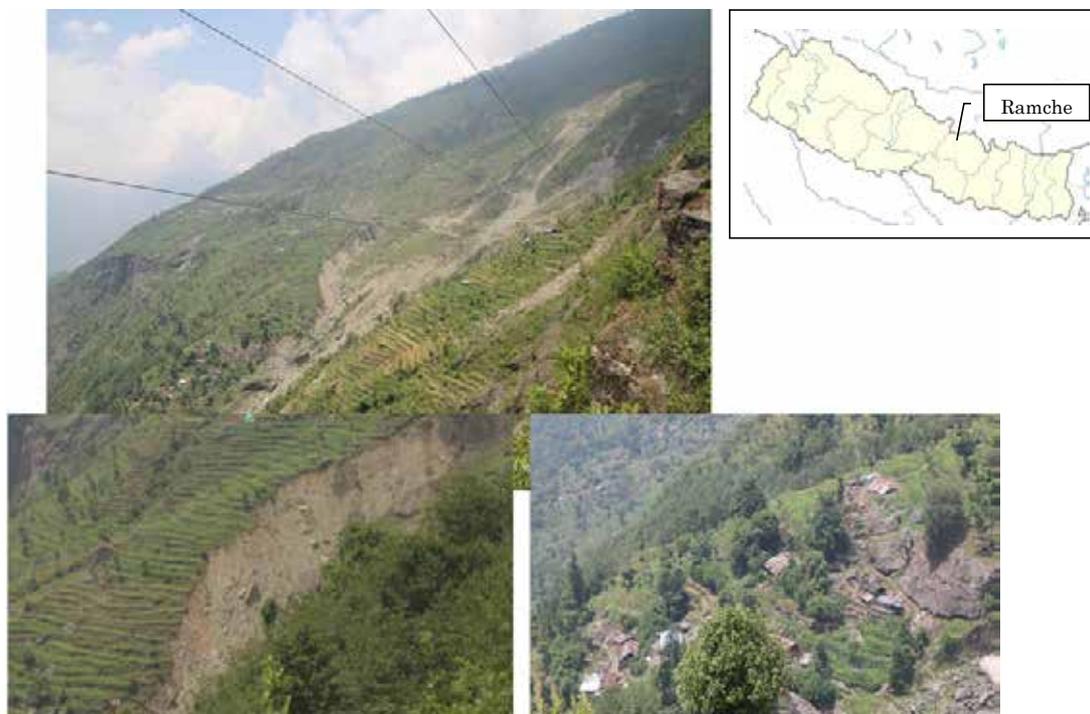
Thick talus is deposited in the landslide area in Ramche, in Rasuwa district. The town is located at an altitude of 2,068 m. There are houses that had been caught in a landslide, but the damage was limited. However, the whole scope of the slope failures is not clear at the present time, because any detailed and total survey in the mountainous area has not been carried out. Thus, causalities will increase as they are found.

Fig. 4.2 Thick talus is deposited in the landslide area in Ramche (photo by T. Ohsumi).

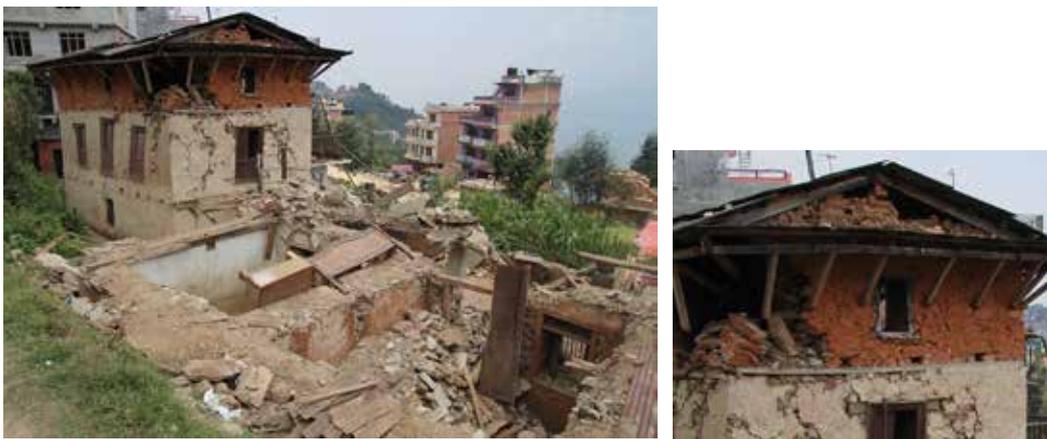
In Dolakha district, adobe style houses collapsed. Primarily, adobe houses collapsed as a result of cracks in the gables and corner foundations as a result of ground motion. Many adobe style houses were broken at their gables. Stone houses could also collapse as a result of delamination. Stone style houses also collapsed by delamination.

Fig. 4.3 Adobe style houses collapsed at the gable part in Charikot, Bhimeshwor Municipality (photo by T. Ohsumi).

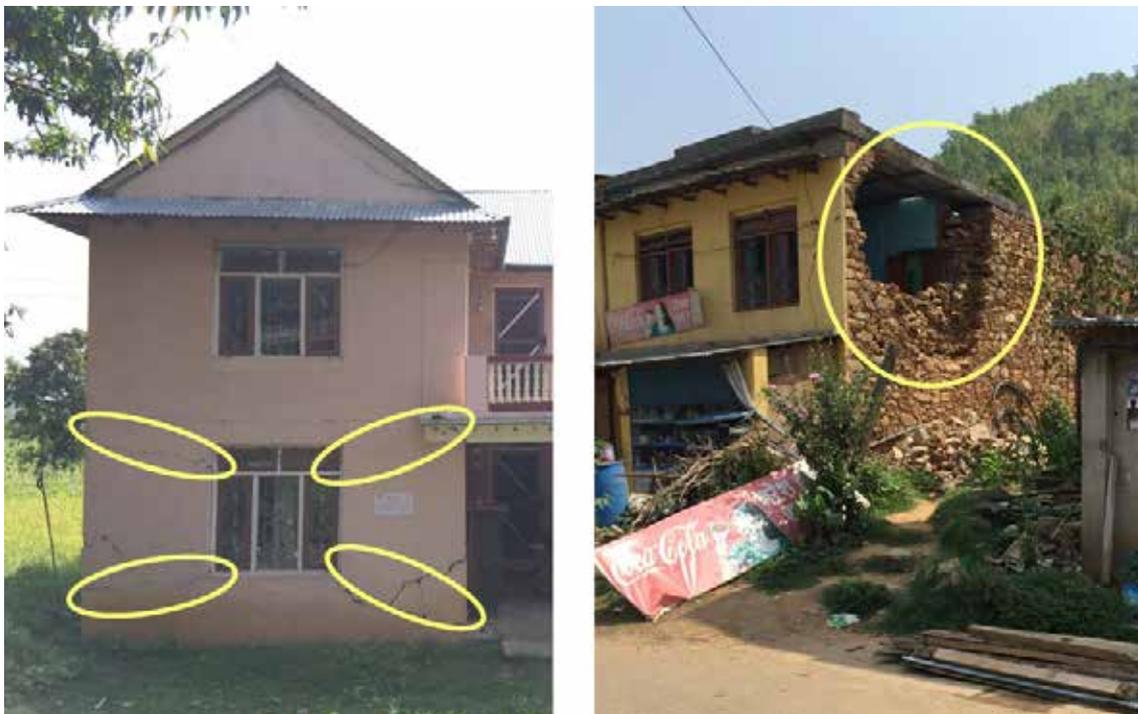
Fig. 5.2 Typical failure pattern of Non-engineered housings left: Nuwakot, right: Ksthmandu (photo by H. Imai).

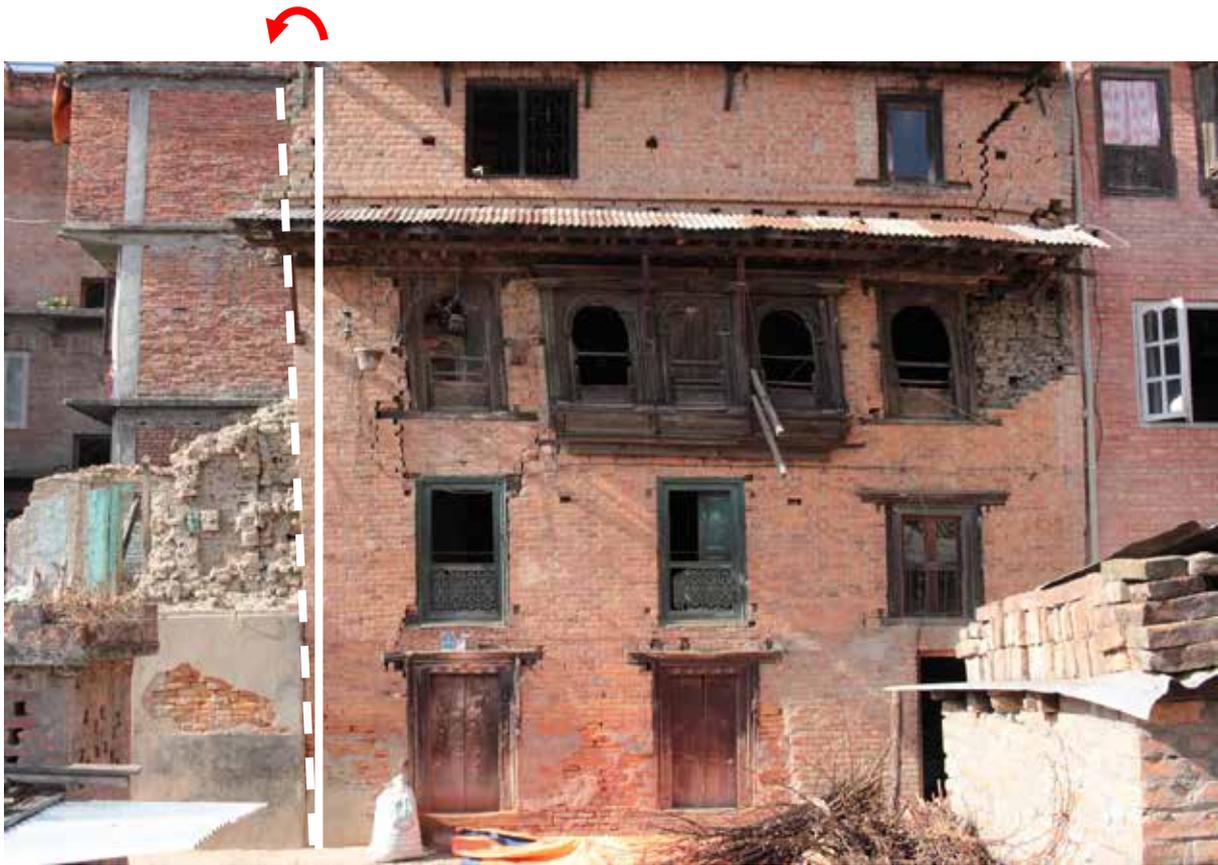
method needs to translate all the inertia. The traditional structures caused brittleness transformations and defective corners of the structures related to the 2015 Gorkha earthquake (**Fig. 2.11, 2.12**). Reinforcement with such components as hold down hardware and battledore bolts is indispensable.

Fig. 2.11 Traditional structures caused brittleness deformations and defective corners of the building related to the 2015 Gorkha Earthquake in Khokana (photo by T.Ohsumi after the 2015 Earthquake).

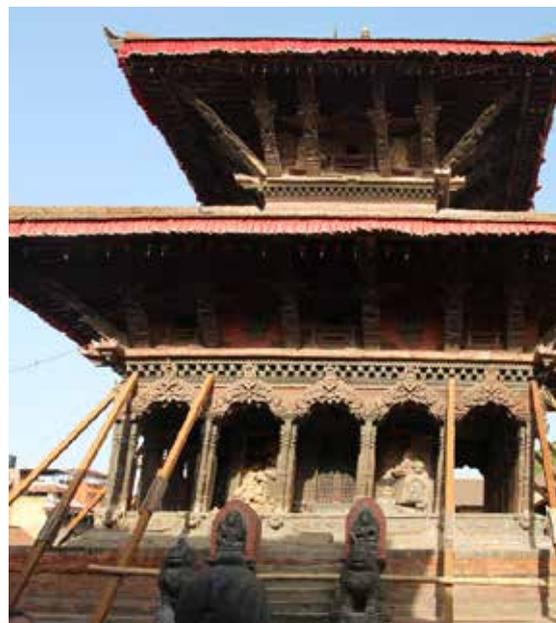
Fig. 2.12 Temple caused brittleness deformations and defective corners of the temple related to the 2015 Gorkha Earthquake in Patan (photo by T. Ohsumi after the 2015 Earthquake).

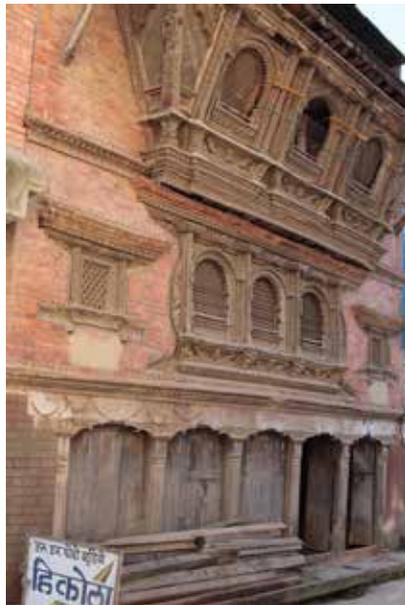
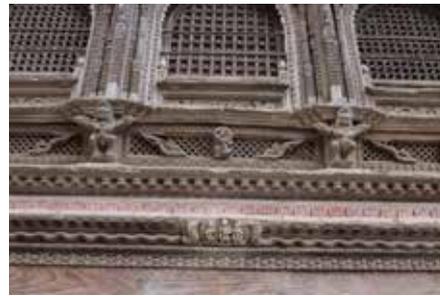
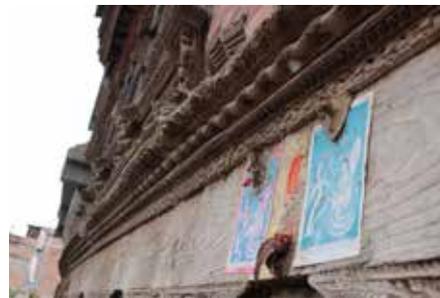
Fig. 2.16 shows a *Naga* band on an altar in Sankhu. A band, designed by *Naga*, has been installed between the first floor and the second floor in the house, throughout the whole building. There is a *Naga* band in a historical masonry building. Damage in Sankhu was extensive in the 2015 Gorkha Earthquake. However, this type of structure survived (Fig. 2.17).

Fig. 2.17 Building constructed over 100 years ago that was slightly damaged by the Gorkha earthquake. The building has a snake (*Naga*) band surrounding it between the first and second floors (photo by T. Ohsumi, taken after Gorkha earthquake in Sankhu).

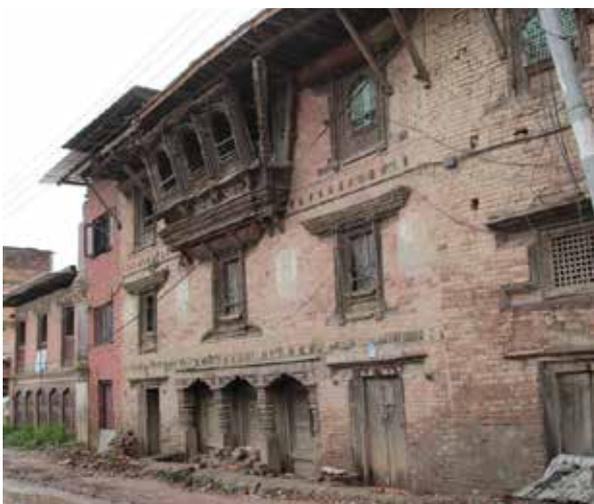
Fig. 5.1 Building that was over 100 years old, showing little damage (photo by T. Ohsumi, taken after Gorkha earthquake in Sankhu).

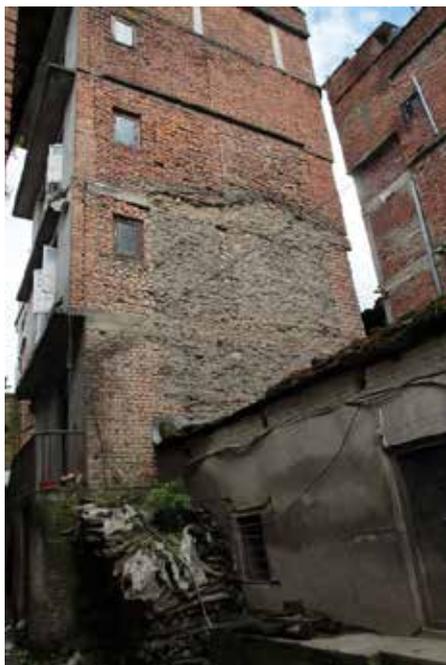
Fig. 6.3 What should be the grade for this building?
The three-story building was reduced to one story.
This building was classified as Grade 4.
(photo by T. Ohsumi, taken after the Gorkha earthquake in Sankhu)
