Flash Report on the Damage of Mexico City and Puebla Related to the 2017 Puebla-Morelos Earthquake

Technical Note of the National Research Institute for Earth Science and Disaster Resilience: No.416

An earthquake with a moment magnitude (Mw) of 7.1 occurred at 13:14 CDT (18:14 UTC) on September 19, 2017, in the city of Puebla in Mexico. A damage survey was conducted in the affected area from November 18 to 21 by a team from the National Research Institute for Earth Science and Disaster Resilience. This paper outlines the findings of the survey in terms of the various aspects of the earthquake that affected Mexico City and surrounding areas. It was observed that the main damage was to masonry reinforced concrete buildings and the most heavily damaged structures correspond to areas underlain by soft soils 10–20 m in thickness. Comparison of estimated acceleration distribution for periods of 1 s corresponds to 8–12 story buildings, and these period areas correspond to heavily damaged structures. In the city of Atlixco, most of the damage was to church buildings.

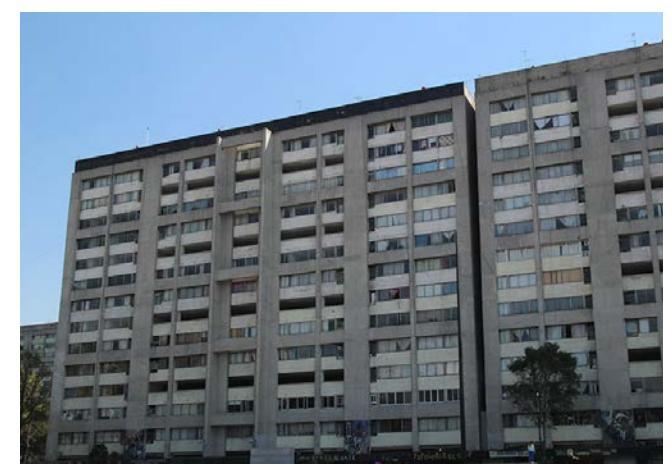
Fig. 4.8 Photograph of the undamaged Tlatelolco Complex from outside inspection, after the 2017 earthquake. (photo taken by T. Ohsumi on November 21, 2017).

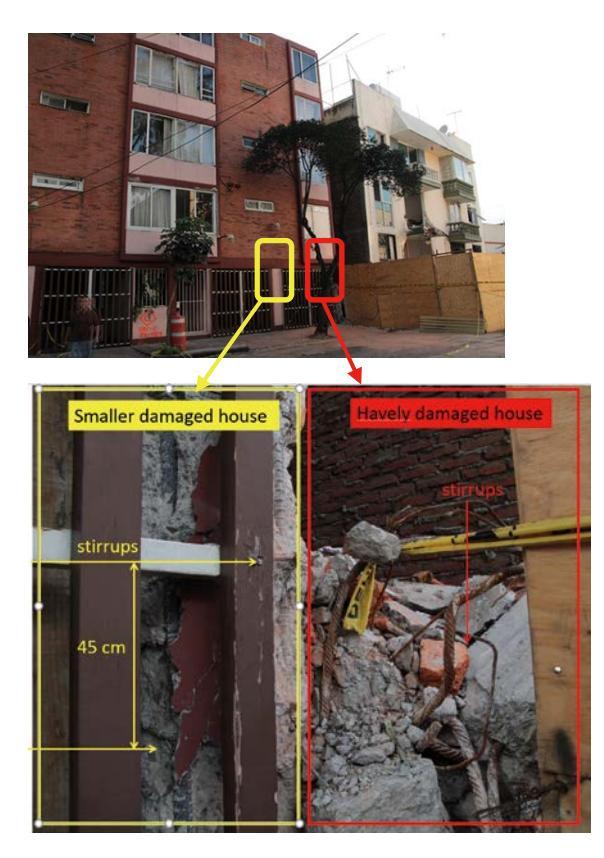
Two adjacent housing blocks were built in the same period in 1970, as shown in **Fig. 4.9**, and both buildings will be demolished. However, the building on the right was heavily damaged and the parking lot on the first floor collapsed. The housing block on the left was inspected, and found to have higher quality concrete than the right block. Also, the building column construction used hoops/stirrups at a 45 cm pitch, while the hoops/stirrups were of very poor quality in the housing block on the right.

Fig. 4.9 Comparison of damage to two housing blocks. Note the heavily damaged housing on the right with poor quality hoops/stirrups (photo taken by T. Ohsumi on November 19, 2017).

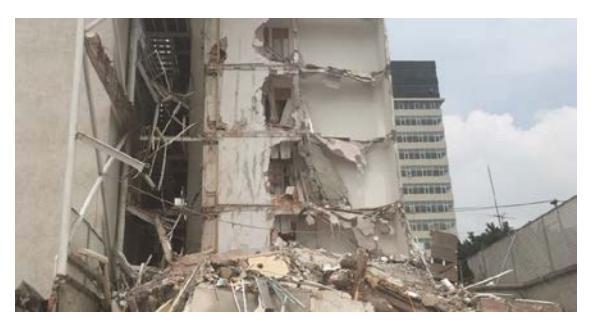
Fig. 4.10 shows the photograph of complete structural failure in the Residencial SanJosé, Zapta 56 (EL FINANCIERO)¹²⁾. **Fig. 4.11** shows the photograph of building damage to the Residencial SanJosé, Zapta from over bridge. **Fig. 4.11** shows the photograph of building damage to the Residencial San José, Zapta from over bridge. The adjacent right building was no damage from outside inspection.

Fig. 4.10 Photograph of complete structural failure in the Residencial SanJosé, Zapta 56 (EL FINANCIERO)¹²⁾.

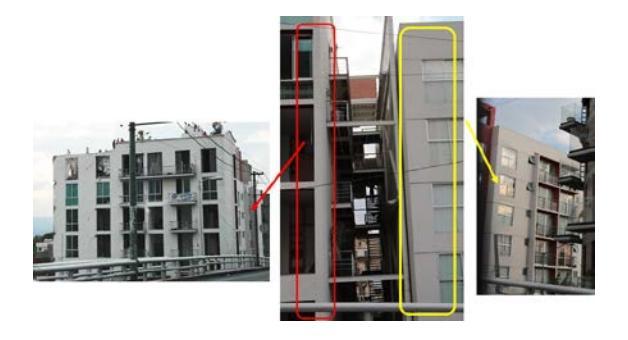
Fig. 4.11 Photograph of building damage to the Residencial SanJosé, Zapta from over bridge (photo taken by T. Ohsumi on November 19, 2017).

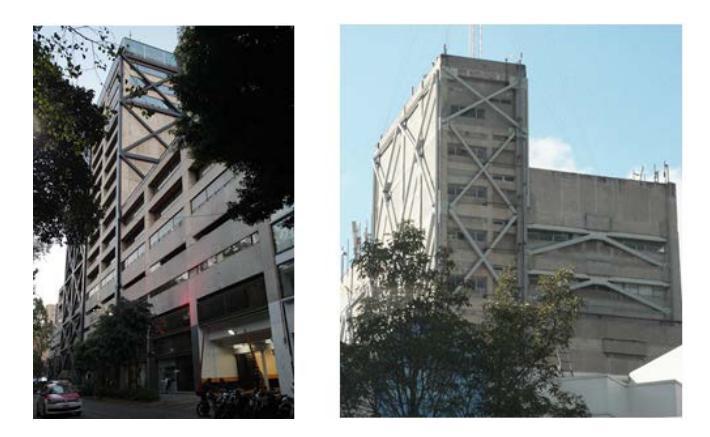
In Mexico City, braces are installed on buildings to decrease the risk of blocks falling off, or bricks in the wall falling out of the plane of the building. Thus, a gable wall between the brace is used to sustain this resilience method (**Fig. 4.14**). Buildings reinforced with steel braces are shown in **Fig. 4.15** and typical diagonal reinforced concrete bracing with masonry infill is shown in **Fig. 4.16**.

Fig. 4.15 Photographs of buildings reinforced with steel braces. (photo taken by T. Ohsumi on November 18-19, 2017)

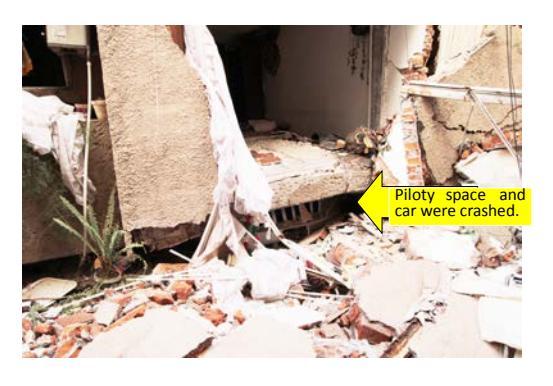
Fig. 4.13 Photograph showing the collapse of the basement space in which cars were crushed. (photo taken by T. Ohsumi on November 19, 2017)

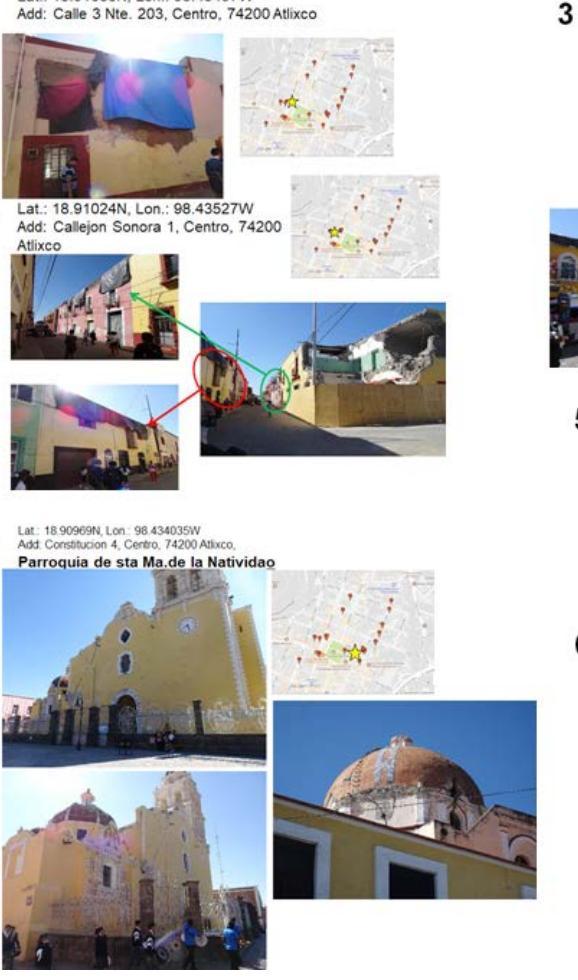
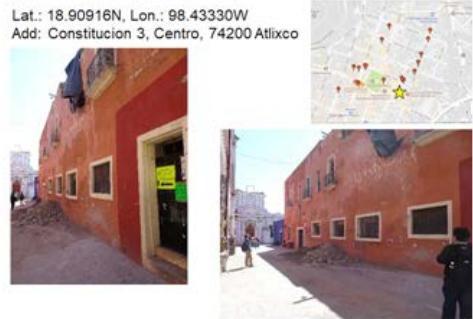
The earthquake damaged areas beyond Atlixco, including the five local governments of Huaquechula, Atzitzihuacán, Santa Isabel Cholula, Tepeojuma and Tianguismanalco. Damage was mostly structural, and church buildings were especially affected (Fig. 4.23).

Fig. 4.23 (a) Various damaged buildings in the Atlixco area (**0**-**6**). (photo taken by Y. Dohi and T. Ohsumi on November 20, 2017)

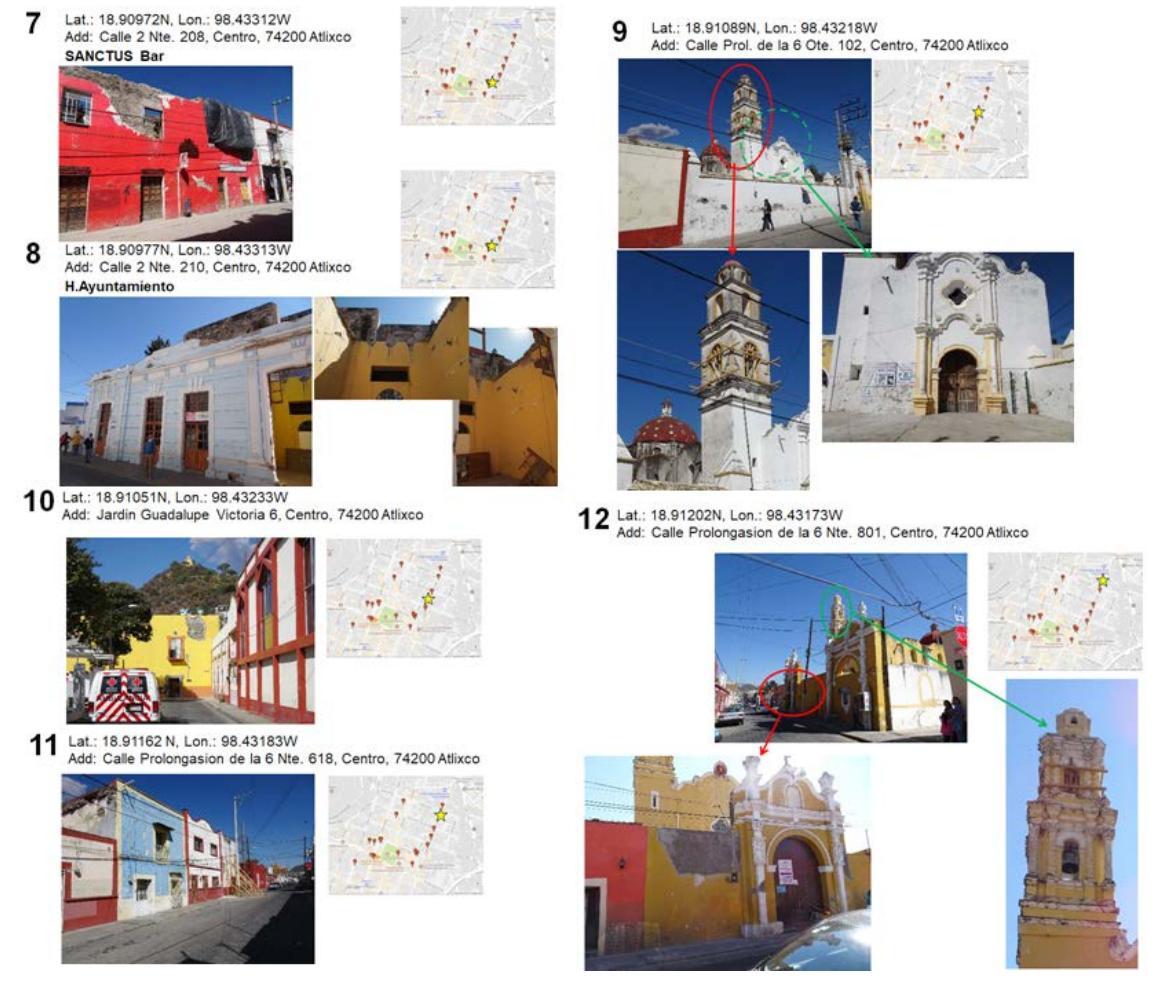
Fig. 4.23 (b) Various damaged buildings in the Atlixco area (O-O) (photo taken by Y. Dohi and T. Ohsumi on November 20, 2017) Flash Report on the Damage of Mexico City and Puebla Related to the 2017 Puebla-Morelos Earthquake - T. OHSUMI and Y. DOHI

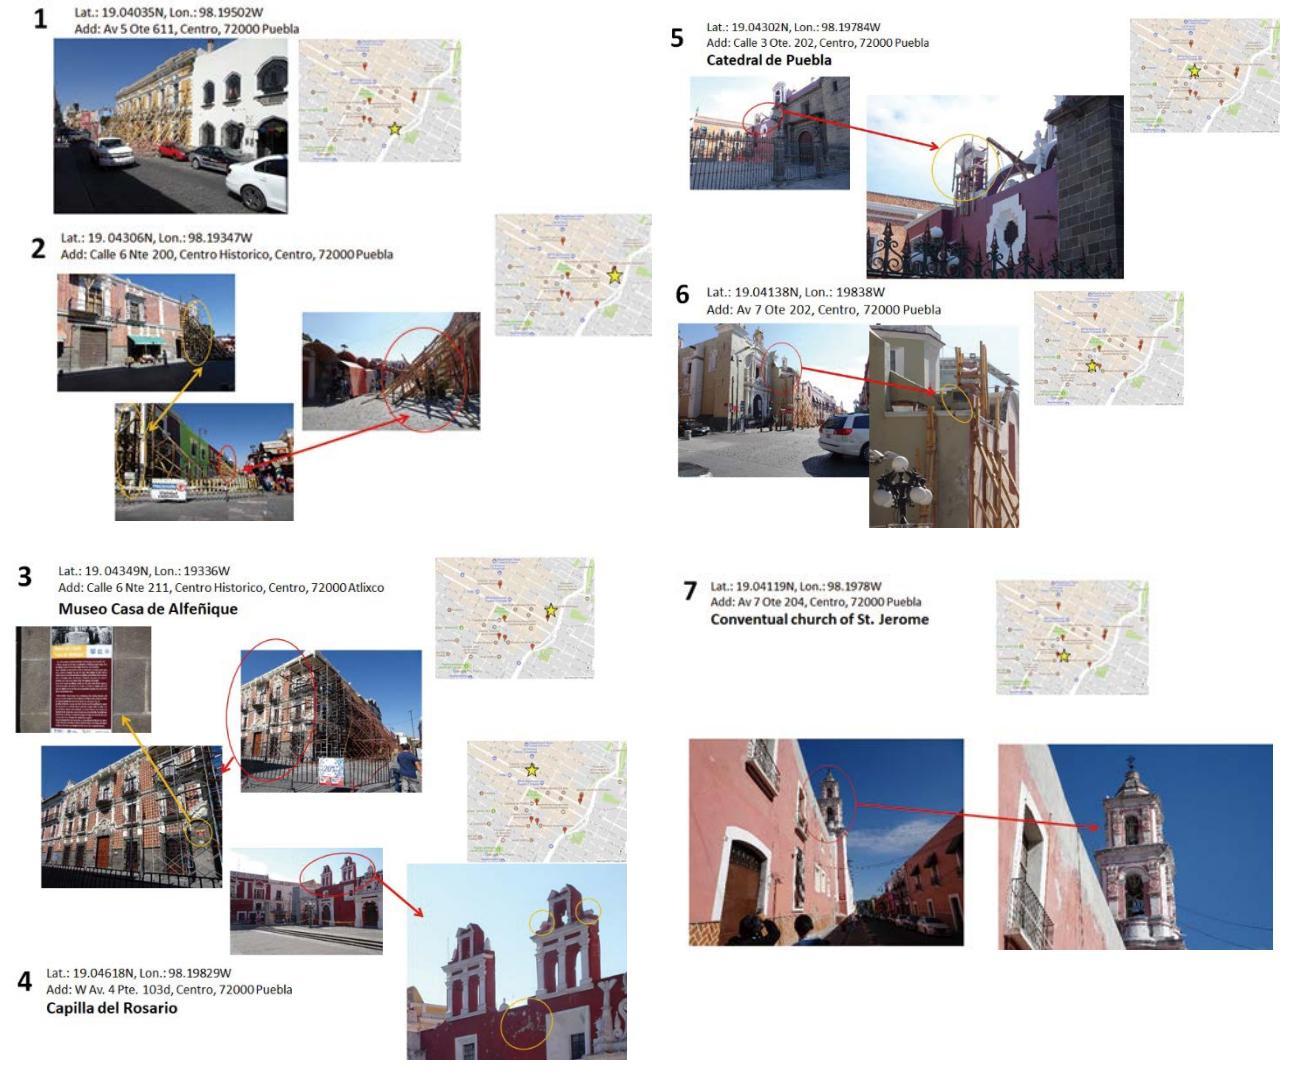
Fig. 4.25 Various damaged buildings in the Puebla City area (●-●). (photo taken by Y. Dohi and T. Ohsumi on November 20, 2017)
