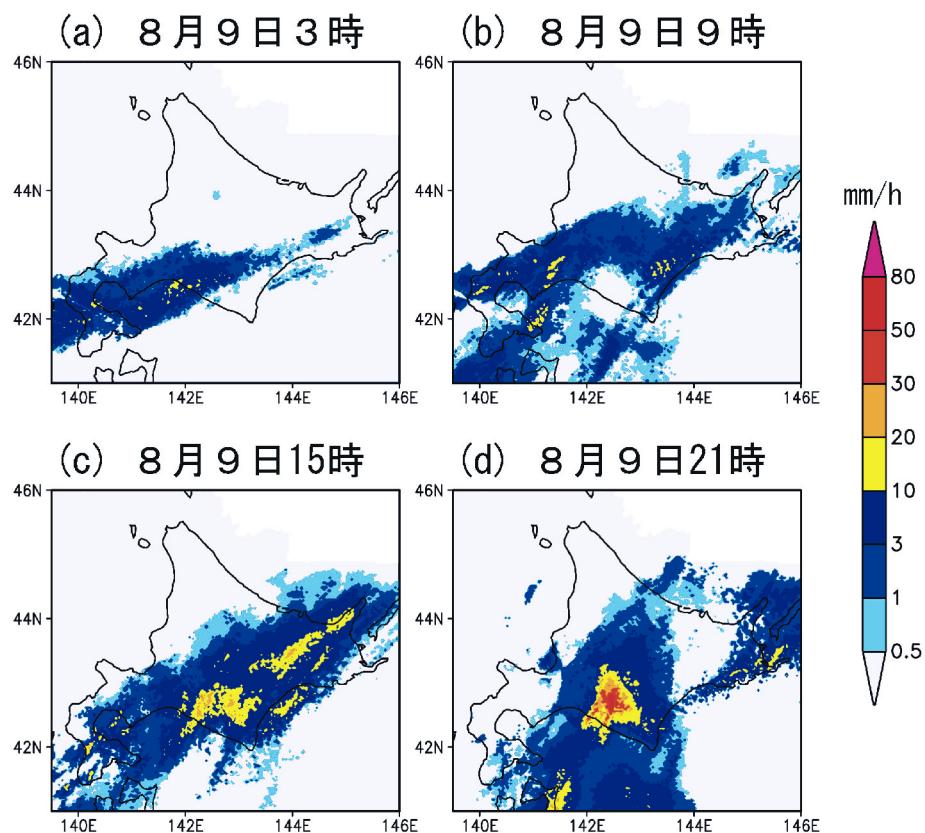
図1 北海道における8月9日(6時間間隔)のレーダー・アメダス解析雨量図

Fig. 1 Isohyetal maps showing hourly precipitation intensity at 03:00, 09:00, 15:00, and 21:00 (JST) on August 9 in Hokkaido using the data from radar-AMeDAS rainfall.

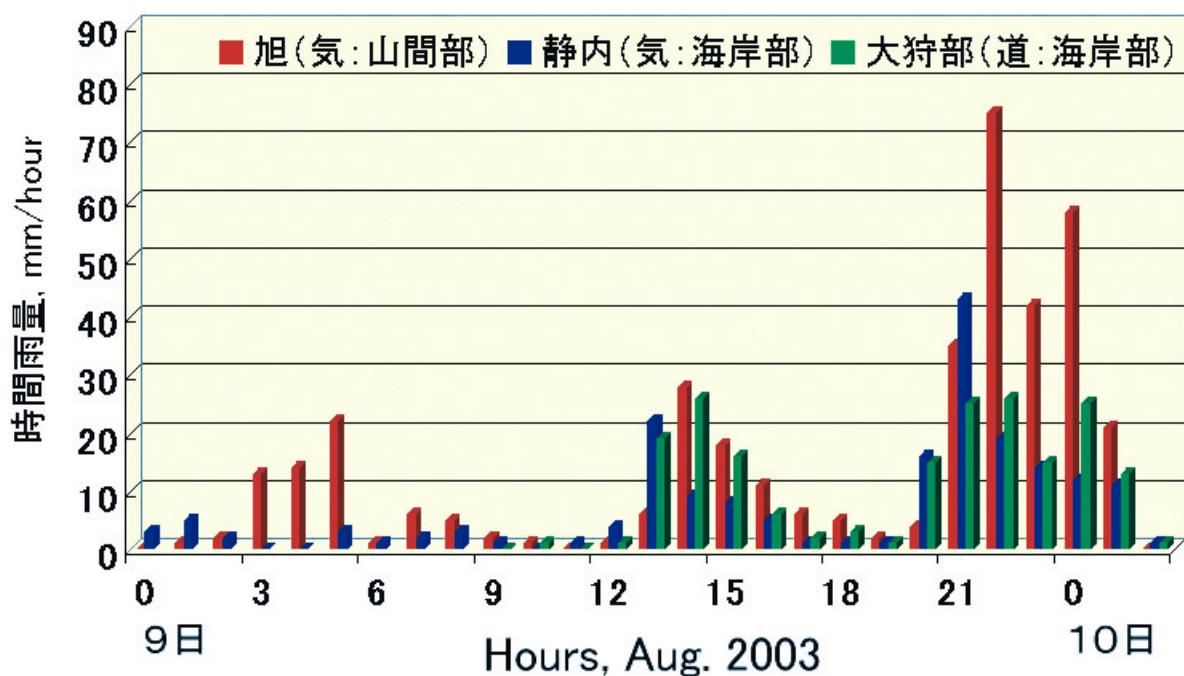
図2 山間部の旭町の雨量と海岸近くの静内町および大狩部町の雨量の時間変化

Fig. 2 The rainfall spells at Asahi Town in the mountains, Shizunai Town and Ohokaribe Town near the coast.

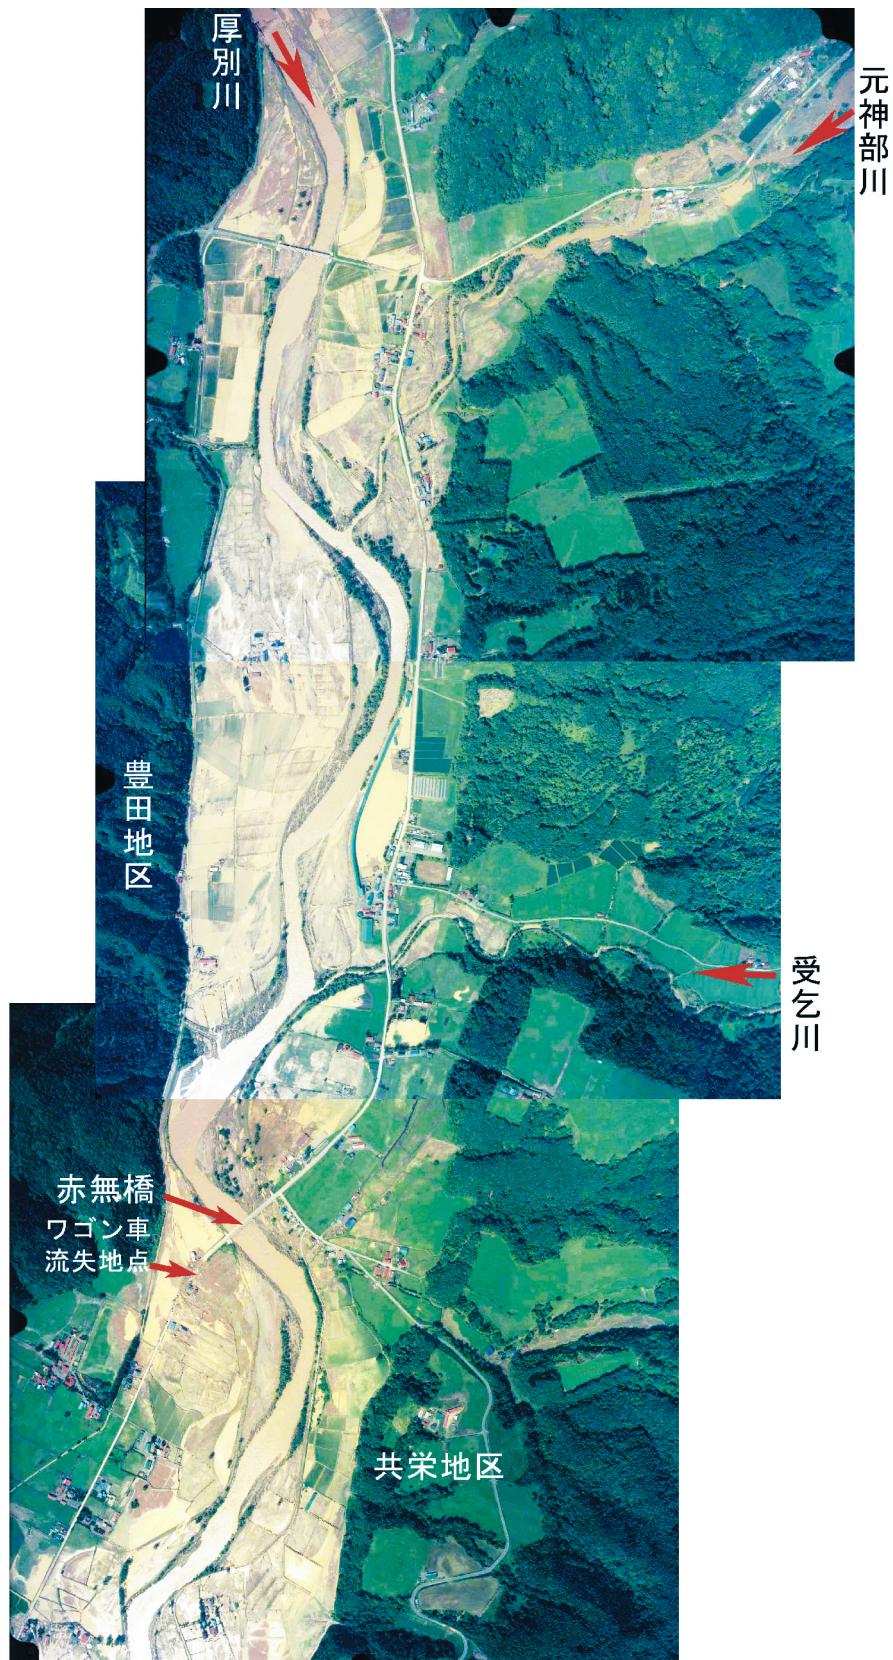
図絵4 門別町と新冠町の境界付近の厚別川沿い低地の浸水被害状況。河川沿いの氾濫源では激しい浸水被害が発生している一方で、河岸段丘上の微高地では浸水被害を免れている（株式会社シン技術コンサル提供、平成15年8月10日撮影）。

Fig. 4 Flood damage on the flood plain along the Appetsu River near the border of Monbetsu Town and Niikappu Town. There was little flood damage in the slight highlands on the riverbank step hill along the Atsubetsu River, comparing the severe flood damage on the low land along the river (courtesy of the Shingijyutsu-konsaru Co., taken on Aug. 10, 2003).

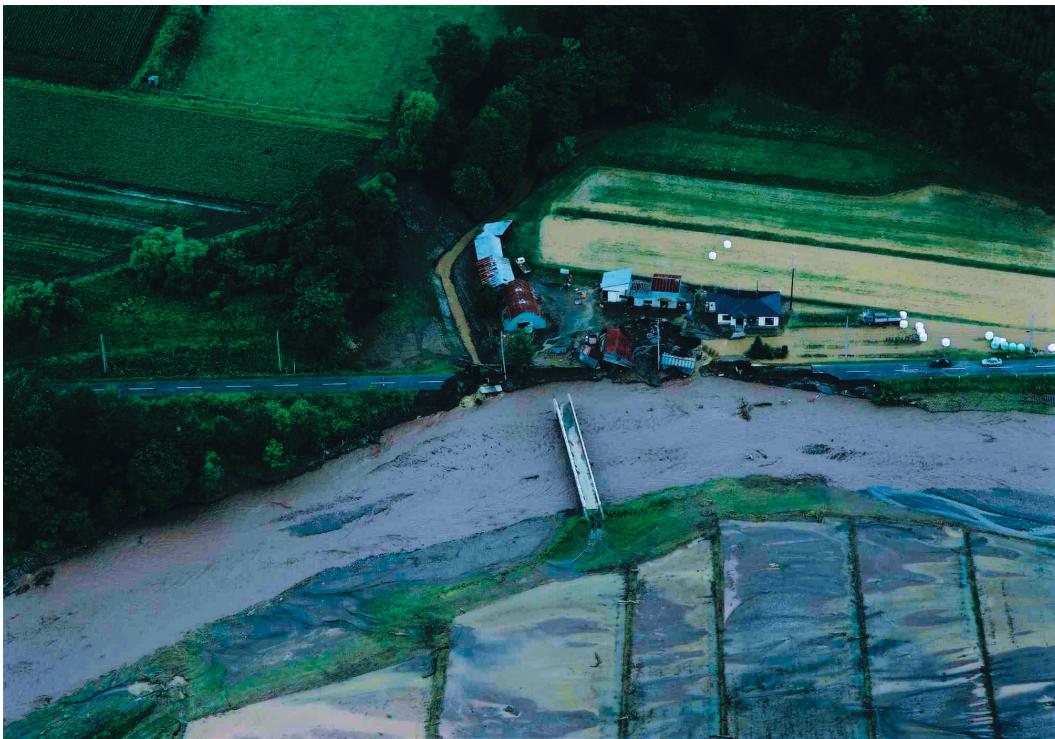
口絵 5 平取町旭地区の貫別川沿い道路の欠壊・橋の流失状況（株式会社シン技術コンサル提供，平成 15 年 8 月 10 日撮影）

Fig. 5 Collapse of the road and damaged bridge crossing the Nukibetsu River in Asahi district of Biratori Town (courtesy of the Shingijyutsu-konsaru Co., taken on Aug. 10, 2003).

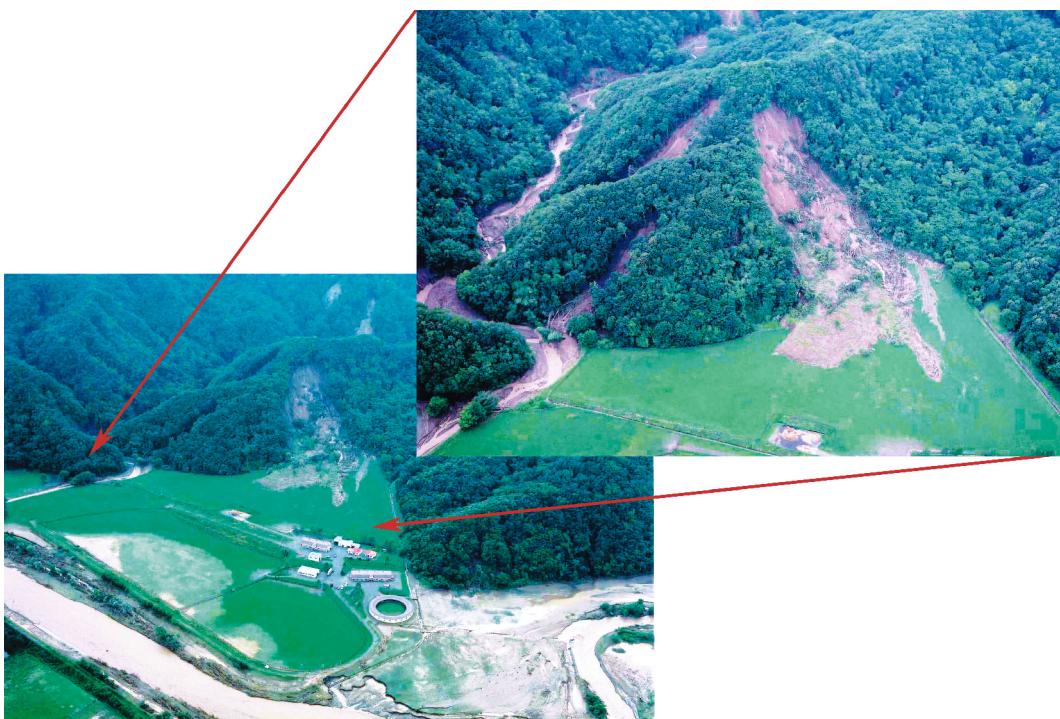
図絵 8 門別町正和地区の厚別川右支川沿い斜面の崩壊による流木生産および河川への土砂・流木の流出状況（株式会社シン技術コンサル提供，平成 15 年 8 月 10 日撮影）

Fig. 8 Mad and driftwood flowing into the Appetsu River in Showa district of Monbetsu Town, which were produced by collapses of the slope along the right tributary of the river (courtesy of the Shingijyutsu-konsaru Co., taken on Aug. 10, 2003).

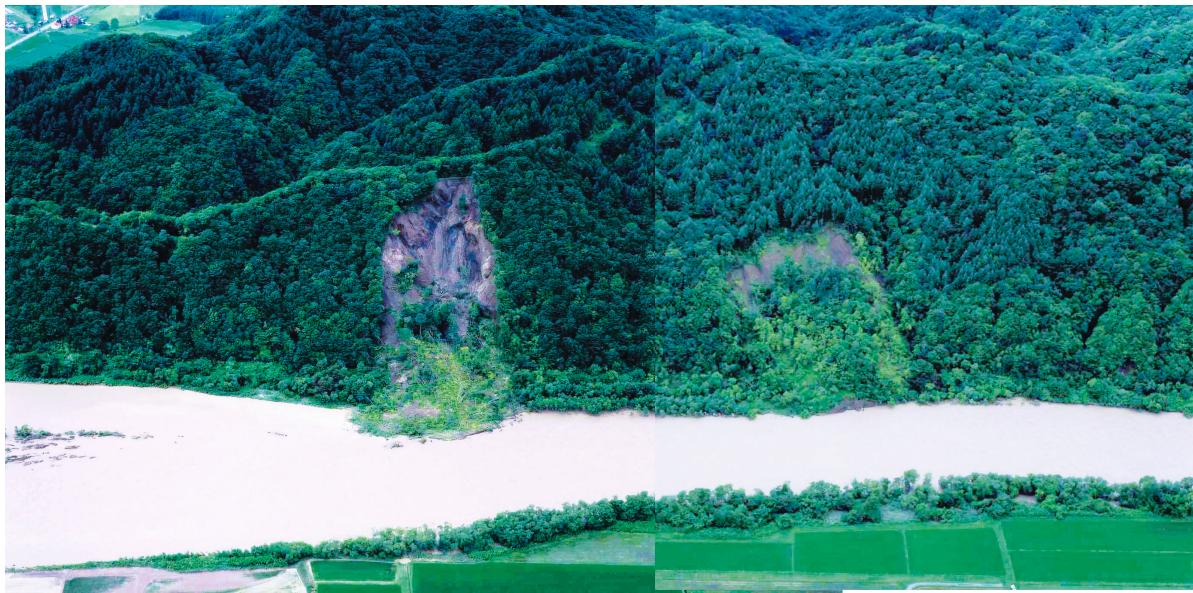
図9 穂別町栄付近の鶴川右岸の斜面崩壊状況、多量の土砂と流木が河川に流れ込む（株式会社シン技術コンサル提供、平成15年8月10日撮影）。

Fig. 9 Collapse on the right side rive slope along the Mu-kawa River around Sakae district of Hobetsu Town, which produced huge mad and driftwood flowing into the river (courtesy of the Shingijyutsu-konsaru Co., taken on Aug. 10, 2003).

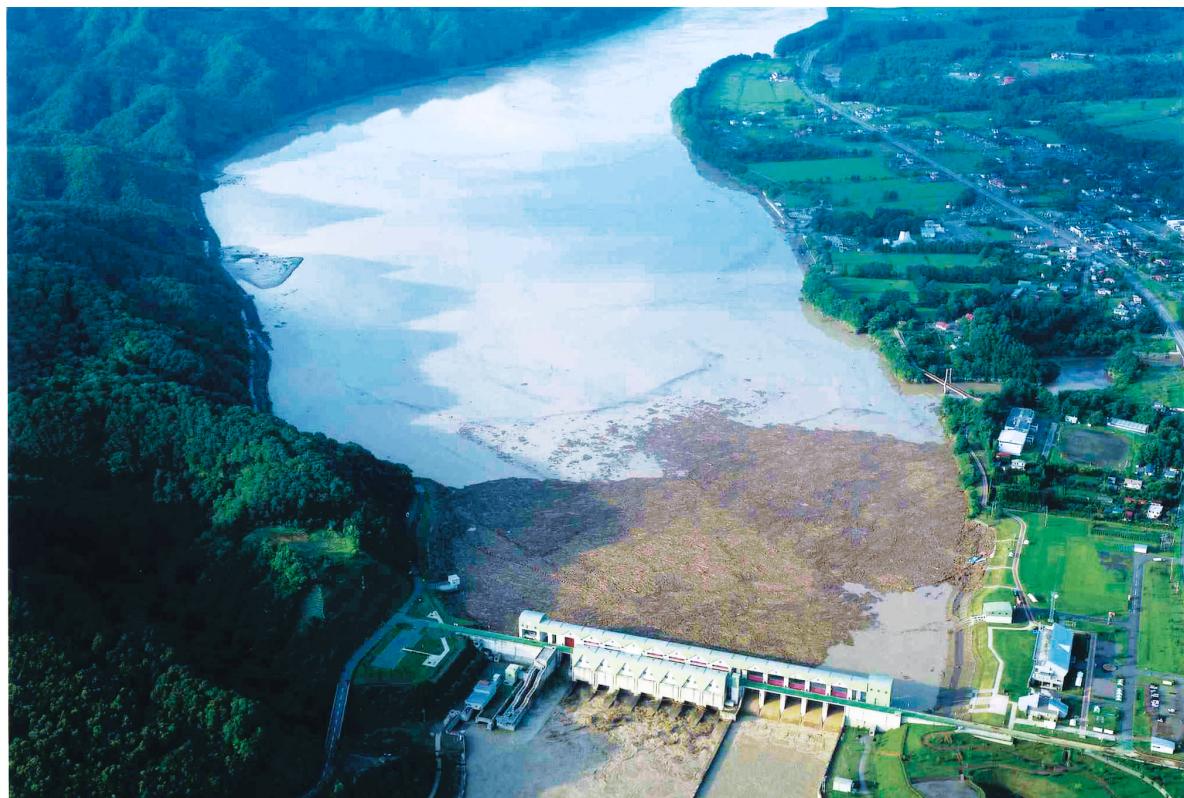
図10 沙流川上流の二風谷ダムで堰き止められた流木。流木量は6万7千m³と推定された（2003年9月5日現在、株式会社シン技術コンサル提供、2003年8月10日撮影）。

Fig. 10 Huge quantities driftwood trapped in the Nibutani Dam Reservoir on the Saru River. The volume of the driftwood was estimated at 67,000 m³ on Sep. 5, 2003 (courtesy of the Shingijyutsu-konsaru Co., taken on Aug. 10, 2003).

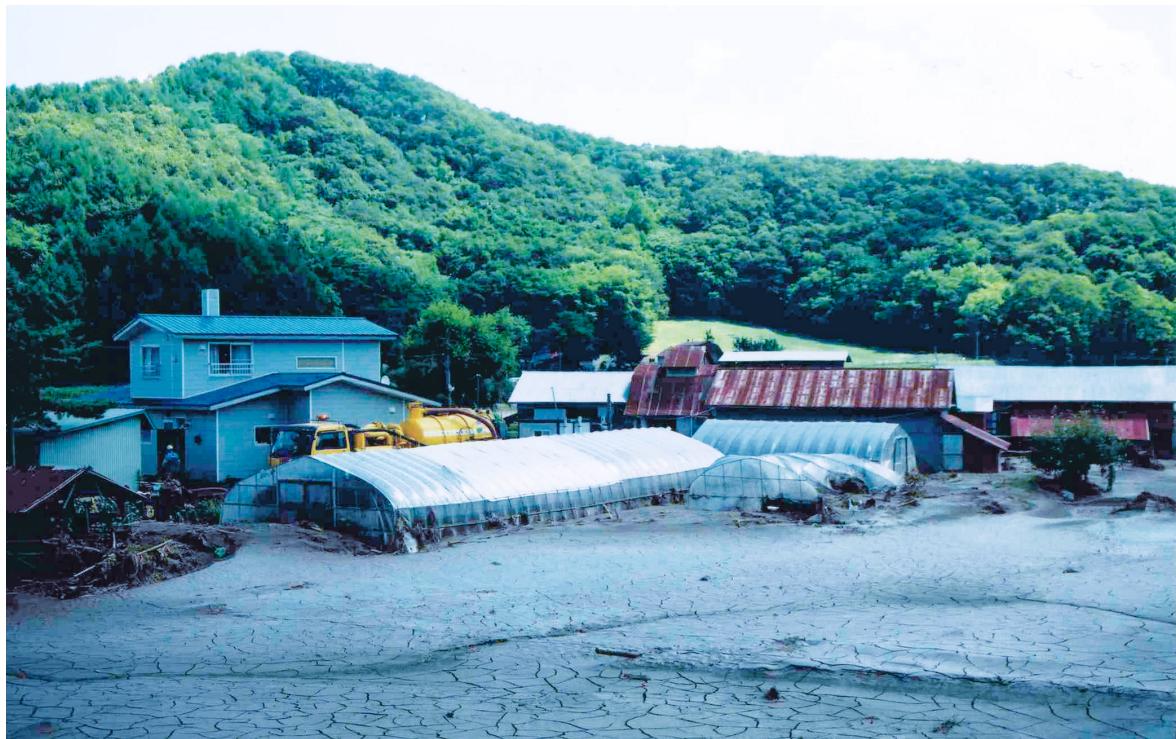
図11 平取町貴別町御幸通り付近での洪水後の泥の堆積状況（平取町提供，平成15年8月13日撮影）

Fig. 11 Accumulation of the mud over the flooded area in Saiwai-dhori of the Nukibetsu district, Biratori Town (courtesy of Biratori Town, taken on Aug. 29, 2003).

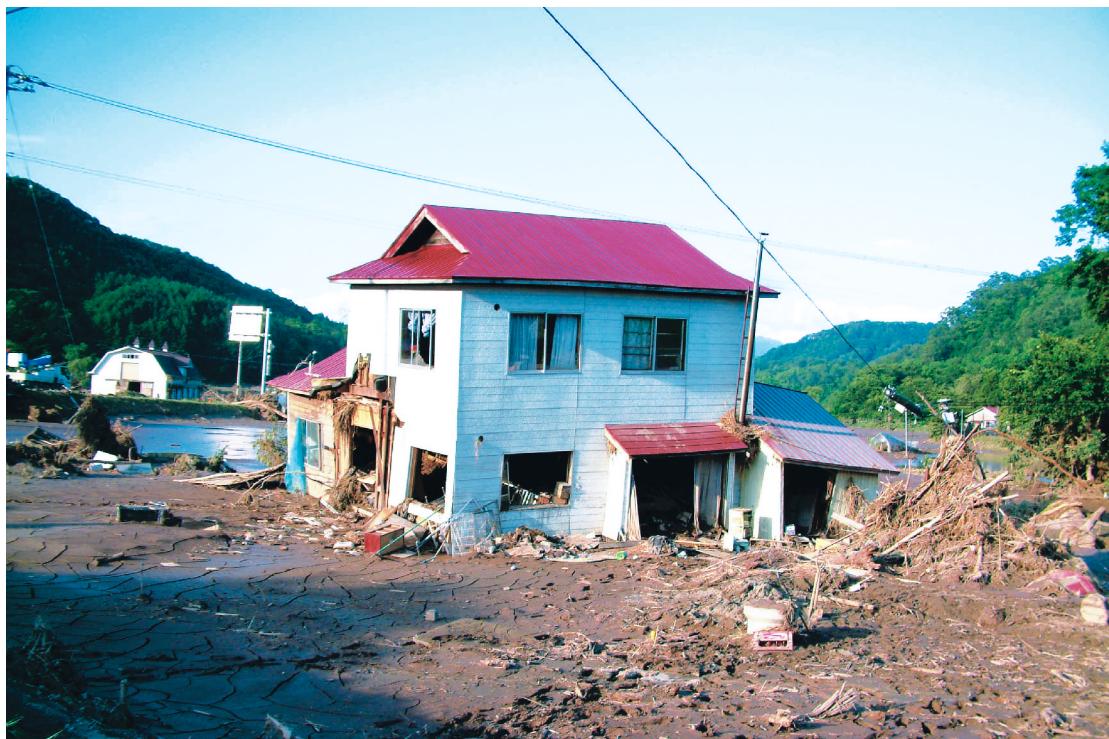
図12 新冠町美宇木原地区比宇川沿い家屋の浸水被害状況（新冠町提供）

Fig. 12 Damaged house by the high flood along the Hiu River in Biu-Kihara district of Niikappu Town (courtesy of the Niikappu Town).

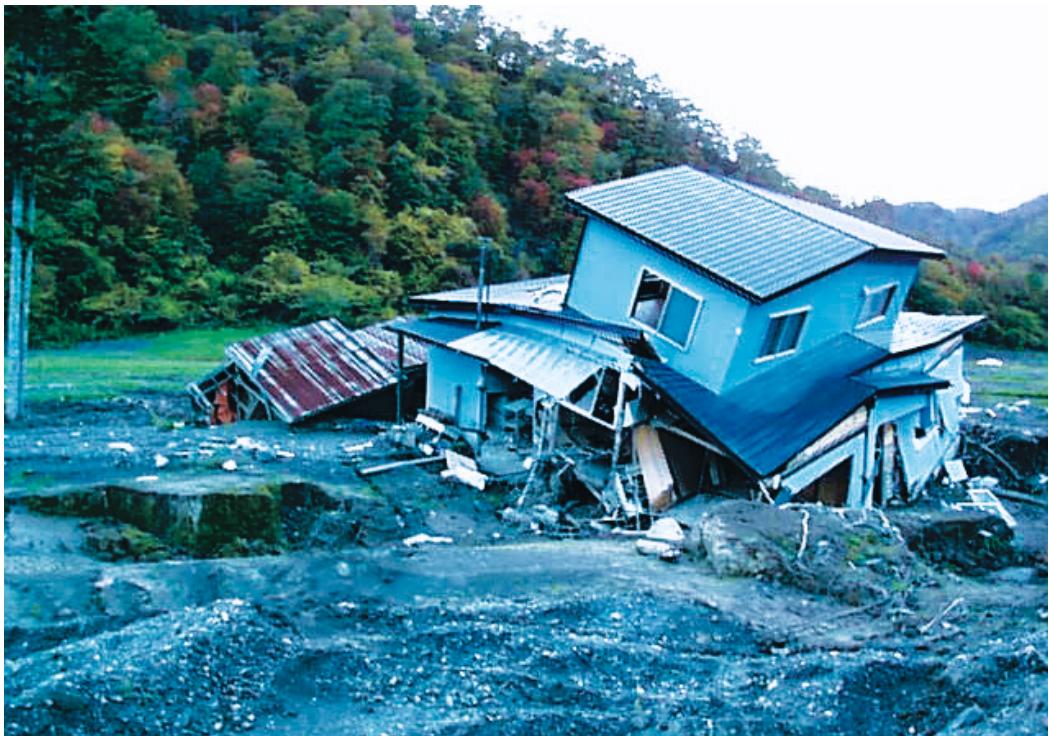
口絵 13 門別町豊田地区の厚別川沿い氾濫源での激しい洪水により被災した家屋。ここで、10日5時半頃、北海道警察のヘリにより、傾きかけていた家の屋根から一家7名が危ないところを救助された(平成15年8月16日撮影)。

Fig. 13 Houses damaged by the severe flooding on the flood plain along the Appetsu River, Toyota district of Monbetsu Town, where seven people of the family were rescued from the roof of the leaning house by the helicopter of the Hokkaido Police about 5:30, Aug. 10, 2003.

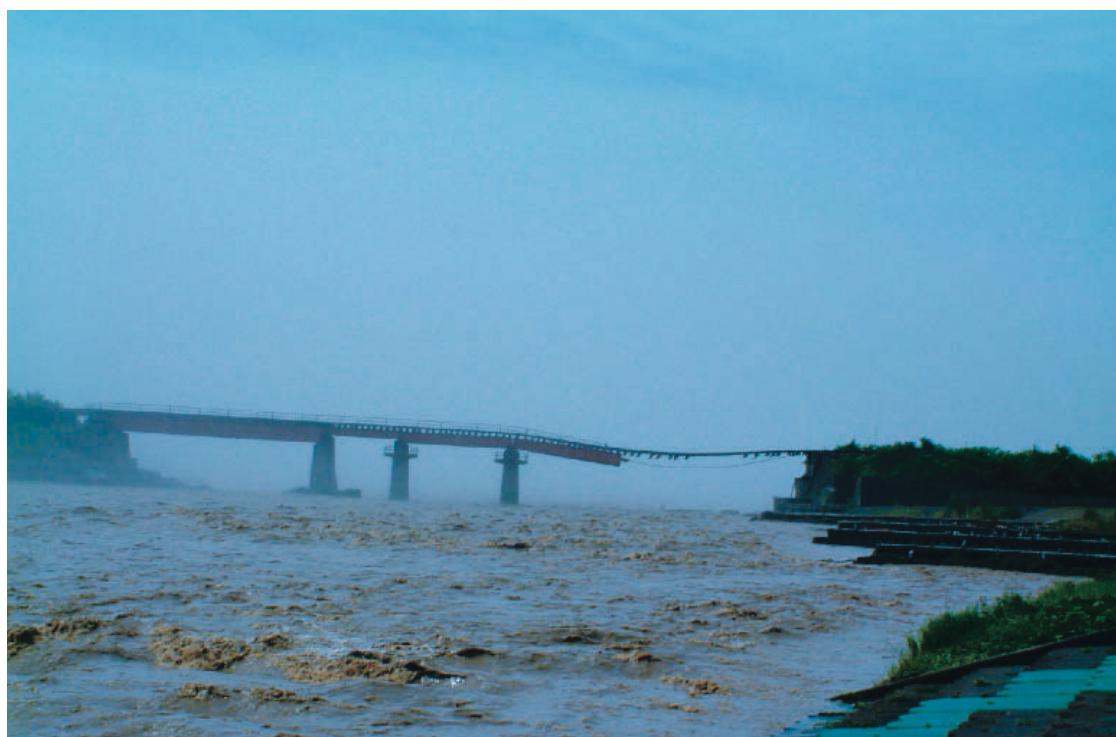
口絵 14 JR 日高線新冠古川第1鉄橋被災状況(新冠町提供)

Fig. 14 Damaged bridge of Niikappu-furukawa-No.1, JR Hidaka Railway crossing the Niikappu River (courtesy of the Niikappu Town).
