図1 奄美市住用支所周辺地図

口絵 1 住用町西仲間地区 冷川右岸 増水の様子 2010 年 10 月 20 日 (奄美市役所提供)
 短時間の間に一気に増水したことが分かる。

口絵 5 奄美市住用支所前の増水の様子 (奄美市役所提供)
Photo 5 Rise in water level in front of Sumiyo Town Branch Office, Amami City (Photo provided by Amami City Office).

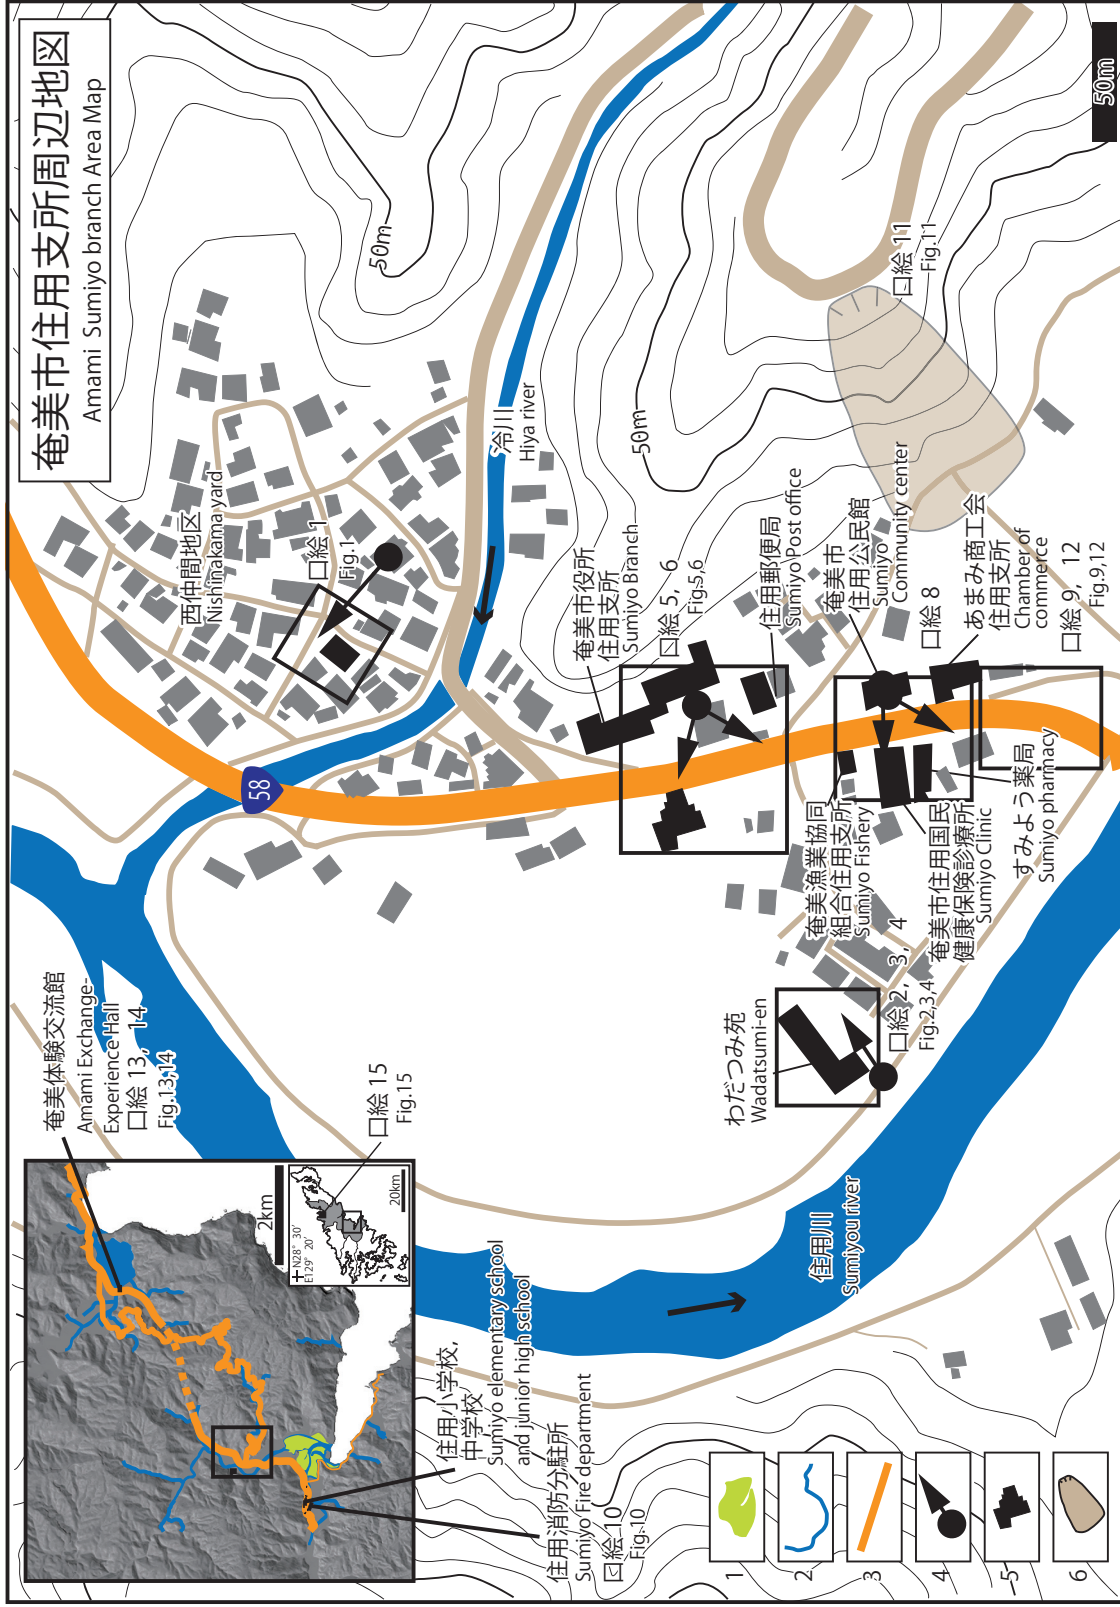
[基図；NTT 空間情報の Geospace を使用し鈴木比奈子が加筆・修正。陰影図；国土地理院基盤地図情報(10 m DEM) を用いてカシミール 3D で作成]
 凡例：1. マングローブ林, 2. 水系, 3. 主要道路, 4. 撮影方向, 5. 主要な建物, 6. 地すべり

Fig.1 Map of around Sumiyo Town Branch Office.

[This map were corrections by Hinako SUZUKI. Base map was used for NTT-GEOSPACE CORPORATION and GSI issue 10 m DEM. And shaded made by Kashimir3D.]
 The legend 1. Mangrove forests, 2. Water area, 3. Main street, 4. Shooting direction, 5. Main building, 6. Land slide.

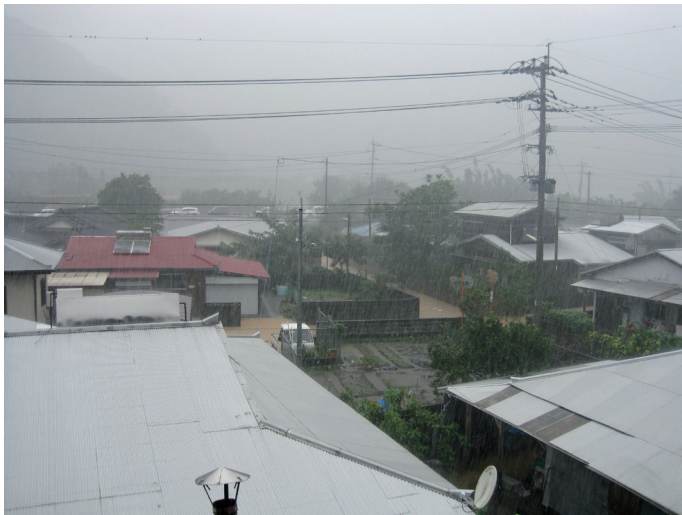
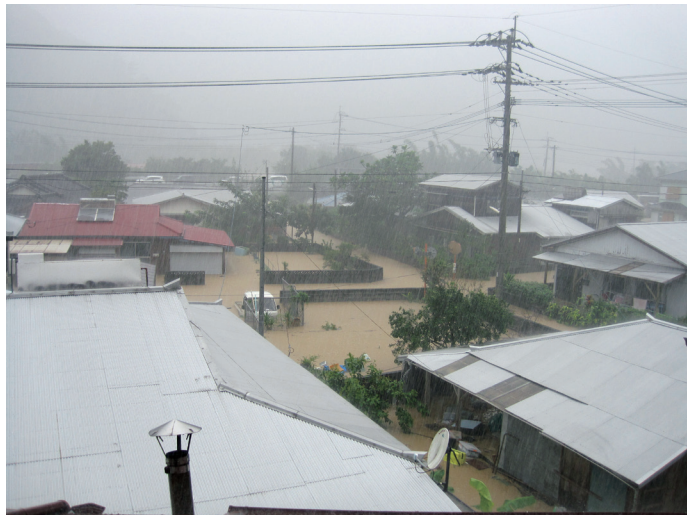
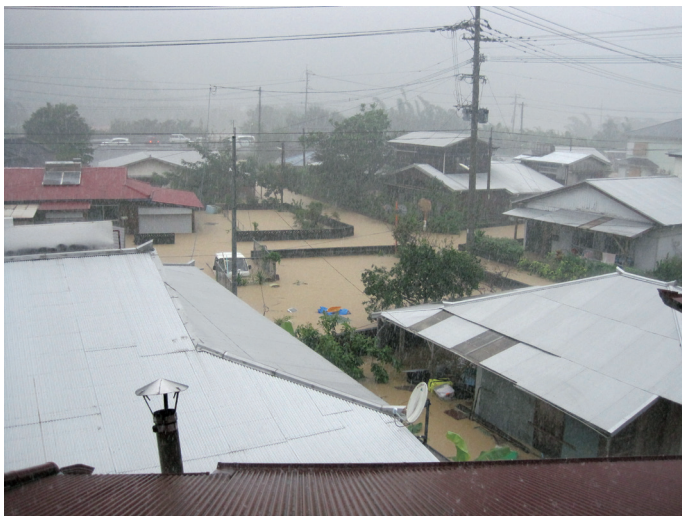
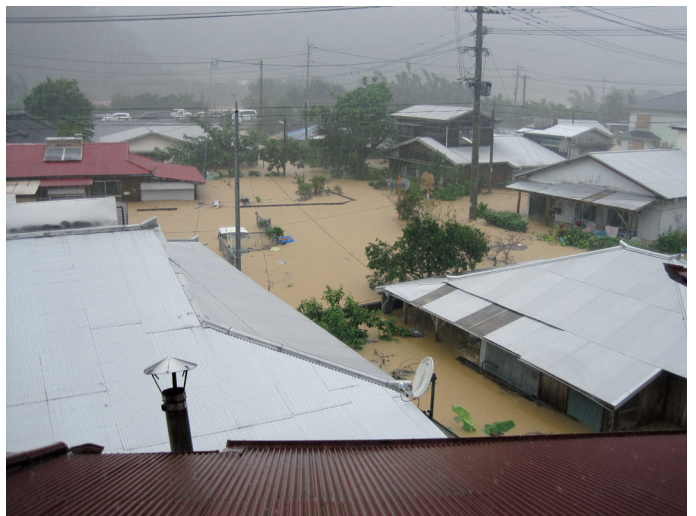
Photo 1 Rise in water level along the right bank of the Hiya River in Nishinakama District, Sumiyo Town,
 on October 20, 2010 (Photo provided by Amami City Office).
 The water level rose in a very short period of time.

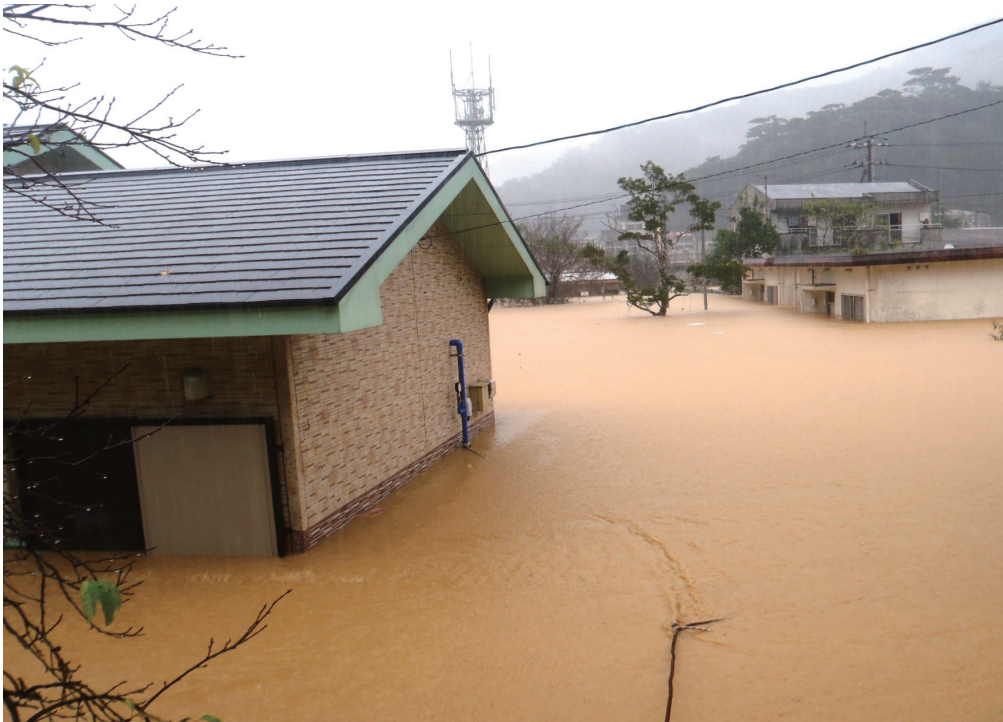
口絵 2 住用町西仲間地区 わだつみ苑 2010年10月20日
15:24 (住用総合支所職員提供)

Photo 2 Group Home Wadatsumi-en in Nishinakama District, Sumiyo Town, at 15:24 on October 20, 2010 (Photo provided by Sumiyo Town General Branch Office staff).

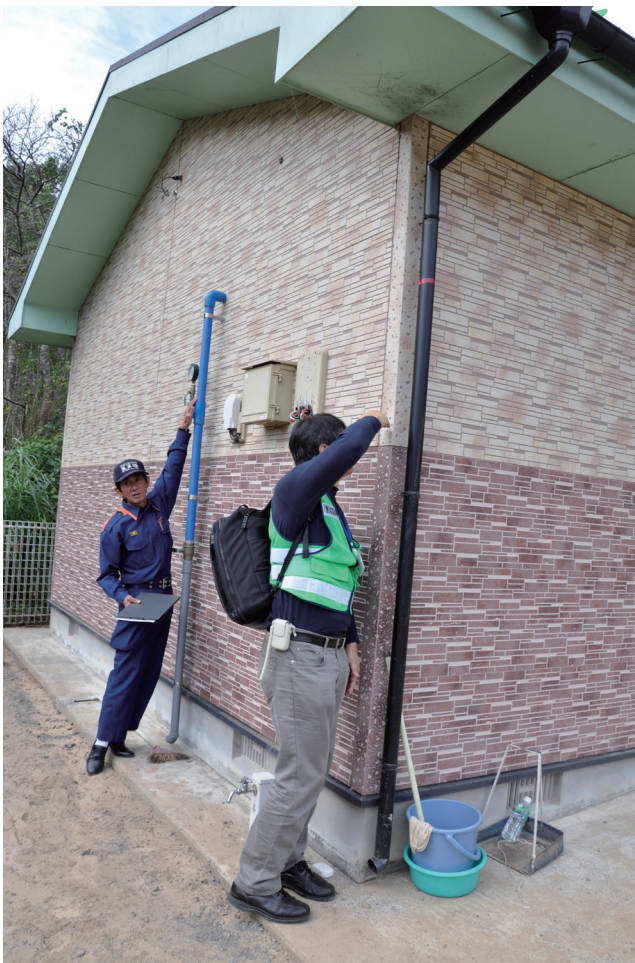
口絵 3 住用町西仲間地区 わだつみ苑
(撮影日: 2010年11月12日)
図中矢印(高さ 250 cm)付近が、当日の最高水位

Photo 3 Group Home Wadatsumi-en in Nishinakama District, Sumiyo Town (Shooting date: November 12, 2010). The arrows in the photo indicate the highest water level of the day (about 250 cm high).

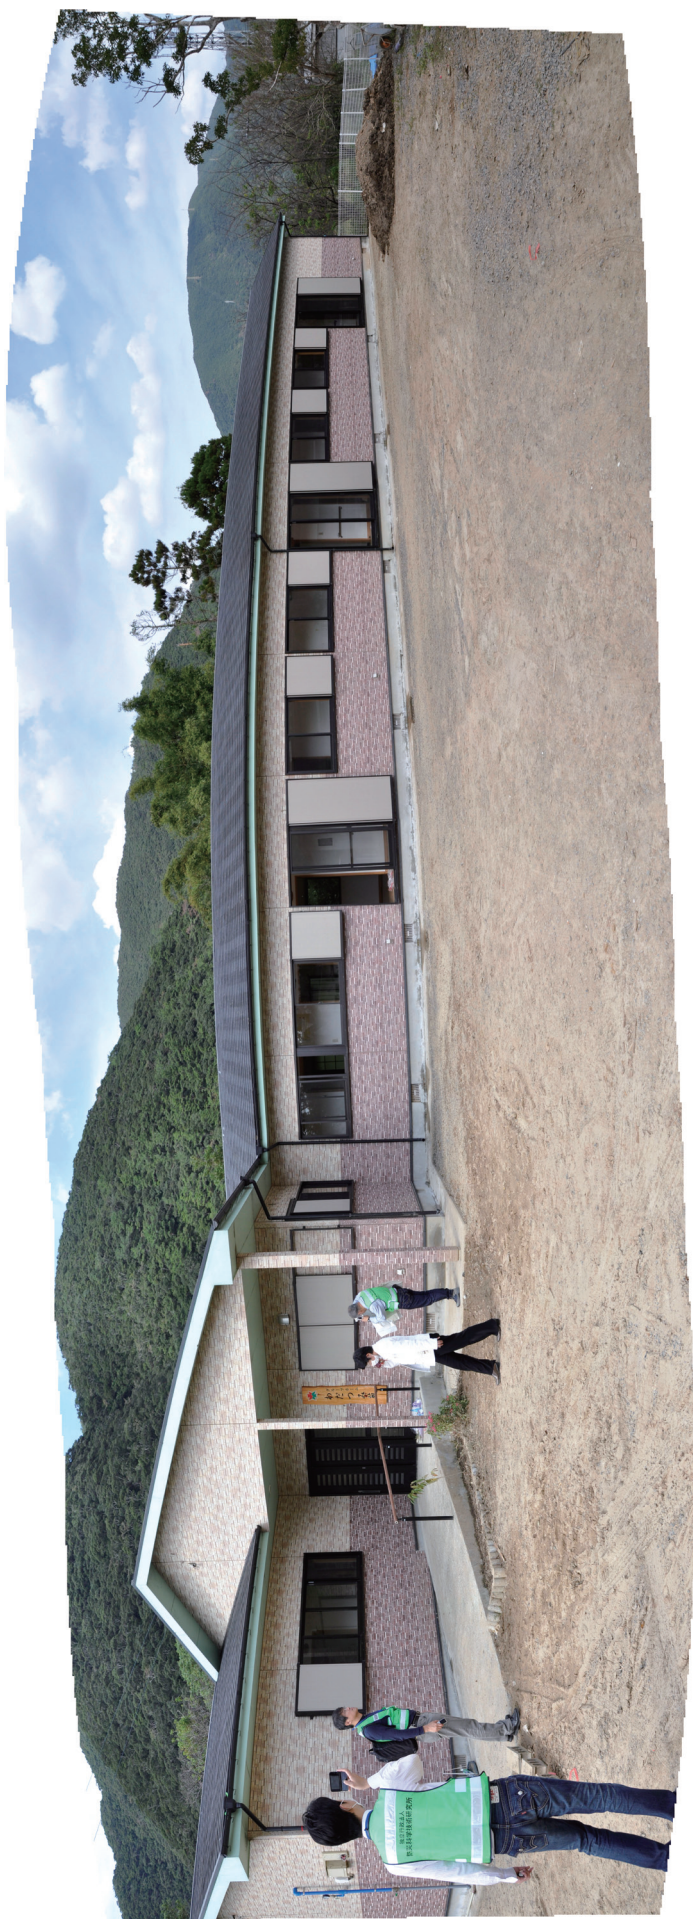
口絵 4 住用町西仲間地区 わだつみ苑 正面全景(パノラマ合成写真, 撮影日: 2010 年 11 月 12 日)

わだつみ苑の建物はバリアフリーを考慮して, 平屋建ての構造をしていることが分かる. わだつみ苑の背後には住用川が流下している.

Photo 4 Panoramic front view of Group Home Wadatsumi-en in Nishinakama District, Sumiyo Town (Panoramic composite picture, Shooting date: November 12, 2010).
Wadatsumi-en is a one-story building to create a barrier-free environment. The Sumiyo River flows behind the building.

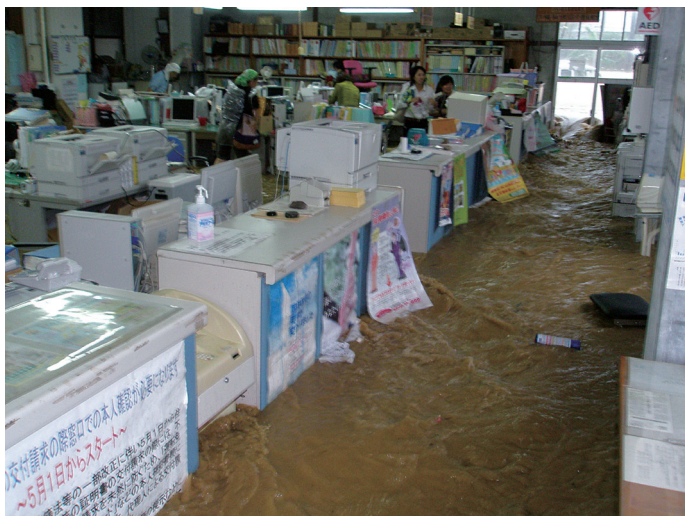
口絵 6.1 2010 年 10 月 20 日 12 : 53 (奄美市役所提供)

口絵 6 住用支所内の床上浸水の様子(口絵 6.1, 6.2 奄美市役所提供)
12 : 53 頃から床上浸水が始まり(口絵 6.1), 翌日の 11 : 00 頃には水がひいたことが分かる(口絵 6.2). 口絵 6.3
は口絵 6.1 の反対側から撮影した 3 週間後の支所内の様子. 支所の 1 階部分の床上浸水が 150 cm 以上に達し
たことが分かる(口絵 6.4).

Photo 6 Inundation above floor level in Sumiyo Town Branch Office (Photo provided by Amami City Office).
The Office started getting inundated above floor level around 12:53 (**Photo 6.1**), and the water receded around 11:00 the
next day (**Photo 6.2**). **Photo 6.3** shows the inside of the Office three weeks after the inundation, which was taken from
the opposite side of **Photo 6.1**. The water level rose to 150 cm or higher above the 1st floor of the Office (**Photo 6.4**).

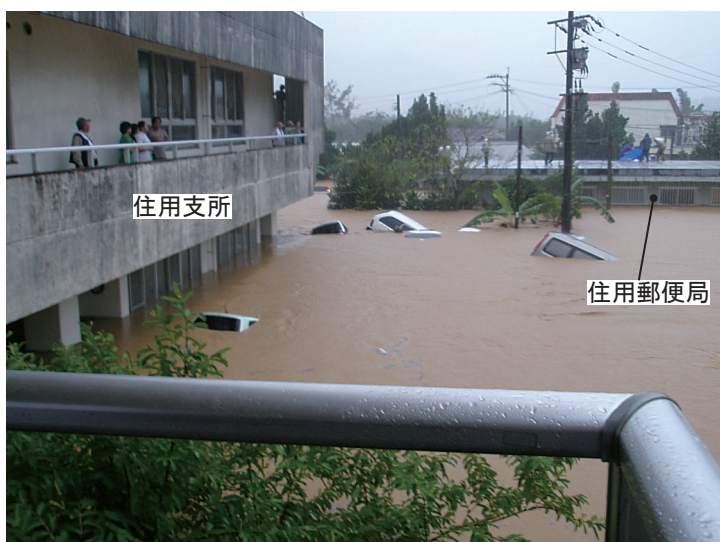
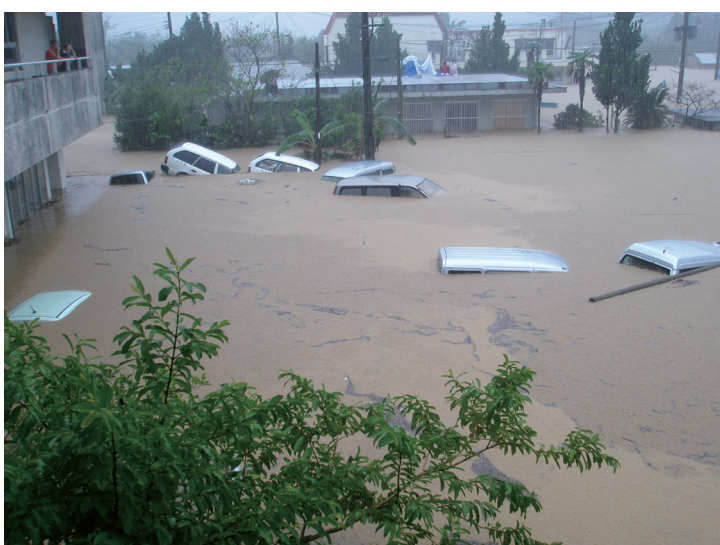
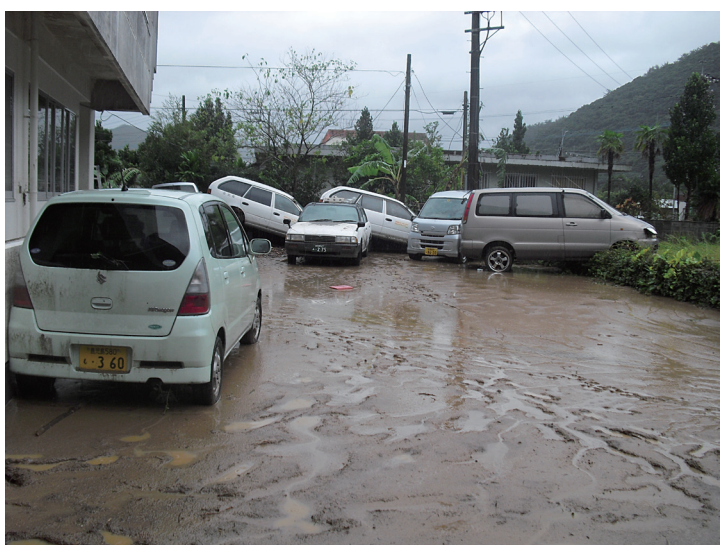
口絵 7 住用支所前と住用郵便局前の増水の様子
写真中央奥の住用郵便局の屋上に郵便局局員が避難している様子が分かる。15 : 00 頃には水位が低下していることが分かる。

Photo 7 Rise in water level in front of Sumiyo Town Branch Office and Sumiyo Post Office.
Postal clerks were evacuating to the roof of Sumiyo Post Office at the back and center of the photo.
The water level lowered around 15:00.

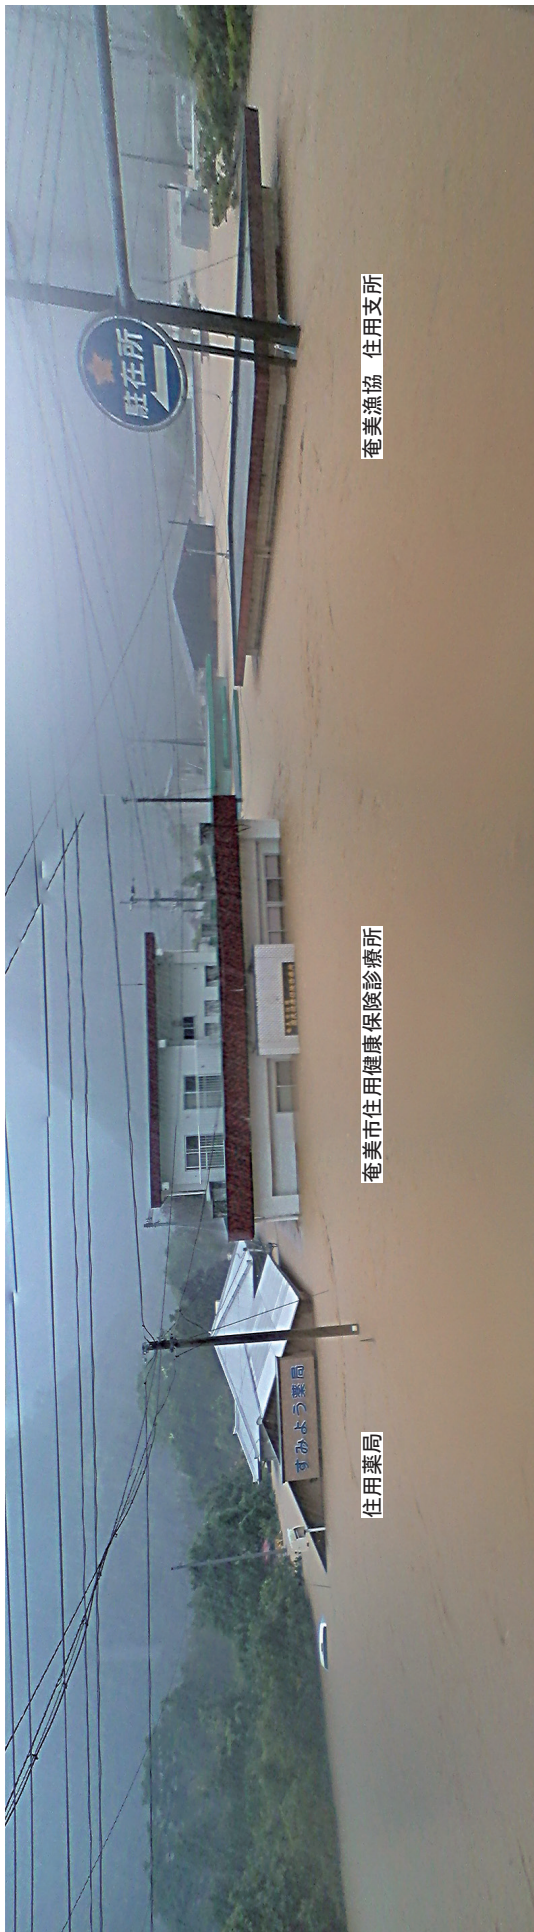
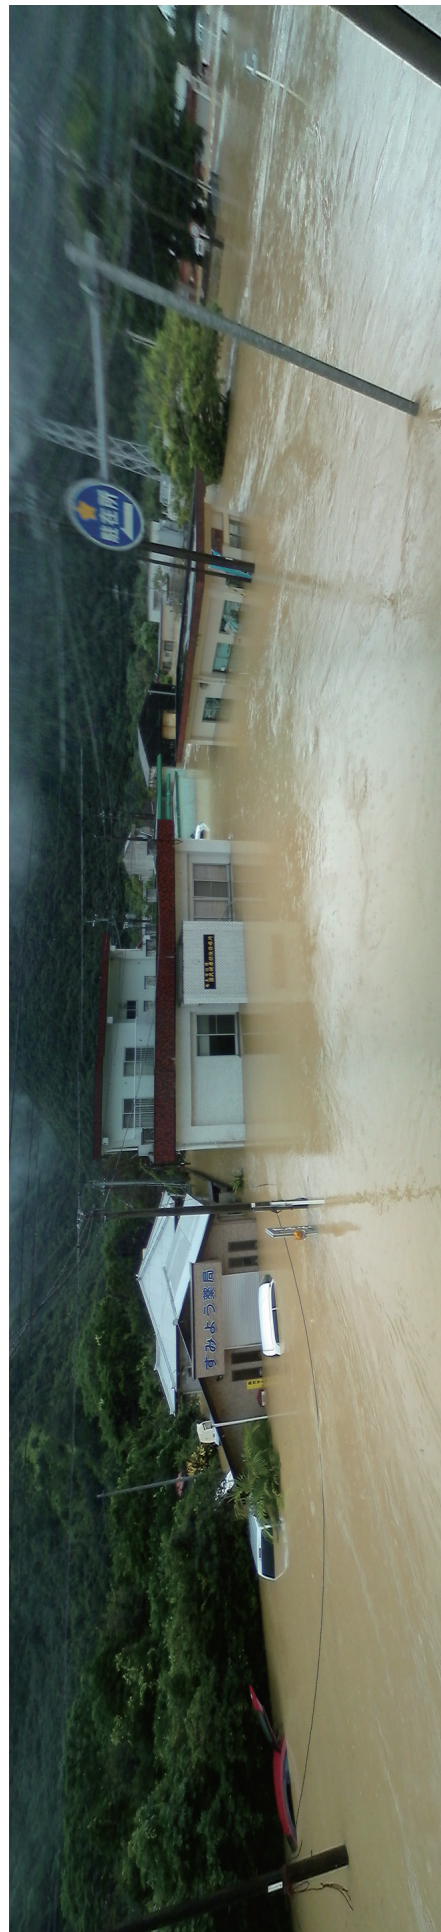
口絵 8 奄美市住用国民健康保険診療所前 増水の様子

当日は 13 : 30 頃が最高水位となり、16 : 15 頃には水が引き始めていることが分かる。診療所に隣接する奄美漁協住用支所は屋根部分を残して 1 階部分はすべて水没してしまったことが分かる。

Photo 8 Rise in water level in front of Sumiyo National Health Insurance Association Clinic in Amami City.

The water level rose to the highest around 13:30 and the water began to recede around 16:15. Excepting the roof, the 1st floor of Sumiyo Branch of Amami Fishery Association adjacent to the Clinic was completely covered with water.

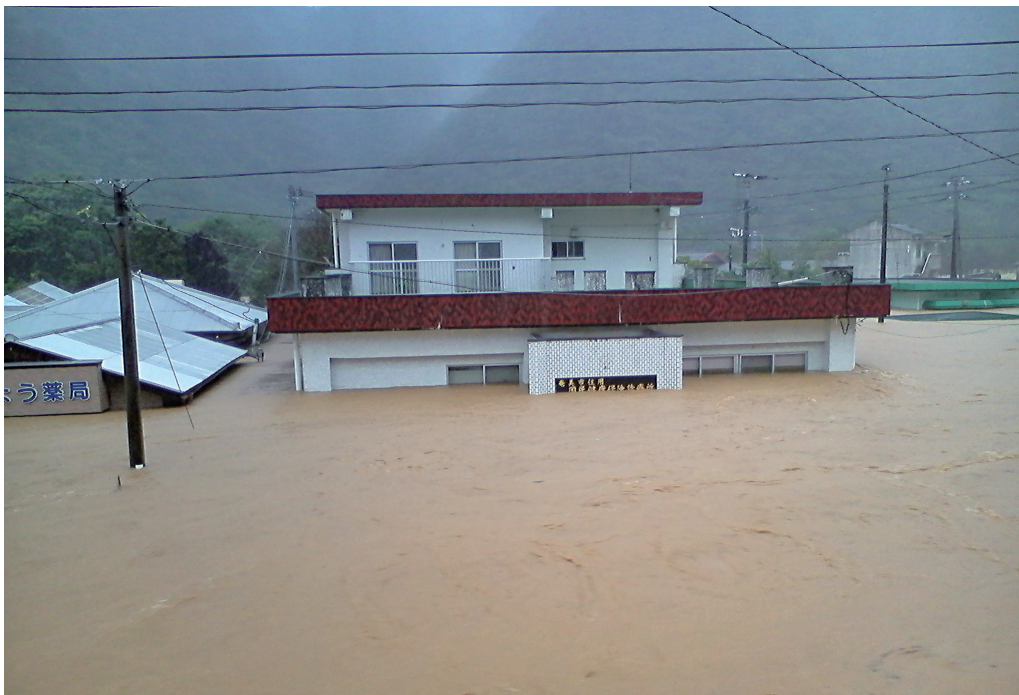
口絵 8.3 2010 年 10 月 20 日 13 : 20 当日の最高水位 (奄美市役所提供)

Photo 8.3 At 13:20 on October 20, 2010 the water level peaked (Photo provided by Amami City Office).

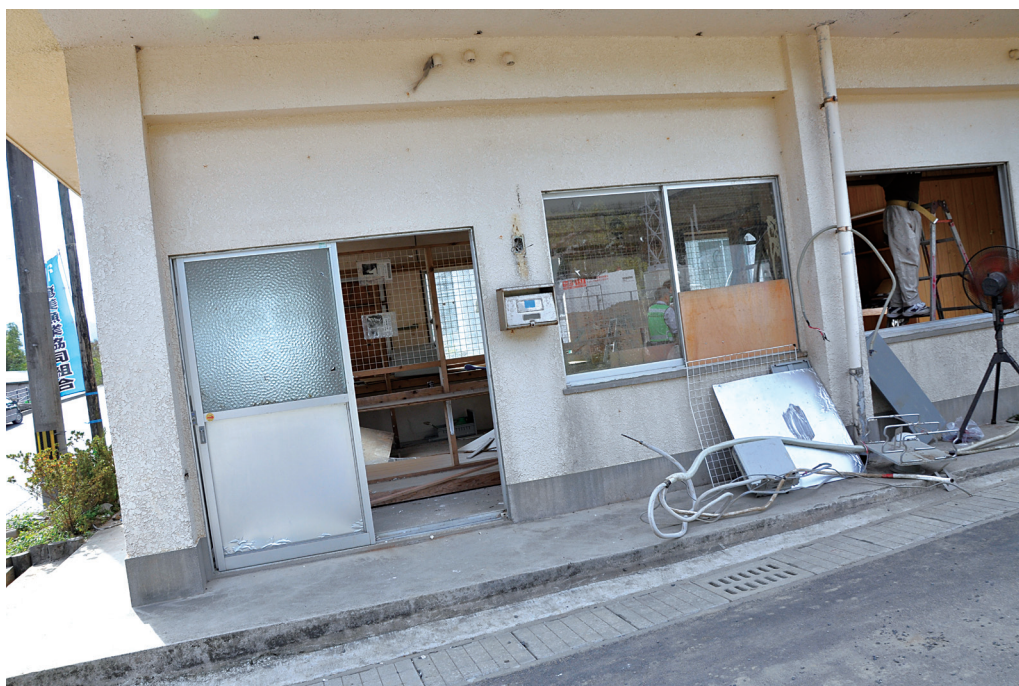
口絵 8.4 豪雨当日天井まで水没した漁協 (撮影日 : 2010 年 11 月 12 日)

Photo 8.4 Water rose to the ceiling of the 1st floor of Fishery Association on the day of heavy rain (Shooting date: November 12, 2010).

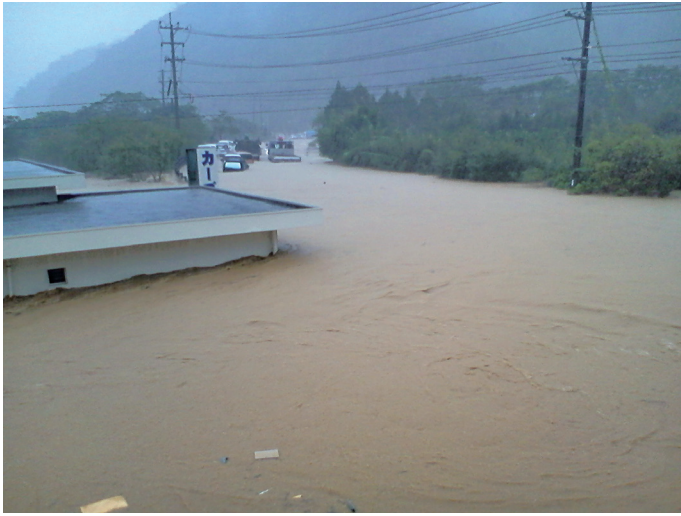
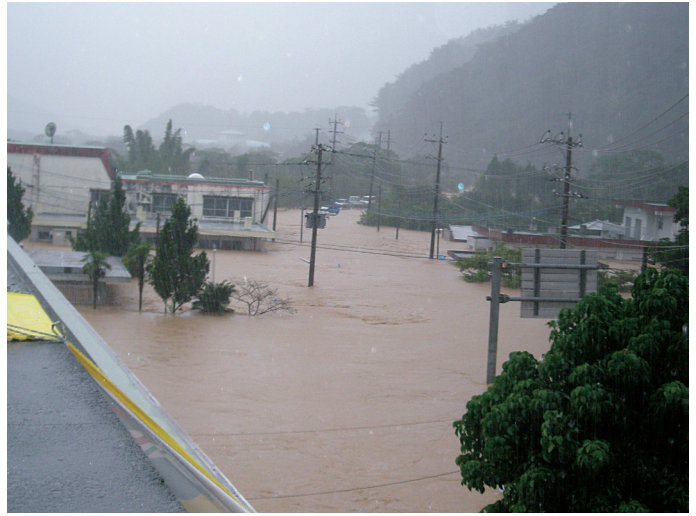
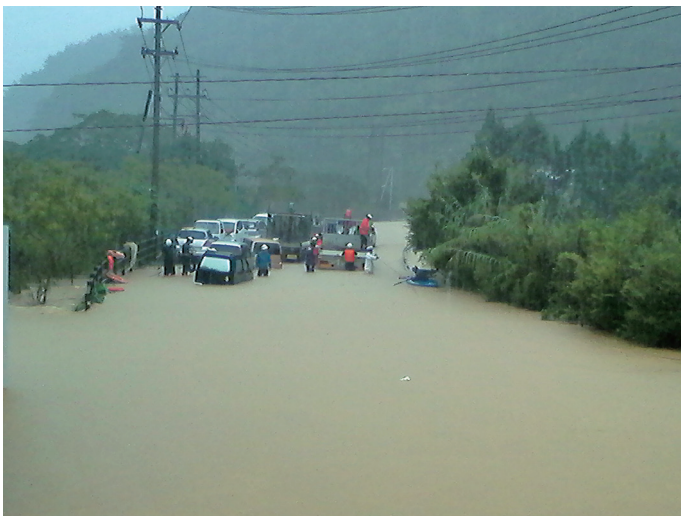
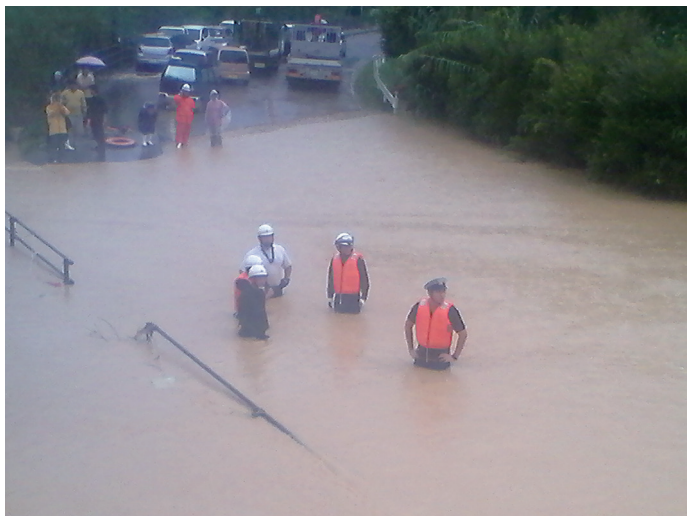
- 口絵 9 商工会議所前 増水の様子(奄美市役所提供)
 車が駐車している場所は住用川を渡る橋の袂に当たる。川の水位が道路と同じ高さまで上がっていたことがうかがえる。
- Photo 9** Rise in water level at Chamber of commerce.
 Where to park the cars were foot bridge going across Sumiyou river. The water level rose to same the load.

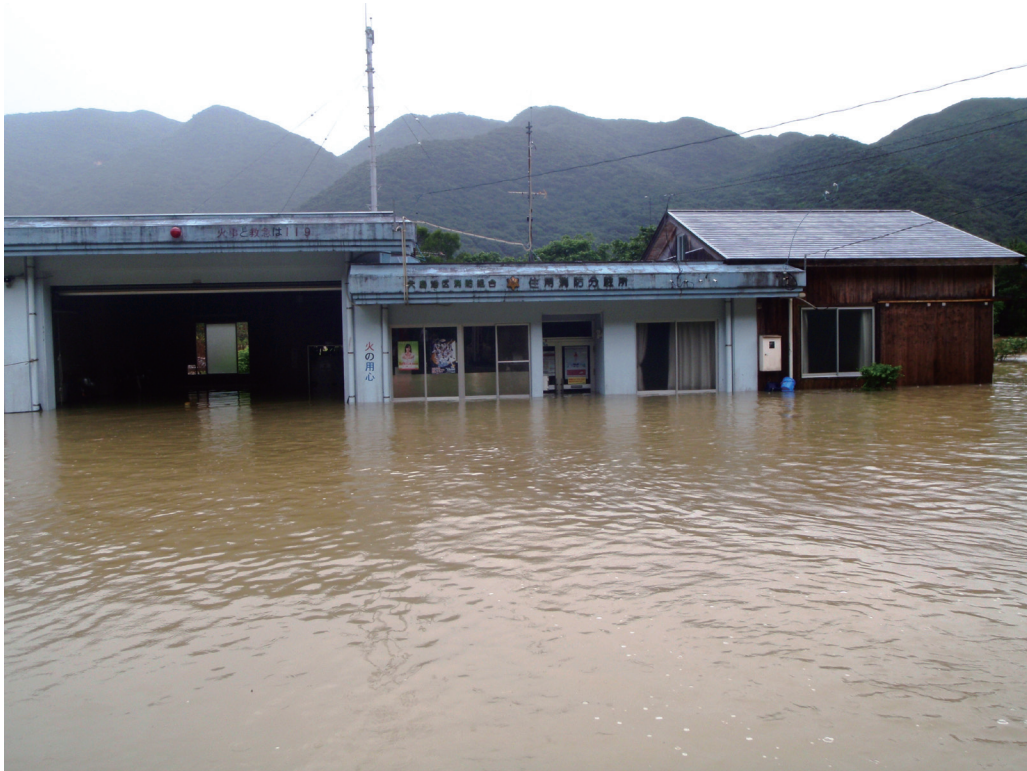
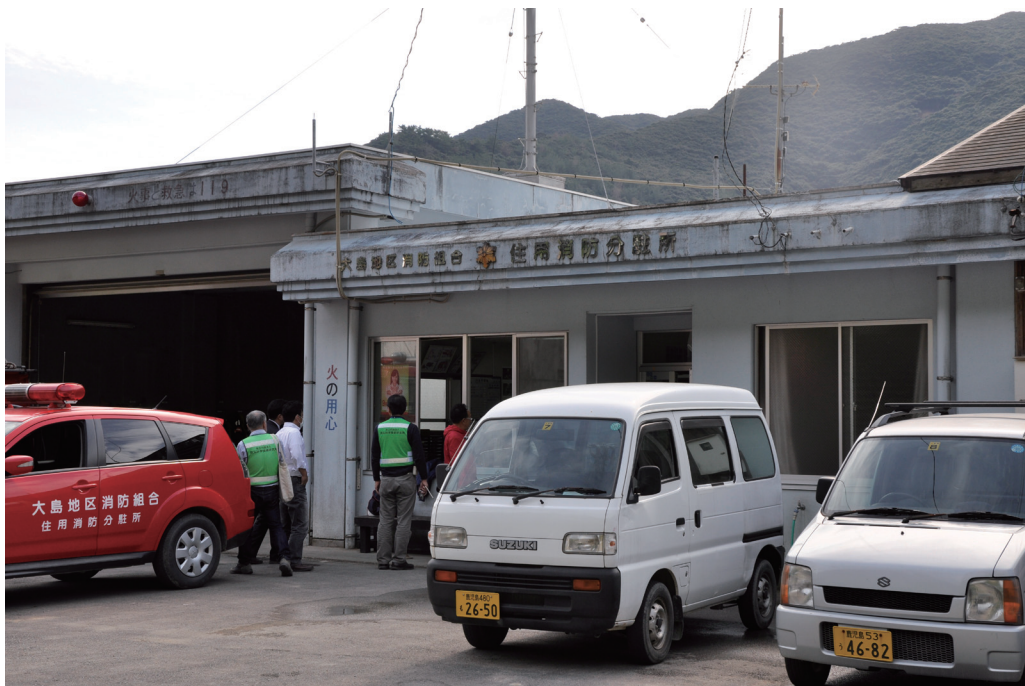
口絵 10 住用消防分駐所 増水の様子

住用川支流の役勝川左岸に位置している住用消防分駐所も、床上浸水に見舞われた。

Sumiyo Fire Substation located on the left bank of the Yakusho River, a tributary of the Sumiyo River, was also flooded above floor level.

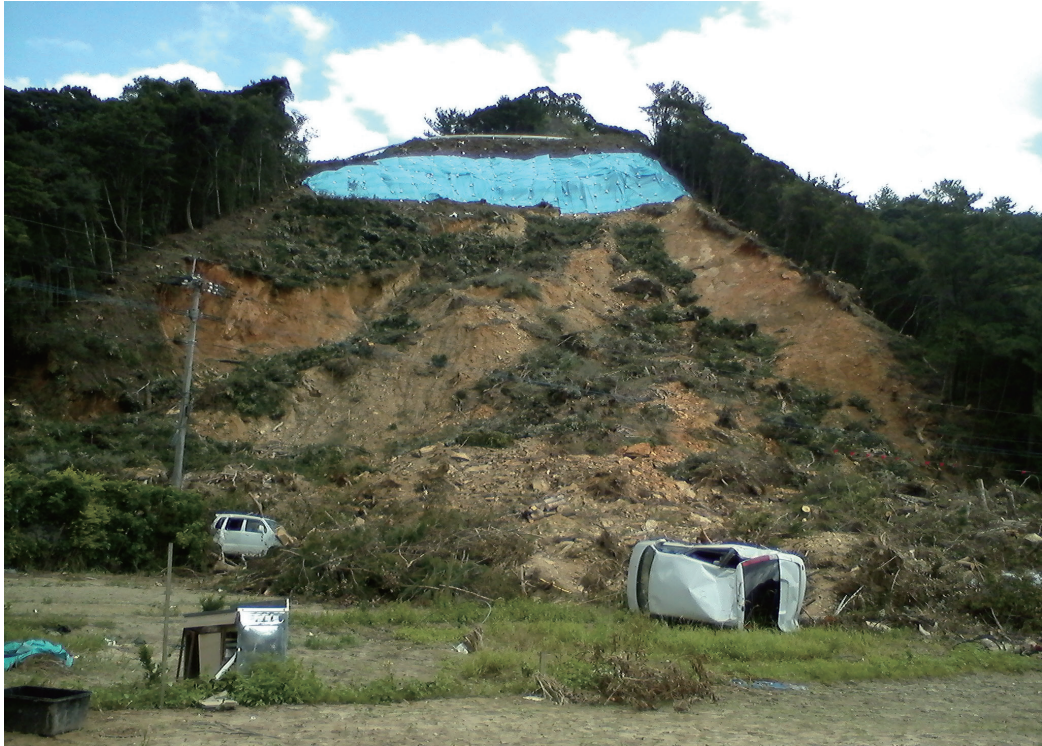
口絵 11 住用支所裏手の斜面災害（撮影日：2010 年 11 月 9 日，奄美市役所提供）

Photo 11 Landslides behind Sumiyo Town Branch Office (Shooting date: November 9, 2010, Photo provided by Amami City Office).

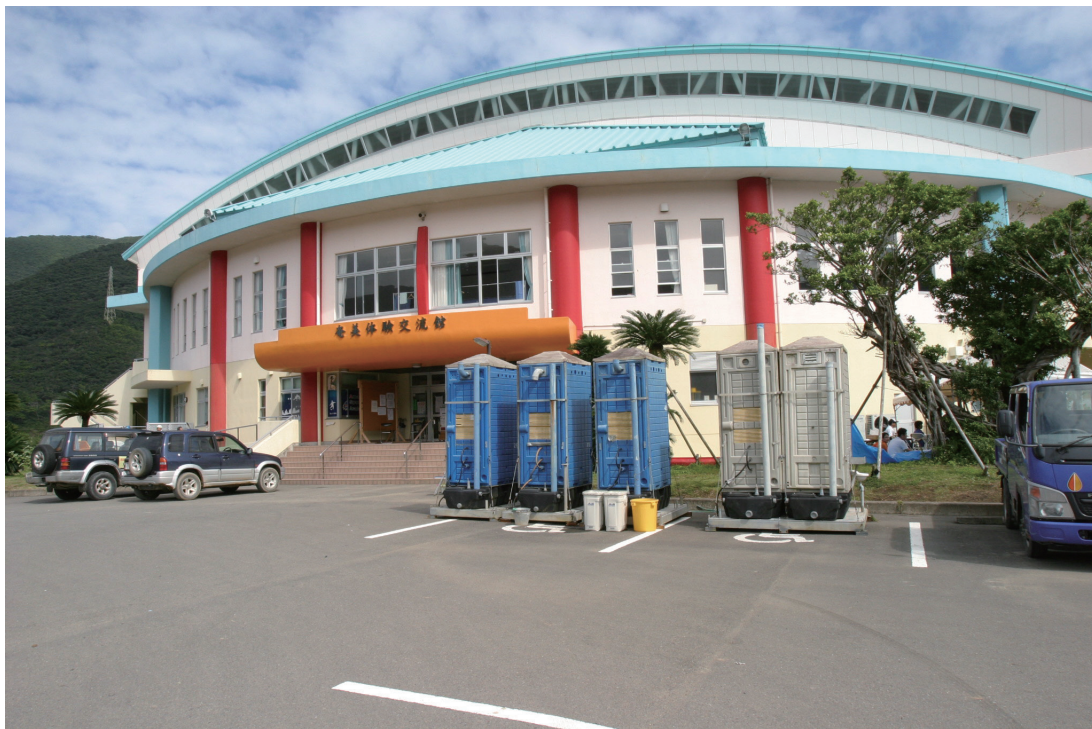
口絵 13 避難所となった奄美体験交流館（撮影日：2010 年 10 月 30 日，奄美市役所提供）
当日，体験交流館入口の階段 6 段目付近まで浸水した。

Photo 13 Amami Exchange-Experience Hall that became the evacuation center (Shooting date: October 30, 2010, Photo provided by Amami City Office).
The water level rose to the 6th step of the stairs at the entrance to the hall.

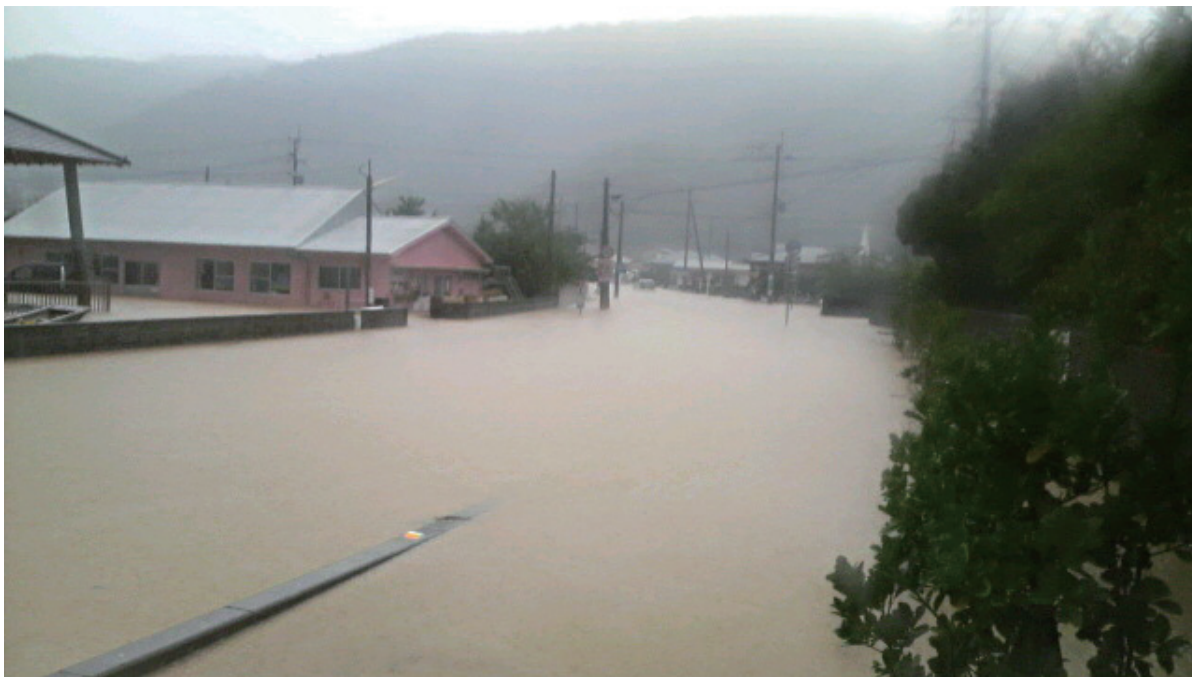
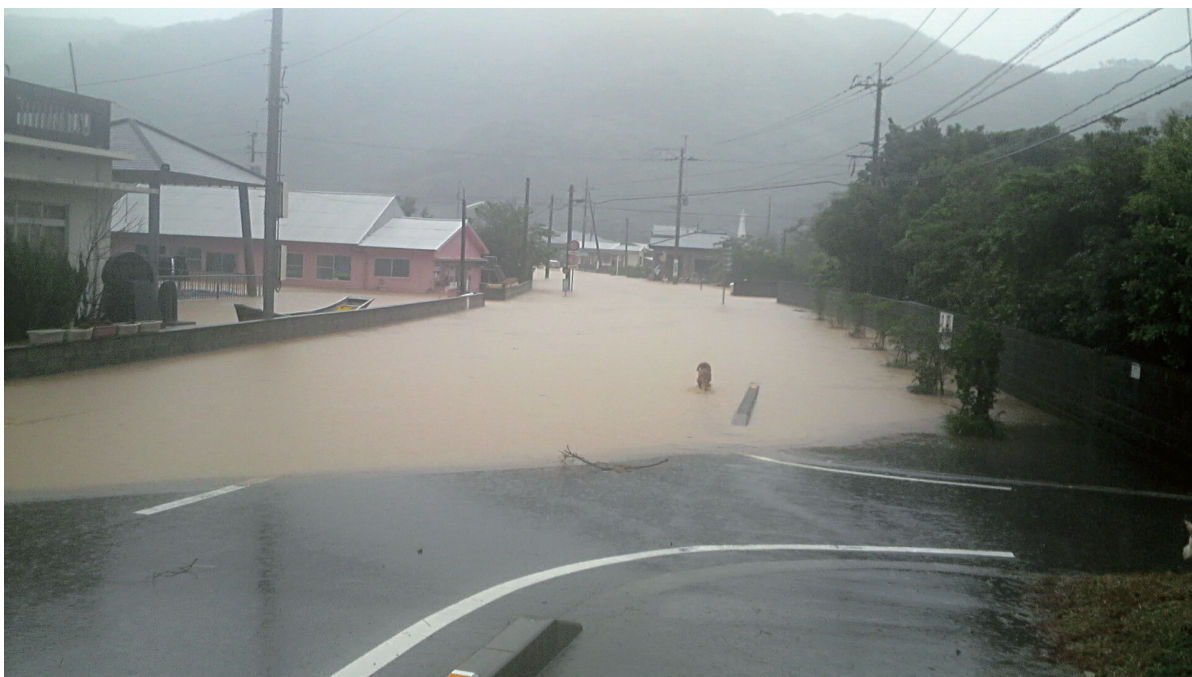
口絵 15 奄美市名瀬小宿「グループホーム虹の丘」前の浸水の様子（虹の丘提供）
Photo 15 Inundation in front of Group Home Niji no Oka in Naze Kosyuku, Amami City (Photo provided by Group Home Niji no Oka).
