2015年4月ネパール地震 (Gorkha地震) における 地震の概要と建物被害に関する情報収集調査報告

Investigation of Damage in and Around Kathmandu Valley Related to the 2015 Gorkha, Nepal Earthquake

防災科学技術研究所研究資料

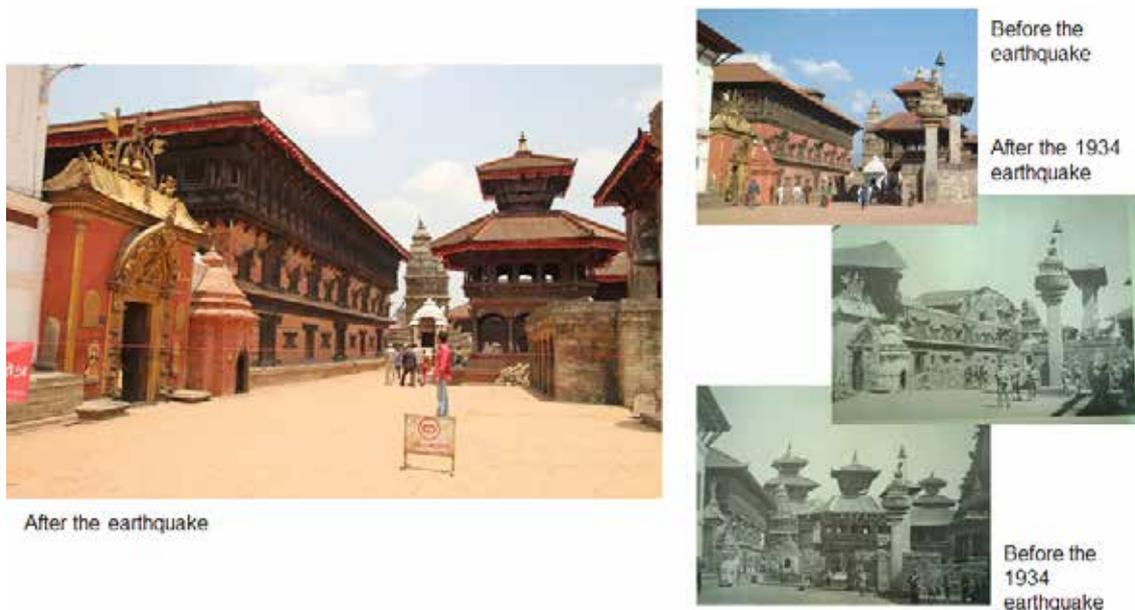
“*Bhakta*” means Devotee in Sanskrit, and “*pur*” means city. Thus, Bhaktapur is the city of devotees. Bhaktapur’s Durbar Square is a conglomeration of pagodas and Sikhara style temples grouped around a 55 Window Palace of brick and wood (Fig. 3.1).

Fig. 3.1 Bhaktapur before / after the earthquake (photo by T. Ohsumi), before / after the 1934 earthquake (Courtesy of MoHA).

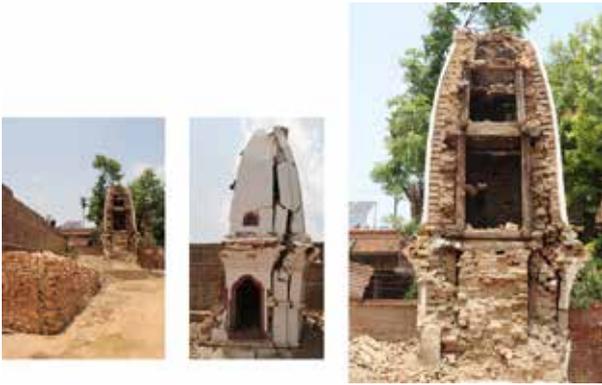
This structure materials are polished decorative bricks of high quality terracotta for lintels of doors and for decorative layers are integrated into the facades (Fig. 3.3). Inside materials are unburned bricks and timber frames. This sikhara had to be demolished later.

Fig. 3.3 This sikhara was demolished (photo by T. Ohsumi).

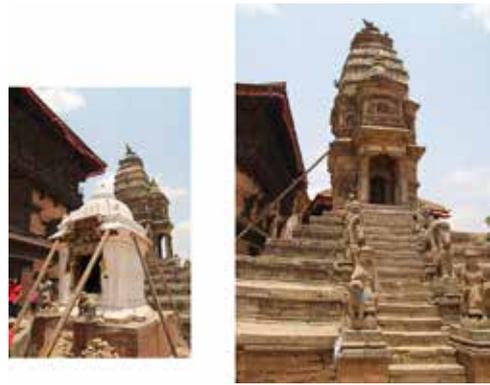
Chasin Mandapa (left) was broken in the lintel (Fig. 3.4). Siddhilakshmi Shikhara (right) survived, except the top of finial. This temple’s construction used stone and Indian style. This style developed in India during the late 6th century, it only appeared in Nepal during the late Licchavi period, 9th century. There was no damage to the statues of guarding lions and the steps leading to the main entrance. The Fasi Dega was destroyed (Fig. 3.5). The large, white Fasi Dega Temple was dedicated to Shiva and it was one of the tallest temples in the second part of Bhaktapur Durbar Square.

Fig. 3.4 Chasin Mandapa (left) and Siddhilakshmi Shikhara (right) (photo by T. Ohsumi).

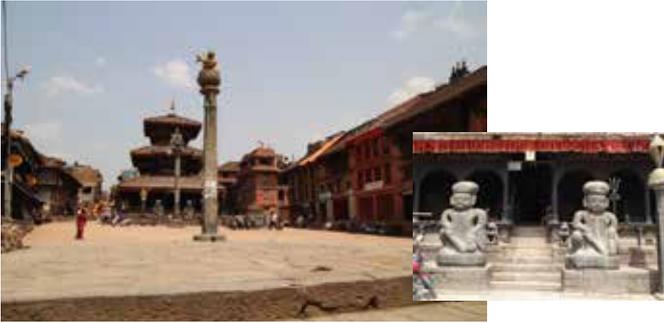
Fig. 3.7 Main Dattatreya temple at Dattatreya Square (left), two watchmen / guardians hold Grakata (right) (photo by T. Ohsumi).

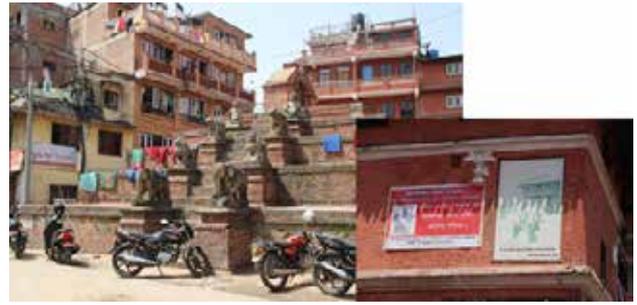
The Nepal calendar is currently 2072. Thus, Nepal 1990 B.S. (Bikram Sambat) correspond to 1934A.D. State, this temple collapsed but has not been rebuilt (Fig. 3.8). If such non-reconstruction of historical buildings that have been lost during earthquakes does not proceed, it will be a major blow to the future Nepal’s tourism-oriented country.

Fig. 3.8 This temple collapsed in 1934 earthquake, but has not been rebuilt (photo by T. Ohsumi).

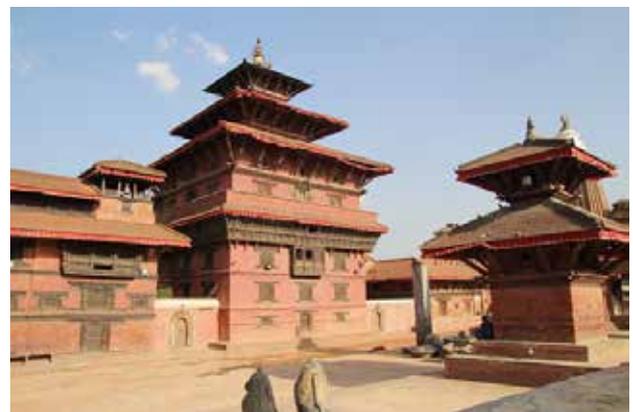
Thus, in Patan, 2015, after the earthquake, this place had only partial damage at Gajur and Baymvah (**Fig. 3.9-11**).

Fig. 3.9 Taleju three-tiered temple Lalitpur (photo by T. Ohsumi).

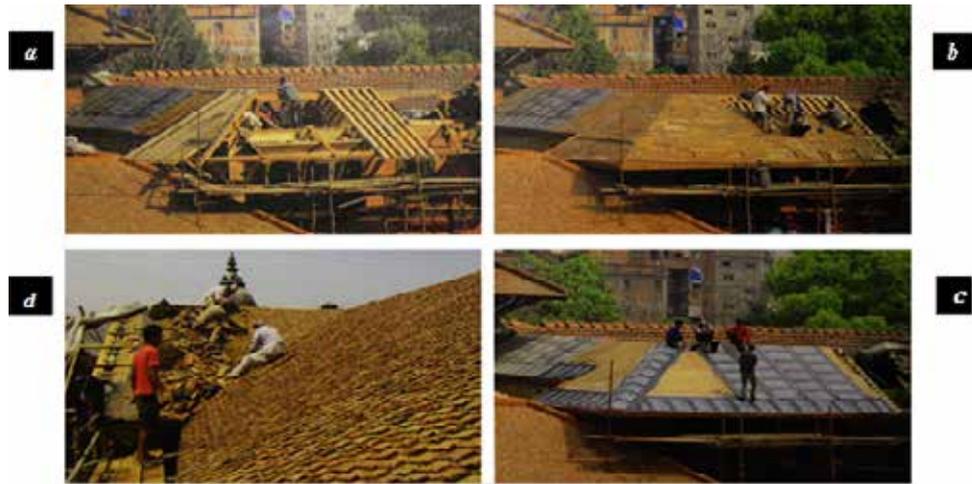
Fig. 3.11 Renovation of the structure and the cover of the roof was carried out in 2011.
a: top left Installation of timber rafters,
b: hand wood planking,
c: waterproof membrane,
d: traditional terracotta roof tiles on a mud-bed
(from Information plate of Patan Museum).

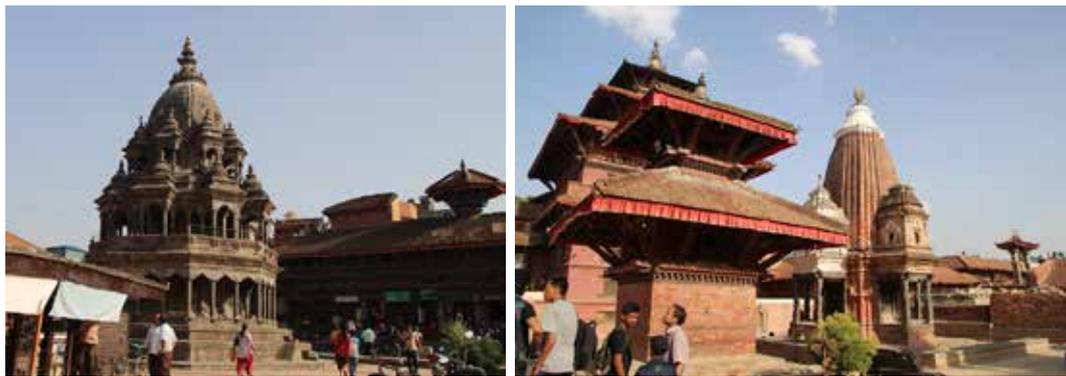
Krishna Sikhara was survived. Jagannarayan Temple (left), Vishnu Temple (center) and Narasimha Sikhara from 1598 (front) were survived (**Fig. 3.12**).

Fig. 3.12 Jagannarayan Temple (left), Vishnu Temple (center) and Narasimha Sikhara were survived
(photo by T. Ohsumi).

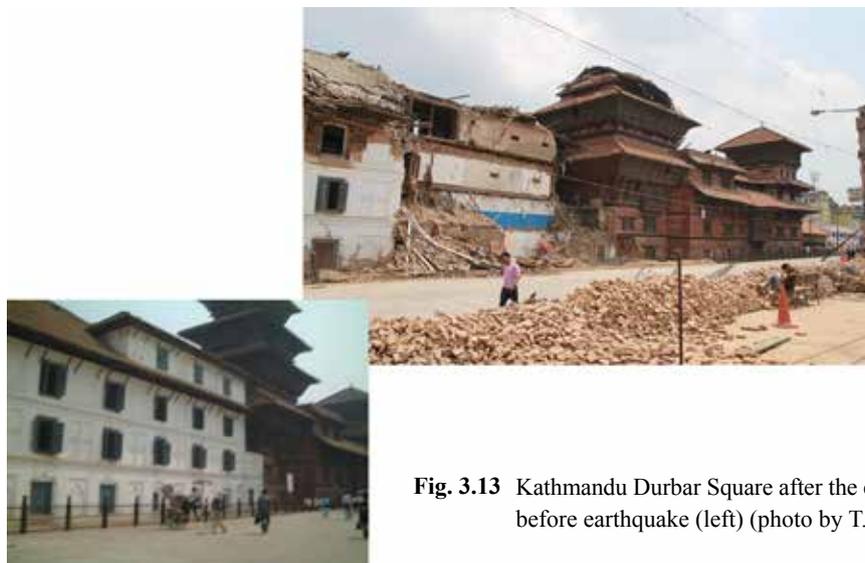
The old palace structures in Kathmandu’s Durbar Square, which had not undergone renovations, had severe damage during the earthquakes (**Fig. 3.13**). In the photo on the left, the white structure is about 150 years old, built during the Rana Dynasty. In the photo on the right side, the four-tiered brown temple is about 300 years old, constructed during the Gorkha Dynasty.

Fig. 3.13 Kathmandu Durbar Square after the earthquake (right),
before earthquake (left) (photo by T. Ohsumi).

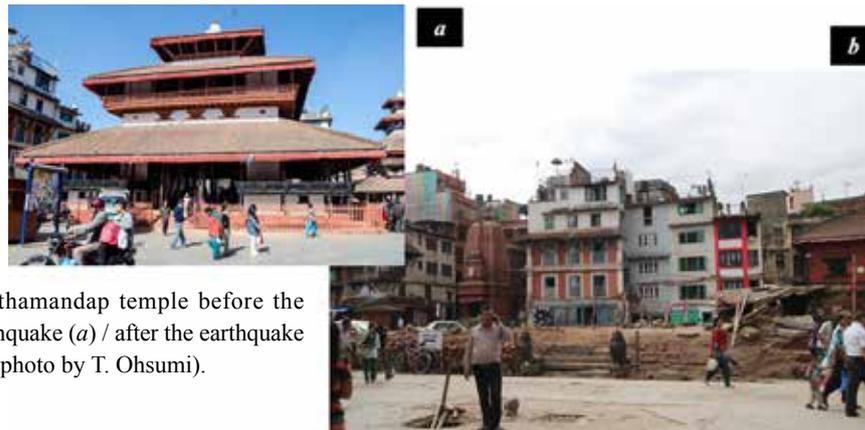
The Kasthamandap temple was built by king Laxmi Narsingha Malla in the early 16th century. The whole temple was made from a single tree. Kasthamandap is said to be the etymology of Kthmandu. The earthquake on April 25, 2015 caused severe damage to this temple and it collapsed (**Fig. 3.14**).

Fig. 3.14 Kasthamandap temple before the earthquake (a) / after the earthquake (b) (photo by T. Ohsumi).

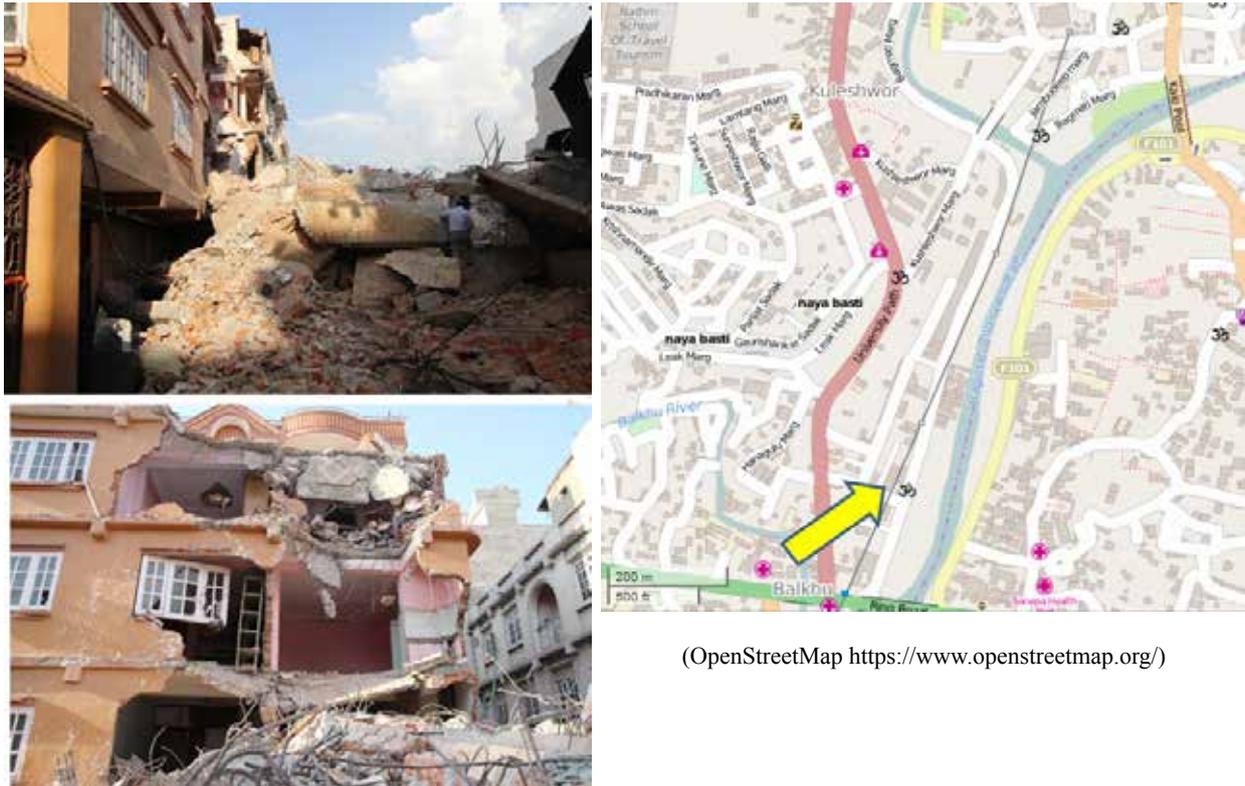
Fig. 3.17 At the branch point of the Bagmati River and the Transformer River, collapsed building fell onto and destroyed the next building (photo by T. Ohsumi).

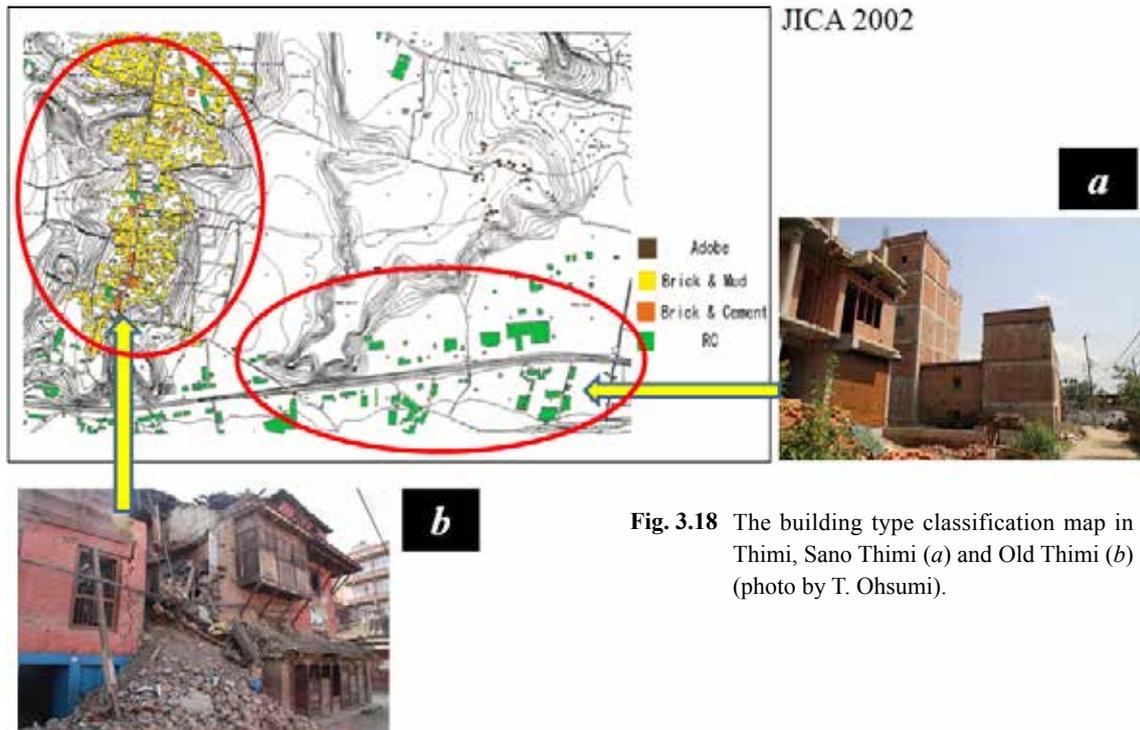
In the JICA (2002) report, building types were classified for the whole Katmandu. The investigation was mainly based on visual observations (**Fig. 3.18**:upper). In newer building areas (**Fig. 3.18(a)**), the damage has been reduced in the building of the RC structures. The core area located on a small hill (**Fig. 3.18(b)**), the houses had been destroyed in 1934 rebuilt and again received severe damages.

Fig. 3.18 The building type classification map in Thimi, Sano Thimi (a) and Old Thimi (b) (photo by T. Ohsumi).

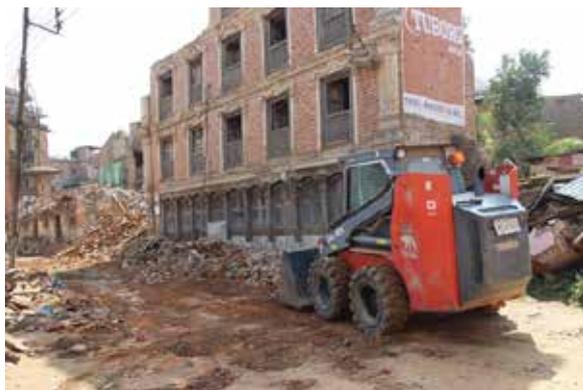
The houses damaged by the earthquake have been demolished with the support of the Canadian Forces in Sankhu. Heavy equipment was brought from Canada (**Fig. 3.19**). The difference in damage as a result of building type was remarkable. Damage in Sankhu was extensive. Brick and cement mortar houses without RC columns experienced a lot of damage. In contrast, the damage to RC structures – particularly those erected in recent years – was generally minor. These structures were mainly five to six story buildings. In contrast, many of the non-engineered masonry structures that experienced complete collapse or partial damage were two to four story buildings in Sankhu (**Fig. 3.20**). Damage in non-engineered masonry structures was initiated by vertical cracks in the corners of the buildings, which contained no RC columns (**Fig. 3.21(a)**), the outer wall structures of such buildings were generally burned brick with cement mortar joints to withstand rain. In several cases, the inner walls of buildings are adobe bricks with mud mortar (**Fig. 3.21(b)**).

Fig. 3.19 In Sankhu, heavy equipment from Canada (photo by T. Ohsumi).

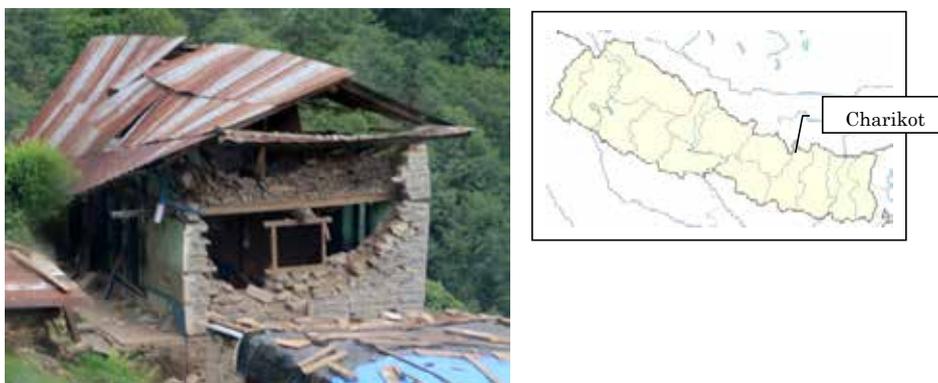
Fig. 4.4 Stone style house in Charikot, Bhimeshwor Municipality (photo by T. Ohsumi).

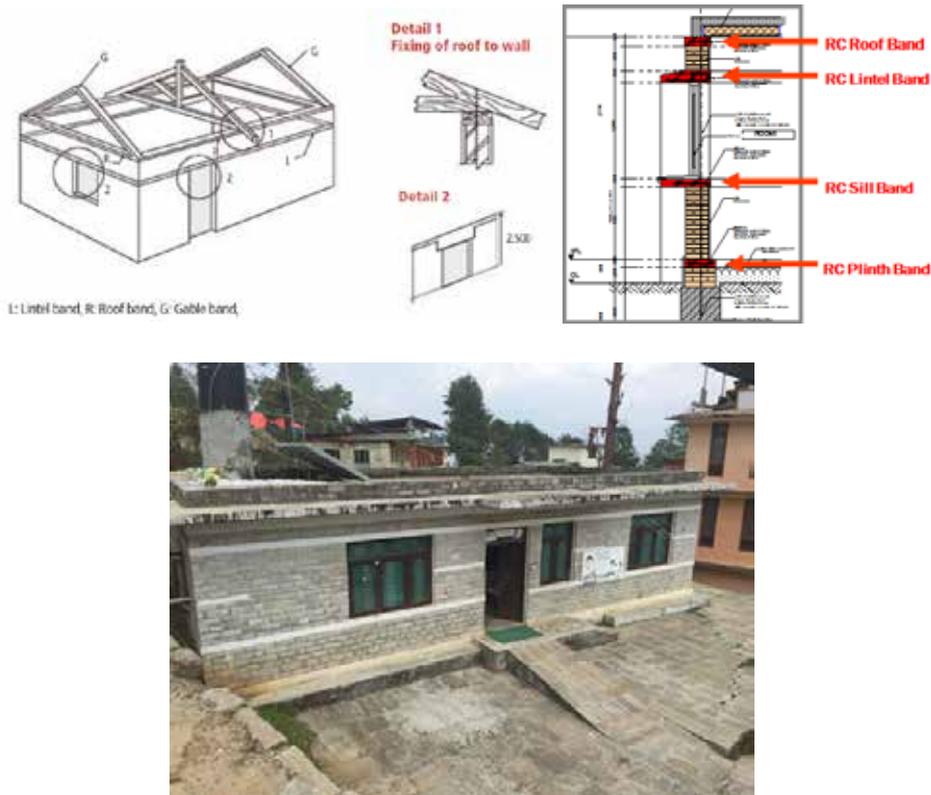
According to “Guidelines for Earthquake Resistant Non-Engineered Construction”¹⁰, horizontal bands or ring beams show detail (Fig. 5.3).

Fig. 5.3 Seismic RC band for stone and brick masonry (NSET promoted in Dolakha, Nepal) (photo by H. Imai) (upper figure from Arya (2013)¹⁰⁾).

The most important horizontal reinforcing is through reinforced concrete bands provided continuously through all load bearing longitudinal and transverse walls at plinth, lintel, and roof eave levels, as well as at top of gables according to requirements as stated hereunder:

- 1) Plinth band: This should be provided where the soil is soft or uneven in its properties as happens in hill areas. It also serves as damp proof course. This band is not too critical.
- 2) Lintel band: This is the most important band and is incorporated in all door and window lintels. Its reinforcement should be extra to the lintel band steel.
- 3) Roof band: This band is required at eaves level of pitched roofs and also below or level with suspended floors which consist of joists and flooring elements, so as to properly integrate them at ends and fix them into the walls.

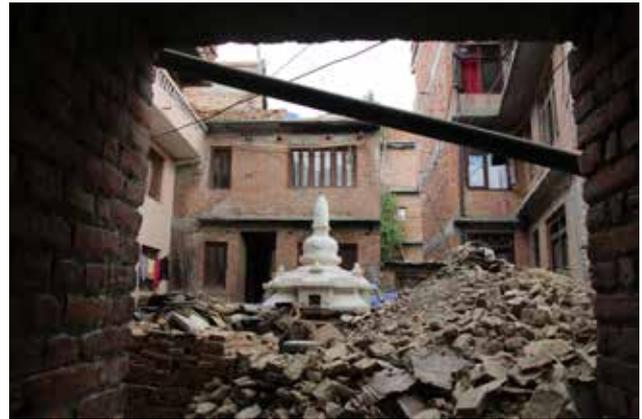
Fig. 2.3 Traditional buildings are gradually becoming less common as a result of rebuilding. (photo by T. Ohsumi, taken after earthquake in Sankhu)

A *chowk* is a type of courtyard that is common in the community of Newar in Nepal. The *chowk* is characterized by a square or rectangular space surrounded by buildings on all sides. The surrounding buildings are built on a raised platform, called *falcha*. Opposite the main entrance on the ground floor is an area dedicated to the Guthi - Social Unify and other gods with idols of deities. The chowk structure is excellent with respect to earthquake resistance. However, these traditional buildings are gradually becoming less common as a result of rebuilding (**Fig. 2.3**).

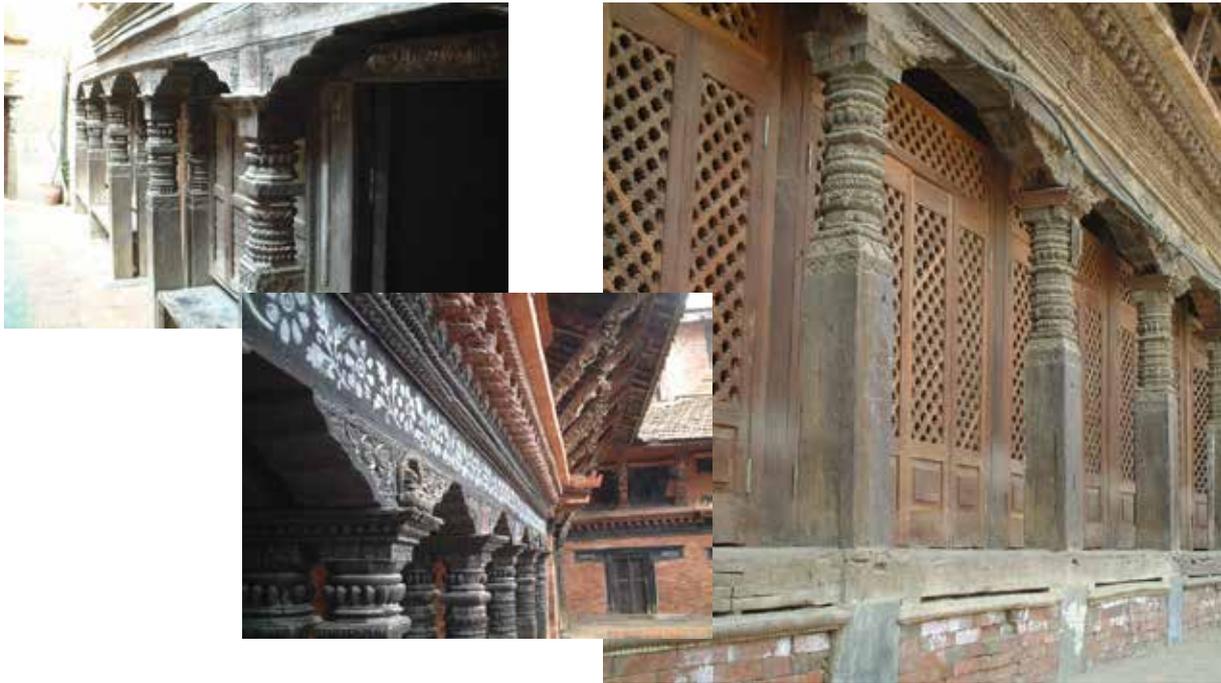
The traditional method of construction, which does not use metal with timber (**Fig. 2.5, 2.6**) has prevented degradation for a long time. Comparison of colonnade peristyle Patan Royal Palace show in 2001 (**Fig. 2.7**) and in 2015 (**Fig. 2.8**). This type of construction should be repaired using traditional methods without resorting to modern methods. **Fig. 2.9** shows a house’s peristyle colonnade and an indoor column with a sub-beam. **Fig. 2.10** shows timber lattice replacements. New timber latticework has been fabricated to replace damaged or lost elements.

Fig. 2.8 Peristyle colonnade in Patan (photo by T.Ohsumi after the 2015 Earthquake).

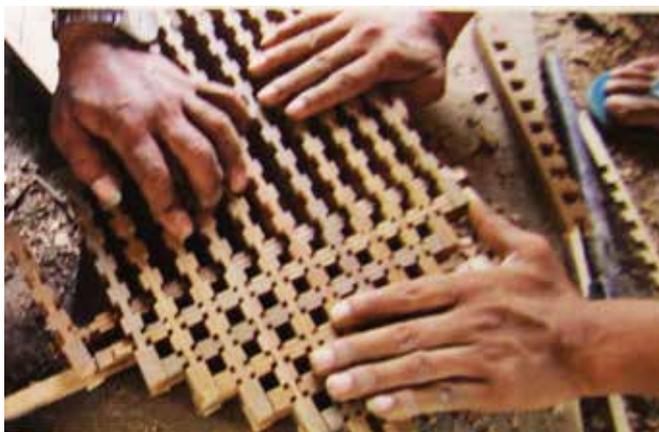
Fig. 2.10 Timber lattice replacements. New timber latticework has been fabricated to replace damaged or lost elements (from information plate at the Patan Museum).

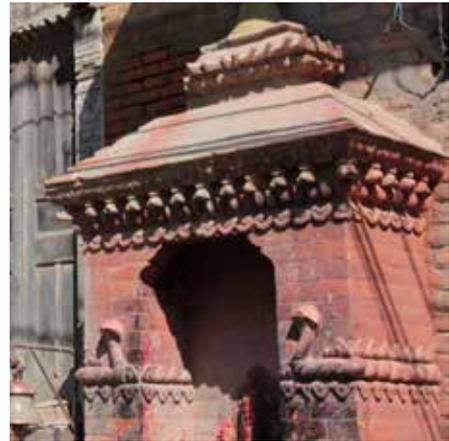
Fig. 2.17 Building constructed over 100 years ago that was slightly damaged by the Gorkha earthquake. The building has a snake (*Naga*) band surrounding it between the first and second floors (photo by T. Ohsumi, taken after Gorkha earthquake in Sankhu).

One of the aforementioned buildings (Fig. 2.17), which is more than 100 years old, was slightly damaged by the quake. This building has a snake (*Naga*) band surrounding the entire building between the first and second floors. This band is made of wood and is effective in restricting brick structure. Fig. 5.1 shows a building with little damage, which is also more than a century old. This building underwent expensive improvement for earthquake resistance, including mixing plaster with mud joints.

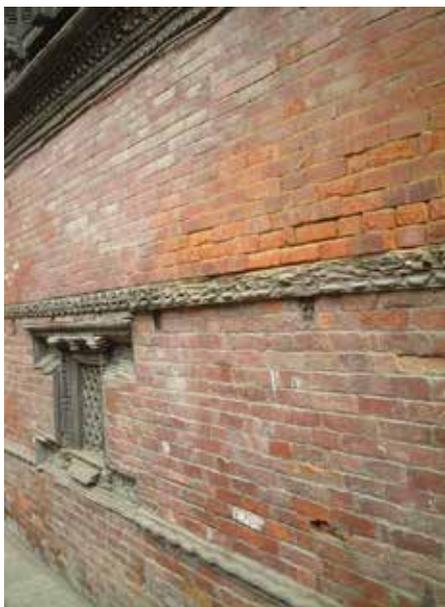
Water rises from underground, and its evaporation deteriorates the wall surface of masonry structures (Fig. 2.23, 2.24). Repair for the brick is required for deteriorates with the prevention of the water rise. Fig. 2.25 shows the scree of bricks. Sun-dried bricks (adobe) of the interior are seen.

Fig. 2.23 Royal Palace wall in Kathmandu (photo by T. Ohsumi in 2001).

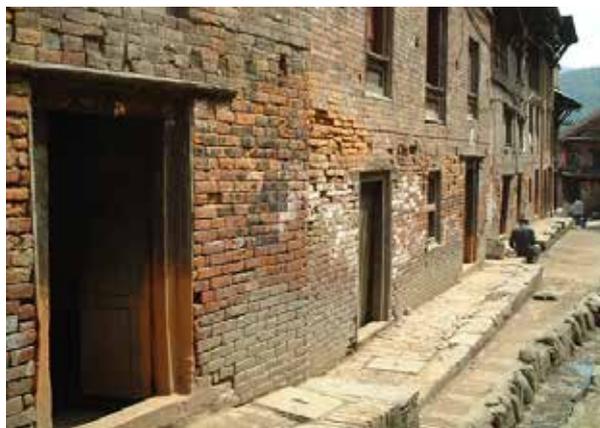
Fig. 2.24 Private house wall in Bhaktapur (photo by T. Ohsumi in 2001).

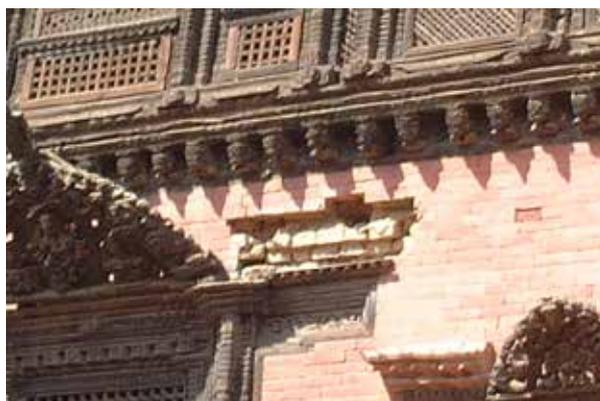
Fig. 2.25 Scree of bricks. Sun-dried bricks (adobe) of the interior are seen (photo by T. Ohsumi in 2001).

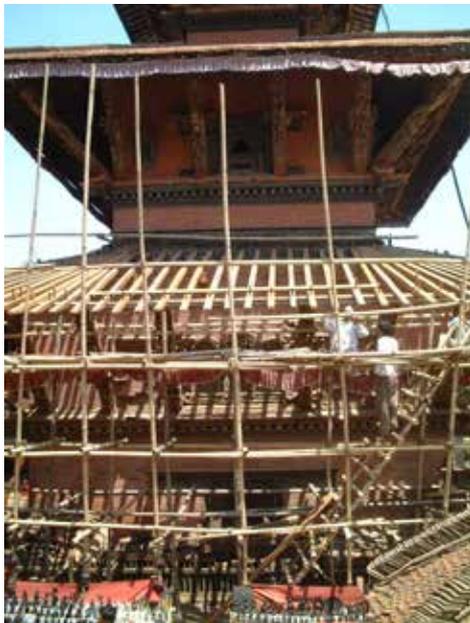
Fig. 3.3 Renovation of a temple's roof was carried out in 2015 (photo by T. Ohsumi).

Renovation of the temple's roof was carried out in 2015 (**Fig. 3.3**). **Fig. 3.4** shows a house roof renovation carried out in 2015.

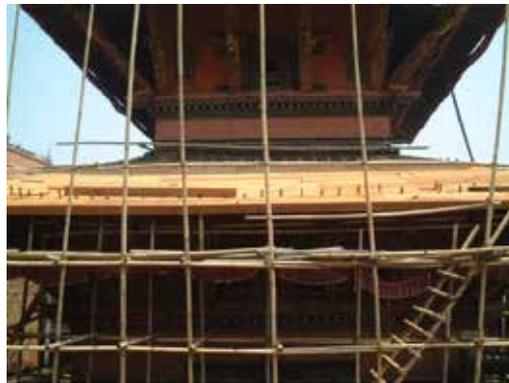
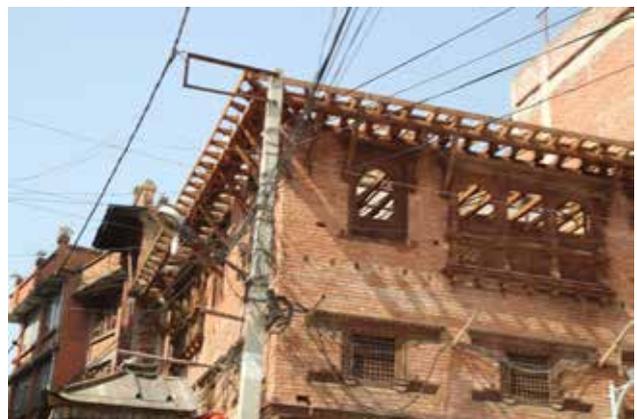
Fig. 3.4 Renovation of a house roof was carried out in 2015 (photo by T. Ohsumi).

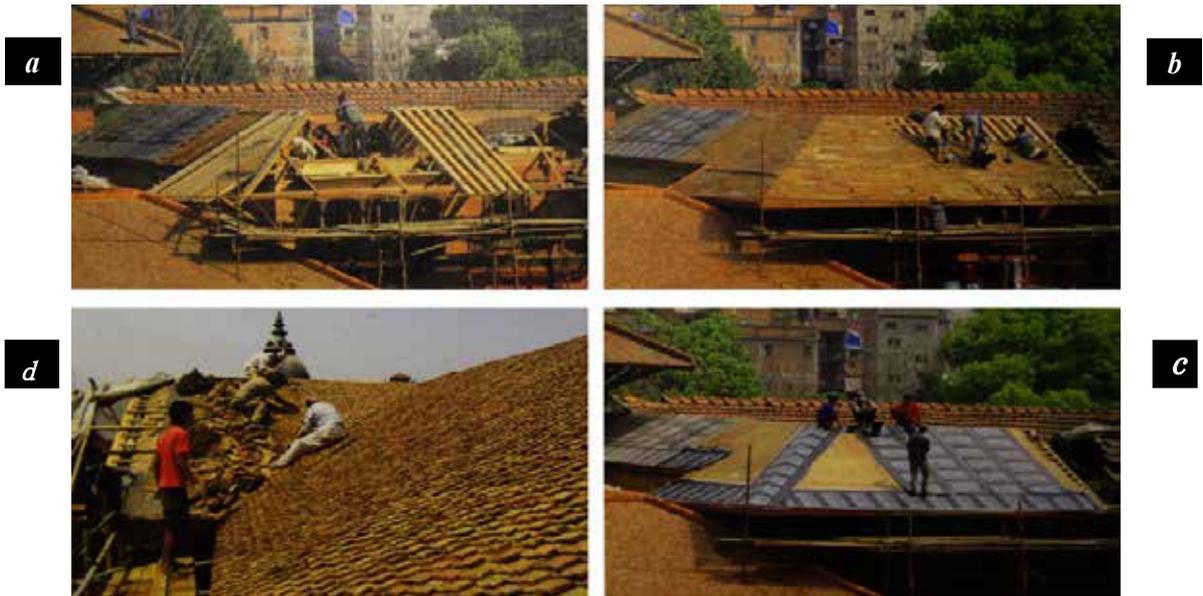
Fig. 3.5 Renovation of the structure and the covering of the roof was carried out in 2011:
a: (top left) installation of timber rafters, *b:* hand wood planking, *c:* waterproof membrane, *d:* traditional terracotta roof tiles on a mud bed (from information plate at the Patan Museum)

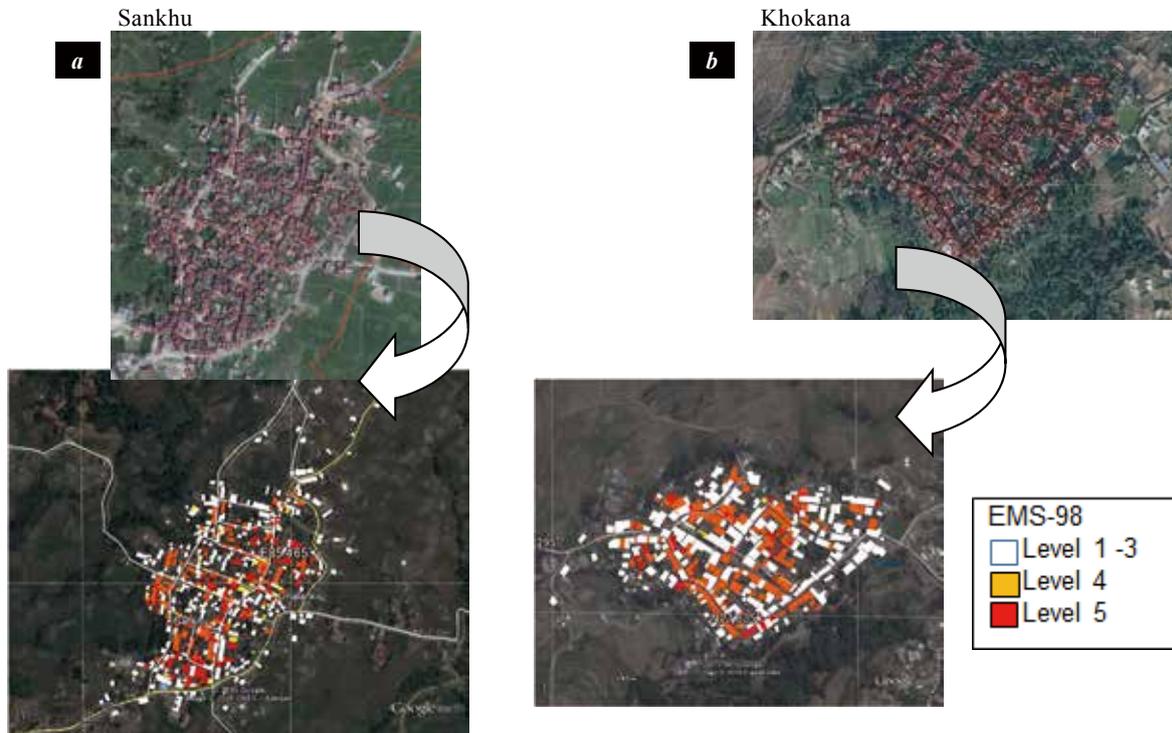
In Sankhu, whereas RC buildings were partially damaged, many masonry buildings were severely damaged. The difference in damage between the various building types is remarkable. Generally, the damage in Sankhu was extensive. Brick and cement mortar houses without RC columns had considerable damage, whereas damage to RC structures—particularly those erected in recent years—was generally minor. These latter structures were mainly five- to six-story buildings, whereas many of the non-engineered masonry structures that experienced complete collapse or partial damage had two to four stories.

Fig. 7.1 Survey of the damage extent for every house in a) Sankhu: (August 17–18, 2015) and b) Khokana: (August 19–20, 2015)^{5), 6)} by the European Macroseismic Scale (EMS) -98.

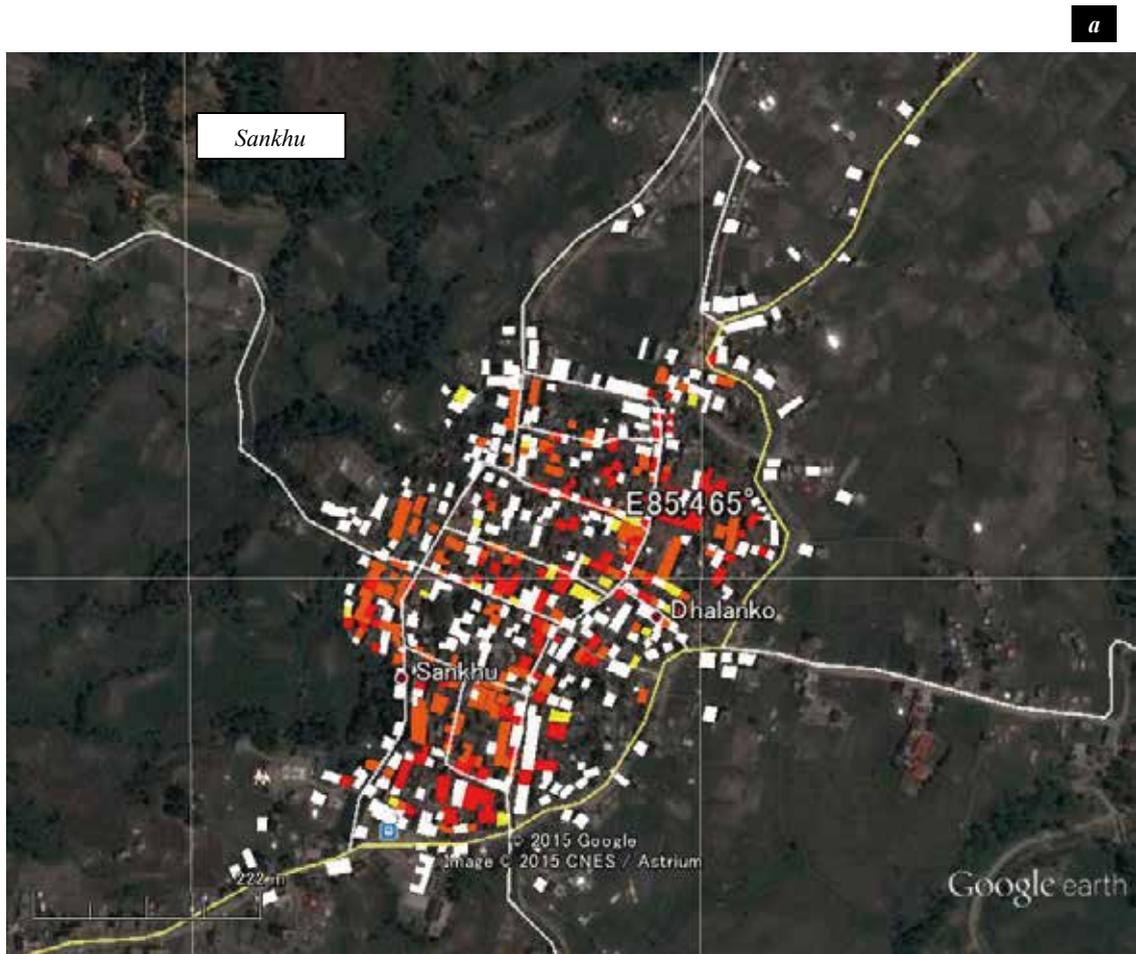
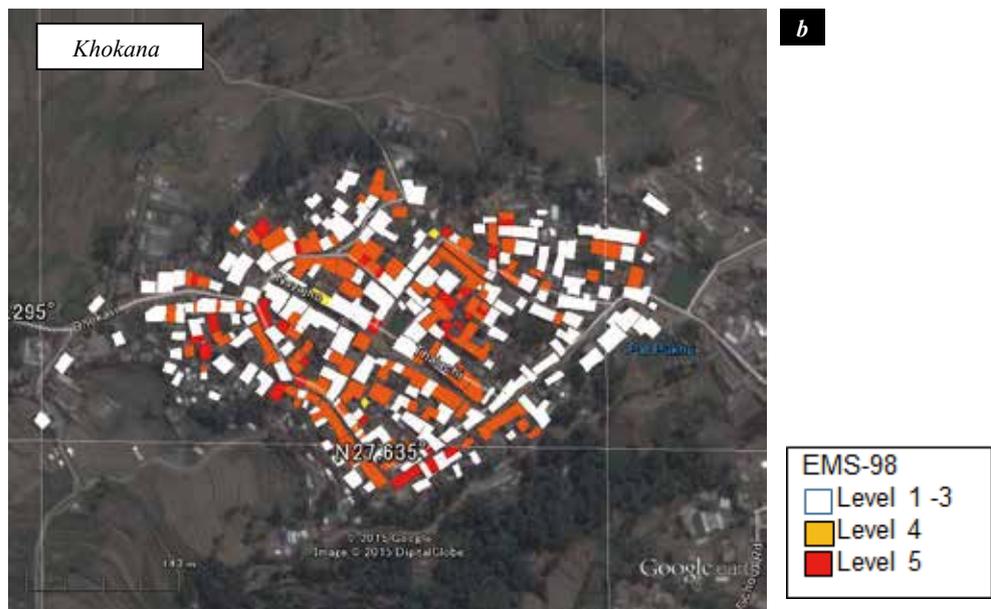
Fig. 7.4 Survey of damage extent for every house in Sankhu and Khokana ^{5), 6)}.

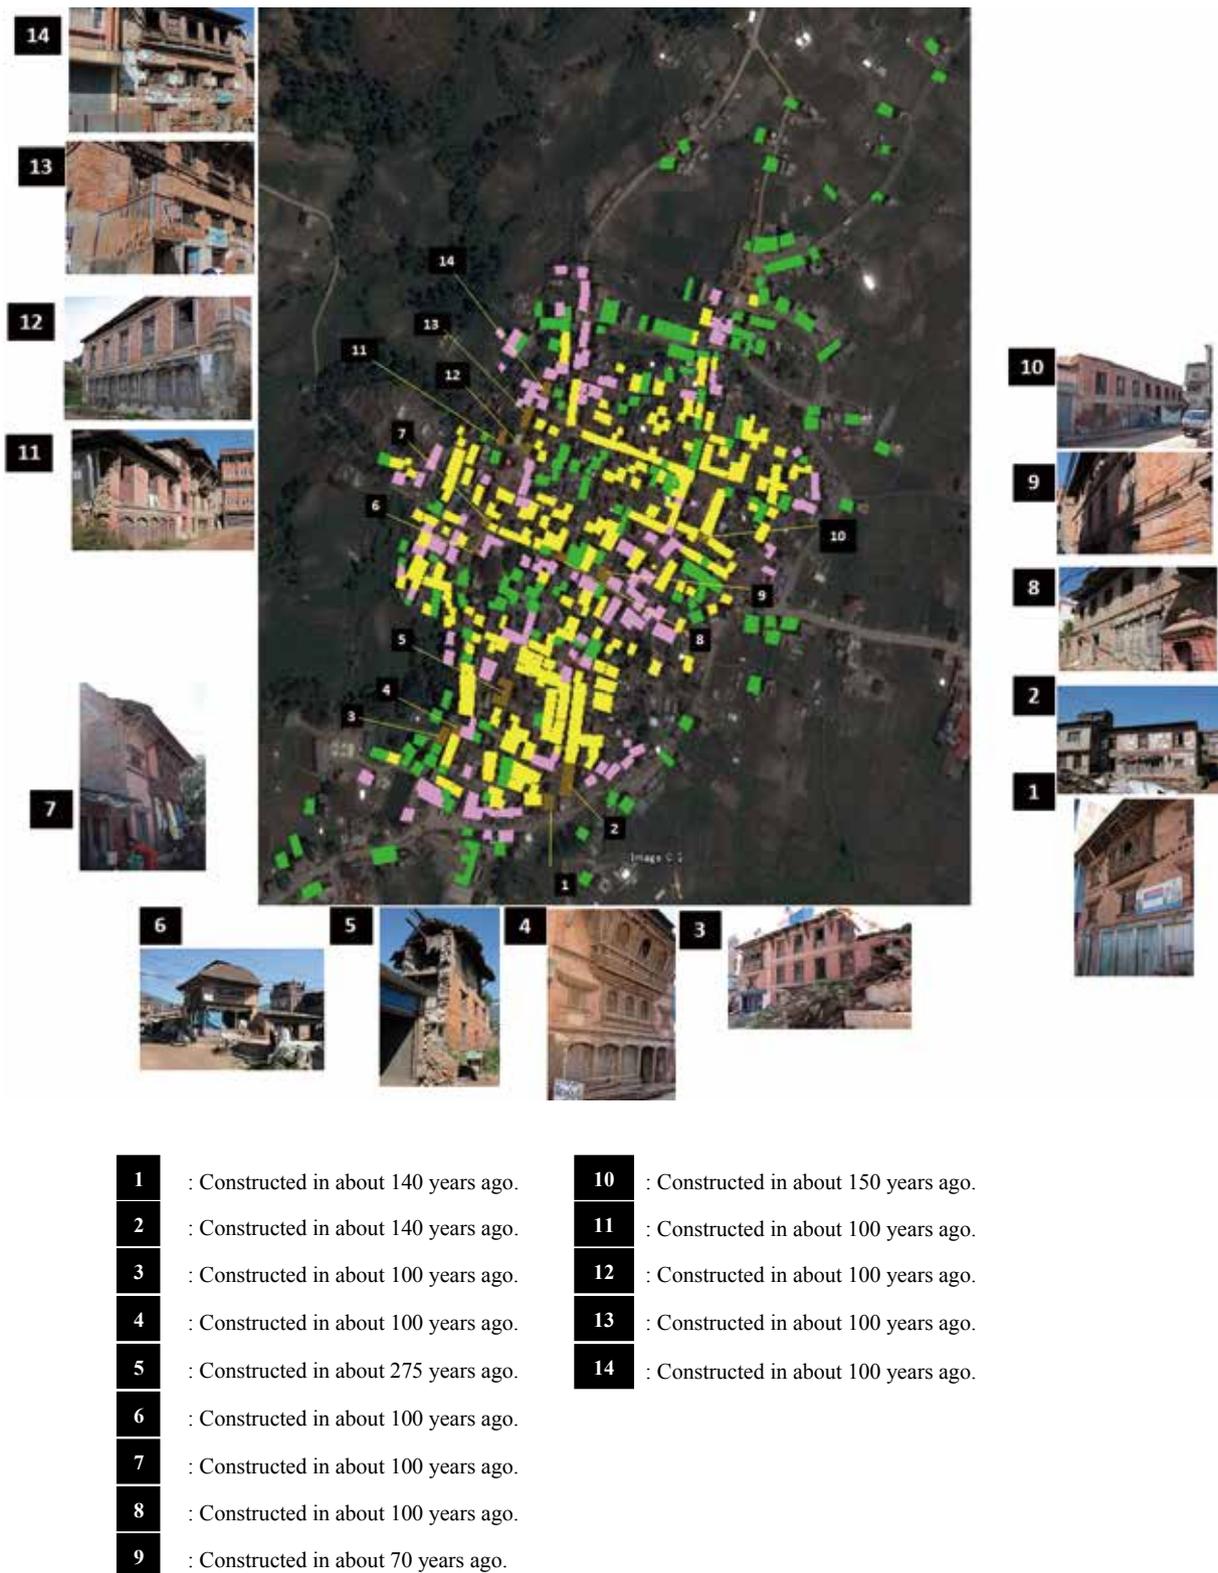
There was heavy structural damage related to the 1934 Bihar Earthquake in both areas. After that earthquake, housing was rebuilt using BM. Well-built historical buildings had expensive renovations; *i.e.*, BMWs were improved by mixing plaster with mud joints. Some BMWs remain in Sankhu (**Fig. 7.6**), and all buildings in Khokana (**Fig. 7.7**) were demolished after the 1934 Earthquake.

Fig.7.6 Survey of well build houses in Sankhu.

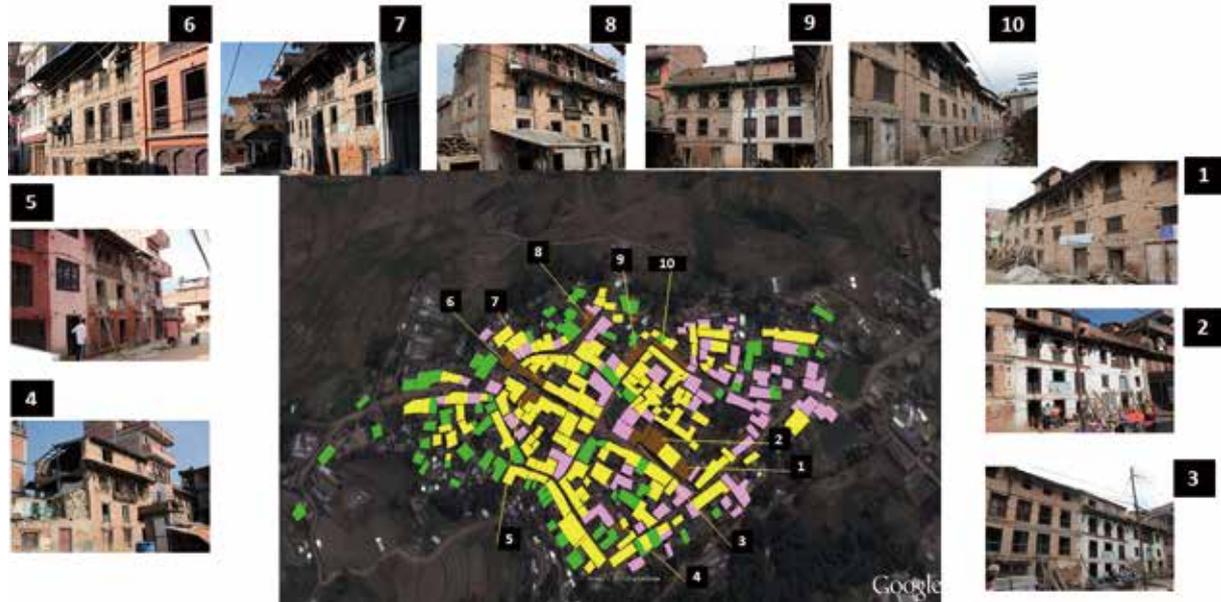
Fig. 7.7 Survey of well build houses in Khokana.

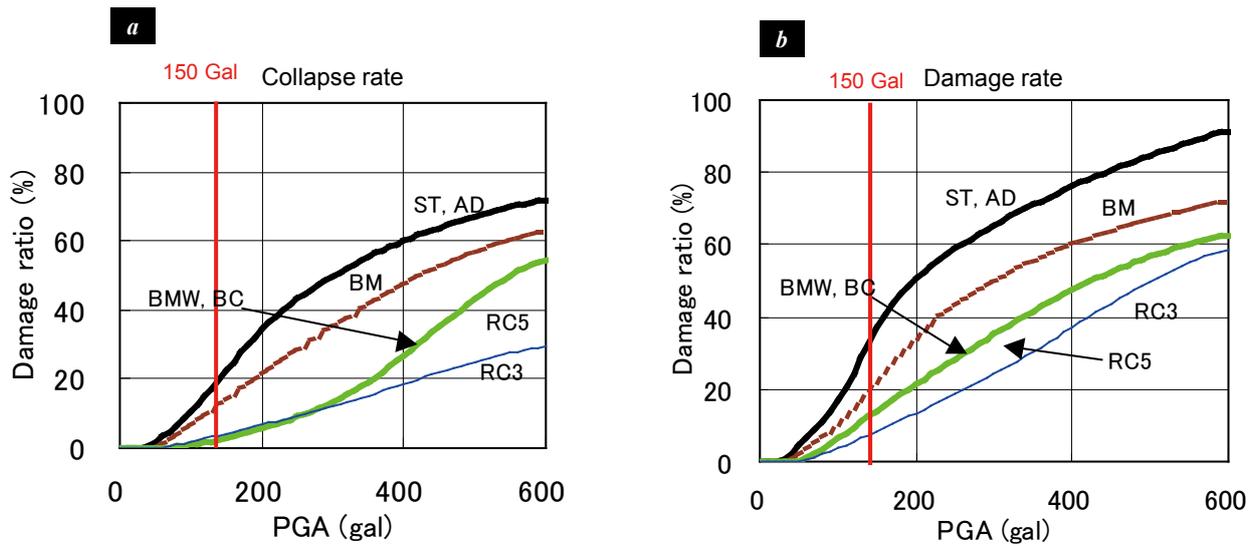
Fig. 7.8 Fragility curves of relation between damage rate and peak ground acceleration.

JICA (2002) study ^{1), 2) 3)} defining fragility curves for estimating damage to buildings was to determine the relationship between damage ratio and ground acceleration for each building type. These curves refer to the graph showing this relationship. In this study, the curves for

buildings in the Kathmandu Valley were determined as shown in Fig. 7.8a and b.

Damage ratio of RC is 7-8 % and damage ratio of BM is the 80 %.

Graed 5, damage ratio of RC is 0 %, damage ratio of BM is 40%. In Khokana, damage ratio (Table 7.5) of RC is 6 %, BM is 70 %. Collapse ratio of RC is 0 %, BM is 20 %. The damage curved line of BM is exceeded the damage curved line of ST, AD.

The complicated composite structure is being classified in BM by the damage function. On the other hand, RC is actual damage rate and the damage function rate are good agreement (Table 7.5).

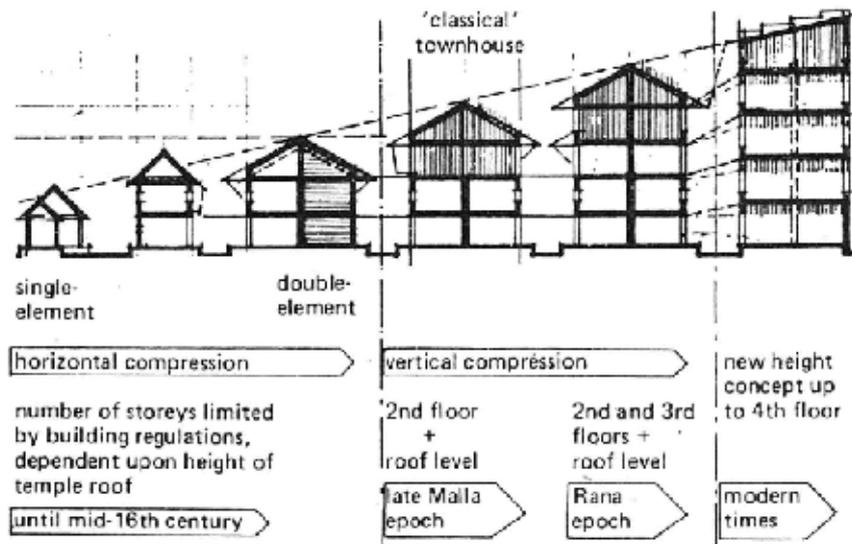
Fig. 7.9 Story height development (Scheibler, G., 1988)¹².

Fig. 7.9 shows story height development (Scheibler, G., 1988)¹²⁾. The building 1st floor could be built by a sun-dried brick in is enlarged specifically. According to this figure, building is the development of the number of floors outlined, and the simultaneous horizontal compression which runs parallel to it from a single-element to a double-element construction.

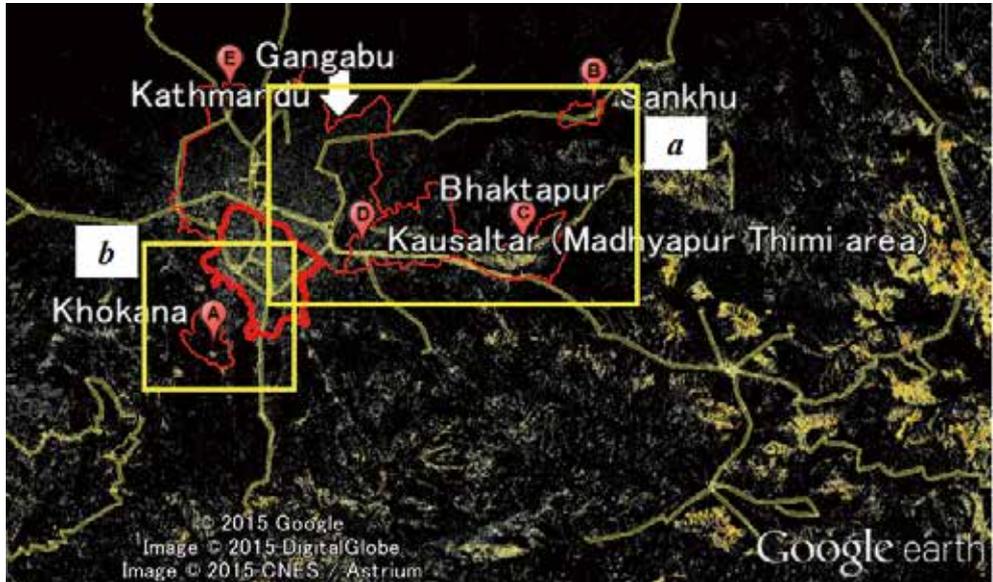
Fig. 7.12 shows the full view area as a Google Earth image, including (a) the Timi, Bhaktapur and Sankhu core areas, and (b) the Kirtipur, Khokana and Bungamati core areas. The damaged core area is identified using the coherence change ($\Delta\gamma$) obtained before the disaster (γ_{pre}) and between the disasters (γ_{int}).

Fig. 7.12 Full view of the area as a Google Earth image, including (a) the Timi, Bhaktapur and Sankhu core areas and (b) the Kirtipur, Khokana and Bungamati core areas. The damaged core area is detected using the coherence change ($\Delta\gamma$) obtained before the disaster (γ_{pre}) and between the disasters (γ_{int}).
 Subscript (pre2-pre1): Two coherences that were acquired from the images before the disaster (γ_{pre}).
 Subscript (pre2-int): Two coherences that were acquired from the images before the disaster (γ_{pre}) and between the disasters (γ_{int}).

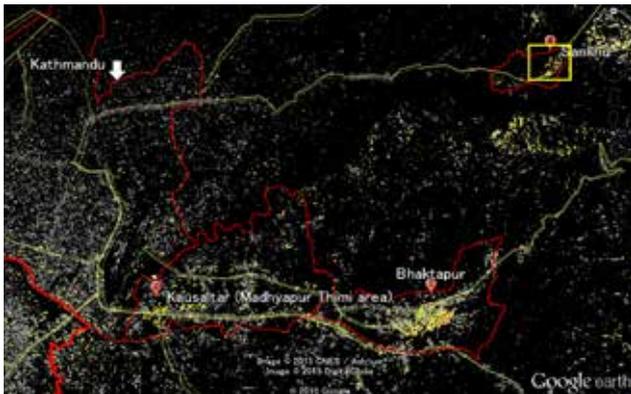
Fig. 7.13 shows regions of bright reflections within severely damaged core areas such as Timi, Bhaktapur and Sankhu. **Fig. 7.14** shows the coherence magnitude and a

Fig. 7.13 Bright reflection areas for severely damaged urban area such as Timi, Bhaktapur and Sankhu core areas.

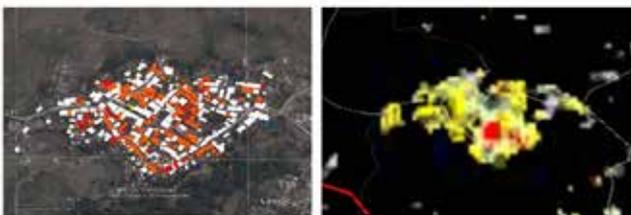
survey of damage extent for every house in Sankhu. The decrease in coherence (γ) in the SAR imagery observed before and after the disaster readily facilitated detection of damage in the region.

Fig. 7.14 Coherence magnitude and the survey of damage extent for every house in Sankhu.

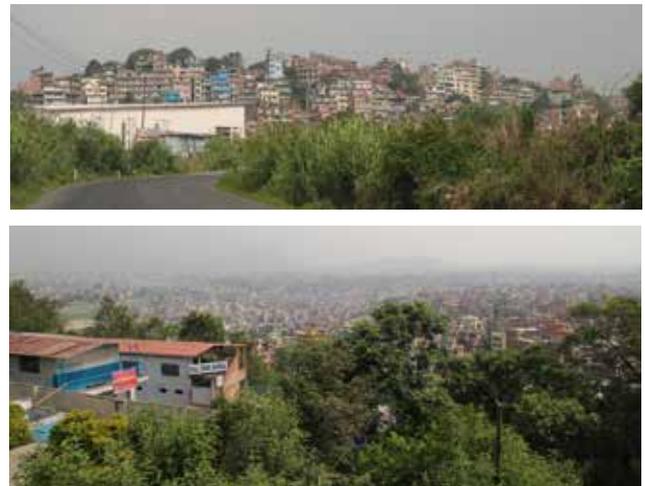
The epicentral distance of the Kirtipur core area was 79.74 km, compared with 80.69 km for the epicentral distance of the Khokana core area. Both core areas are old traditional towns on small hills in the southwestern Kathmandu Valley (**Fig. 7.17, 18**). According to Takai *et al.* (2015), acceleration was amplified in Patan (Khokana) located in the Kathmandu Valley. In contrast, acceleration was less amplified in Kirtipur, which is located on outcropping basement rock units outside the valley (**Fig. 7.19**).

Fig. 7.17 The Kirtipur core area is located on small hills (photo by T. Ohsumi).

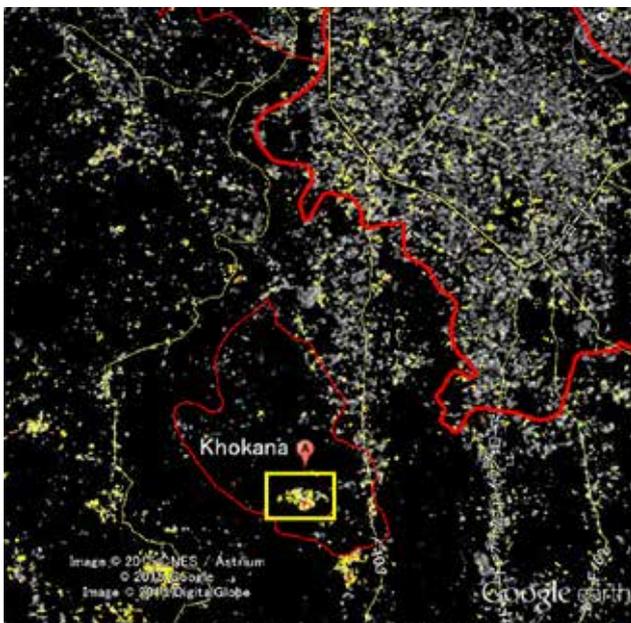
Fig. 7.15 shows regions of bright reflections within severely damaged core areas such as Khokana and Bungamati. **Fig. 7.16** shows the coherence magnitude and a survey of damage extent for every house in Khokana. Reflections in the slightly damaged Kirtipur core area are not as clear and bright as those in the severely damaged core areas of Khokana and Bungamati.

Fig. 7.15 Bright reflection areas for Khokana and Bungamati core areas. Kirtipur was not clear bright reflection.
