2015年4月ネパール地震 (Gorkha地震) における 地震の概要と建物被害に関する情報収集調査報告

Investigation of Damage in and Around Kathmandu Valley Related to the 2015 Gorkha, Nepal Earthquake

防災科学技術研究所研究資料

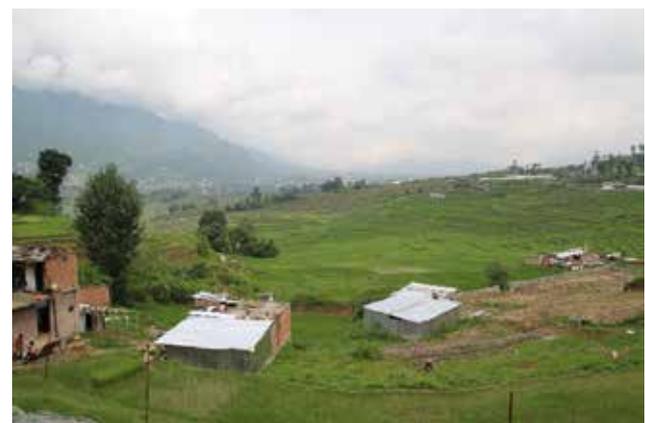
The epicentral distance of the Kirtipur core area was 79.74 km, compared with 80.69 km for the epicentral distance of the Khokana core area. Both core areas are old traditional towns on small hills in the southwestern Kathmandu Valley (**Fig. 7.17, 18**). According to Takai *et al.* (2015), acceleration was amplified in Patan (Khokana) located in the Kathmandu Valley. In contrast, acceleration was less amplified in Kirtipur, which is located on outcropping basement rock units outside the valley (**Fig. 7.19**).

Fig. 7.18 The Khokana core area is located on small hills (photo by T. Ohsumi).

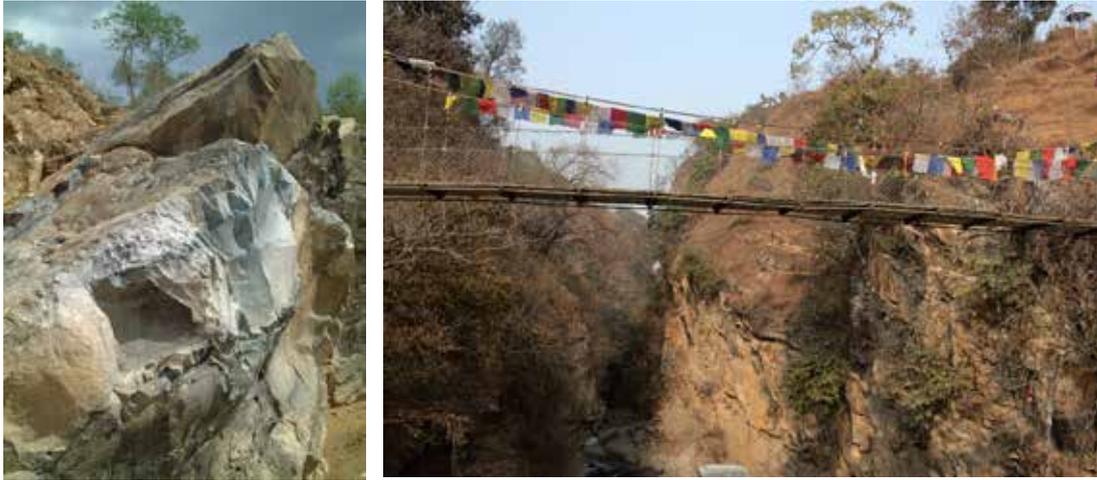
Fig. 7.19 Outcropping basement rock in Kirtipur (photo by T. Ohsumi).

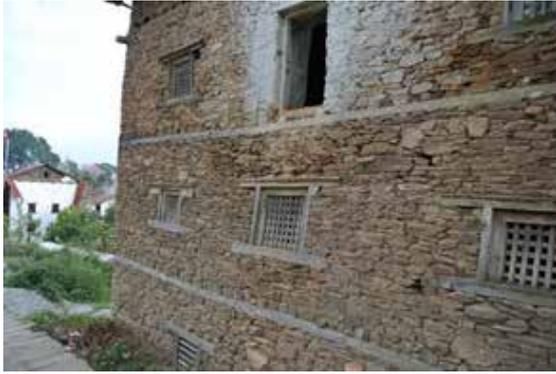
In Dolakaha Bazaar, an old town located 4 km from Charikot in north-eastern Nepal, buildings installed horizontal timber support planks. The timber planks were installed between the first and second floors of the building, along the outside wall of the building. In buildings with narrow sides and a gable wall, the timber is usually fitted along the outer periphery of the building separate from the floor beam. In the long side of the building, the timber is installed so as to form a common joint in the outer periphery of the building. The corner joint varies according to the building style, but notched joints are commonly used (**Figs 8.4, 8.5**).

Fig 8.4 Timber band installed between the first and second floors in a house in Charikot.

Traditional construction methods should be sustained by traditional communities not only to conserve world heritage but also to improve the earthquake resistance of cities. Technologies for the construction of earthquake-resistant buildings using traditional methods such as stabilizing buildings using mud mortar with lime and horizontal timber beams are both effective and sustainable.

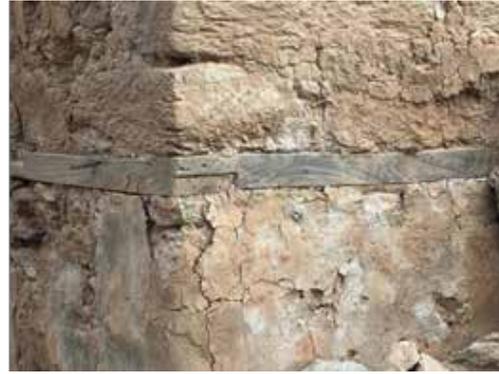
Fig 8.5 Corner joint of horizontal timber planks (photos by H. Imai).
