Flash Report on the Damage of Mexico City and Puebla Related to the 2017 Puebla-Morelos Earthquake

Technical Note of the National Research Institute for Earth Science and Disaster Resilience: No.416

An earthquake with a moment magnitude (Mw) of 7.1 occurred at 13:14 CDT (18:14 UTC) on September 19, 2017, in the city of Puebla in Mexico. A damage survey was conducted in the affected area from November 18 to 21 by a team from the National Research Institute for Earth Science and Disaster Resilience. This paper outlines the findings of the survey in terms of the various aspects of the earthquake that affected Mexico City and surrounding areas. It was observed that the main damage was to masonry reinforced concrete buildings and the most heavily damaged structures correspond to areas underlain by soft soils 10–20 m in thickness. Comparison of estimated acceleration distribution for periods of 1 s corresponds to 8–12 story buildings, and these period areas correspond to heavily damaged structures. In the city of Atlixco, most of the damage was to church buildings.

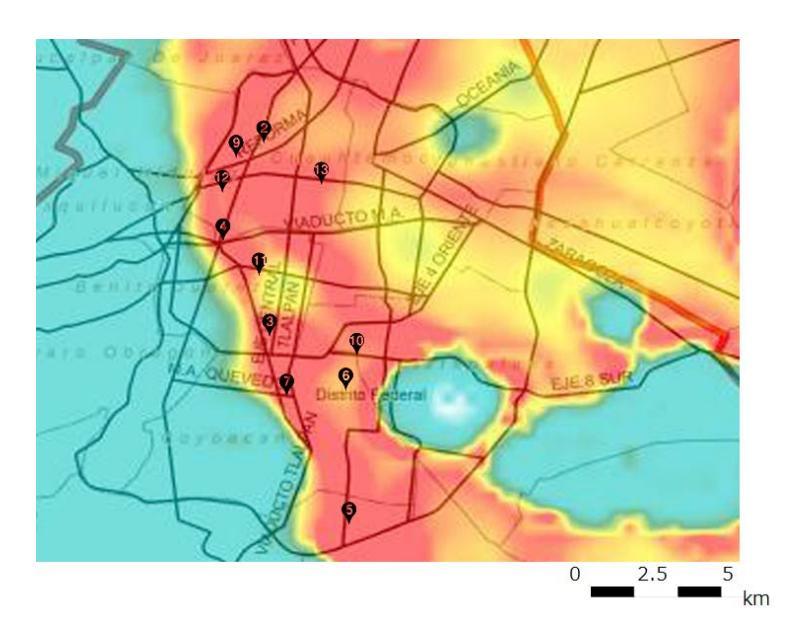
Fig. 4.3 shows the demolition level structures with the acceleration distribution for the 1.0 s period estimated from the roofs of buildings. All structures are within the 1.0 s acceleration period area.

Fig. 4.3 Map showing the distribution of the 13 structures designated for demolition level within the 1.0 s acceleration period area²⁾.

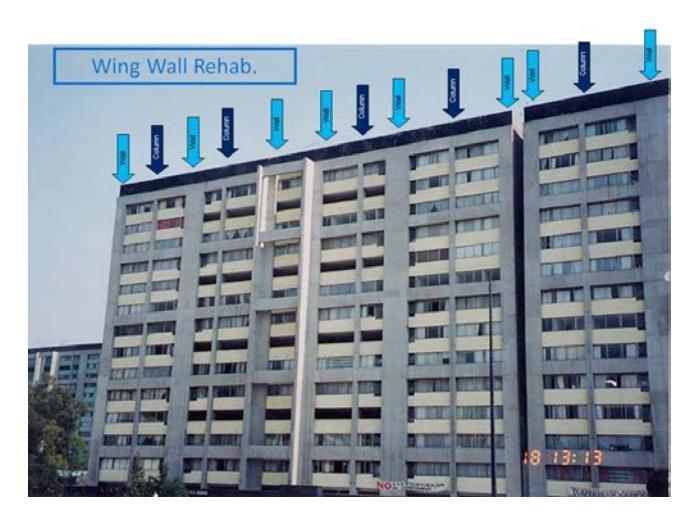
Fig. 4.7 Photographs of the renovated Tlatelolco Complex, after the 1985 earthquake (courtesy of Prof. Nakano with Tokyo Univ.).

The Tlatelolco Complex area was heavily damaged in the 1985 earthquake (**Fig. 4.4**). For example, the 14-story RC Nevo Lion building in the Tlatelolco Complex, which included a north side and southern wing connected by an Expansion Joint, suffered a collapse of the two north side buildings that resulted in many casualties. After the 1985 earthquake, the Nevo Lion was renovated with new wings and walls with JICA (Japan International Cooperation Agency) support (**Fig. 4.7**).

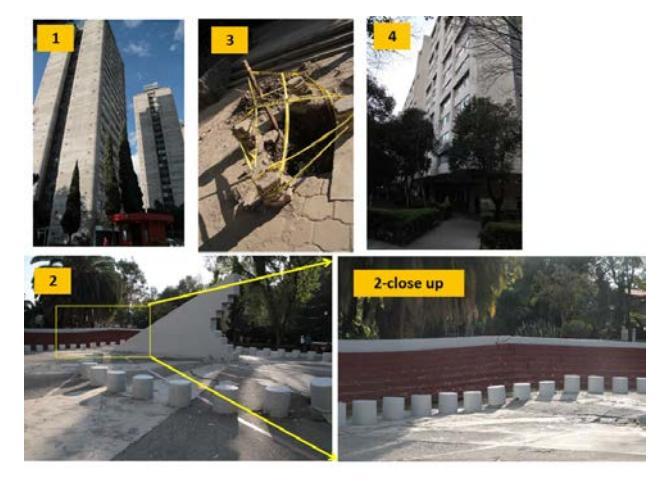
Fig. 4.6 Photographs of the Tlatelolco Complex area. (photo taken by T. Ohsumi on November 19, 2017).

We visited the Tlatelolco Complex area (**Fig. 4.5**) to verify this renovation. **Fig. 4.6** shows photos of the Tlatelolco Complex area, in which it is evident that ground surface deformation appeared after the 2017 earthquake. However, structures designed and built with earthquake-resistance showed no discernible damage after the 2017 earthquake based on external inspection. **Fig. 4.8** shows the lack of externally visible damage evident in the renovated Tlatelolco Complex after the 2017 earthquake. **Fig. 4.4** is included in

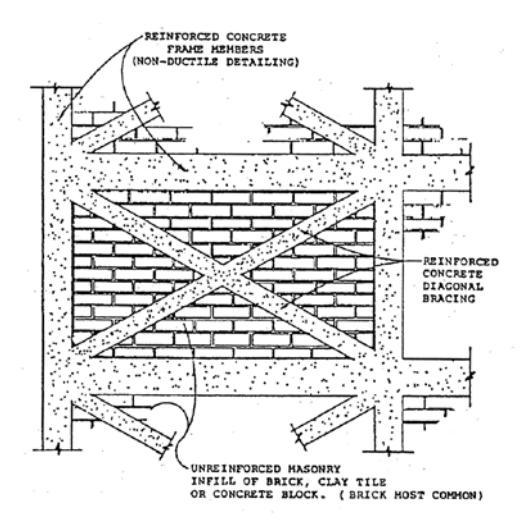
Fig. 4.14 Typical diagonal reinforced concrete bracing with masonry infill used in Mexico City¹⁴.

In Mexico City, braces are installed on buildings to decrease the risk of blocks falling off, or bricks in the wall falling out of the plane of the building. Thus, a gable wall between the brace is used to sustain this resilience method (**Fig. 4.14**). Buildings reinforced with steel braces are shown in **Fig. 4.15** and typical diagonal reinforced concrete bracing with masonry infill is shown in **Fig. 4.16**.

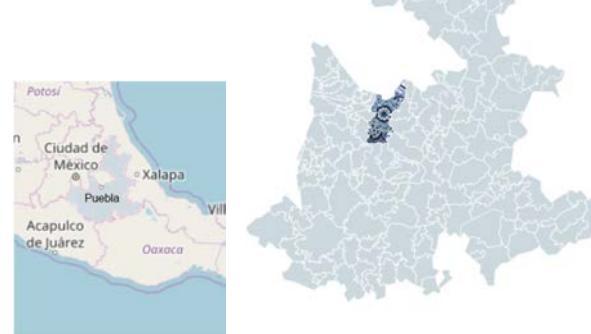
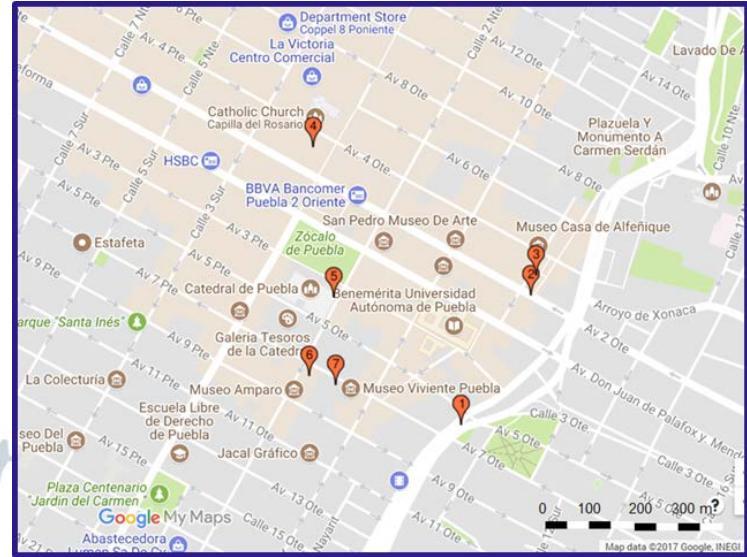
Puebla City is known as Puebla de los Angeles, and is located within the Puebla Municipality, the capital and largest city in the state of Puebla. Puebla City is famous for the ceramics (Las talaveras) it produces (**Fig. 4.24**). **Fig. 4.25** shows the damaged structures.

Fig. 4.25 Various damaged buildings in the Puebla City area (●-●). (photo taken by Y. Dohi and T. Ohsumi on November 20, 2017)

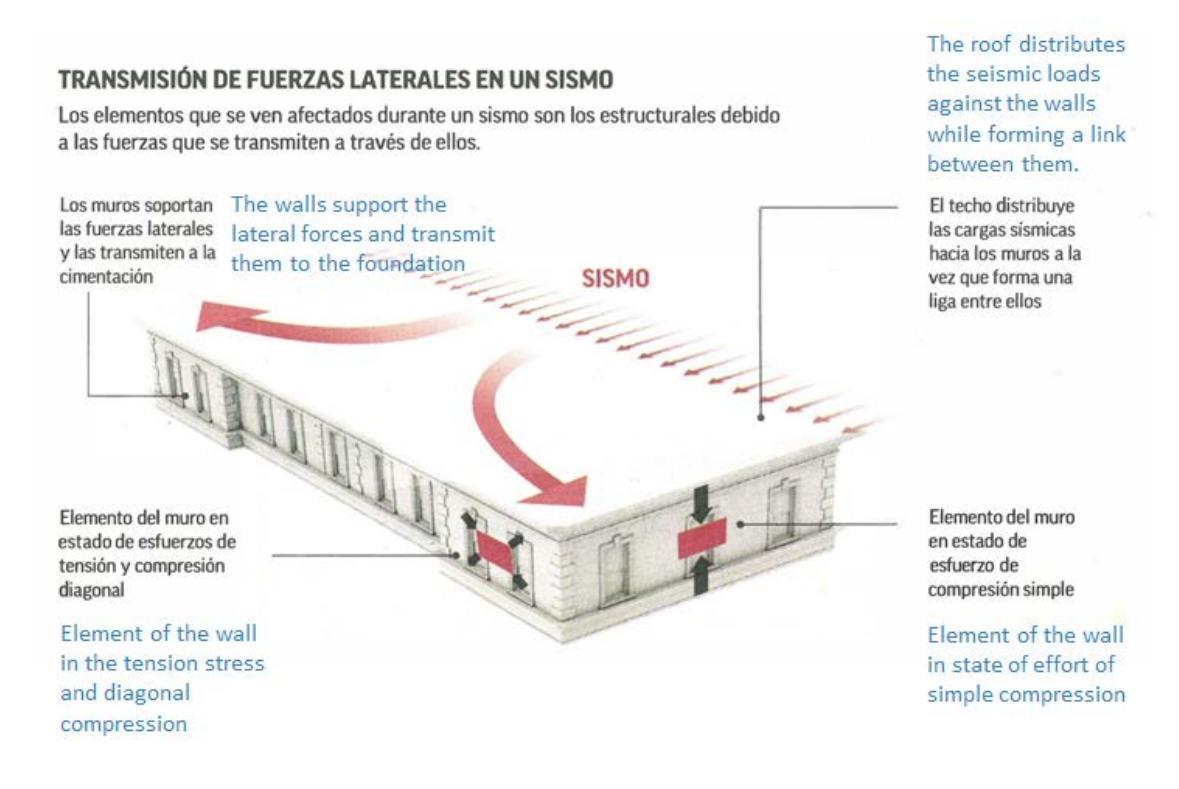
The elements within a building that are most affected during an earthquake are the structural elements because of the forces that are transmitted through them (**Fig. 5.1**).

Fig. 5.1 Diagram illustrating the transmission of horizontal forces during an earthquake (courtesy of EL FINANCIERO, September 26, 2017).

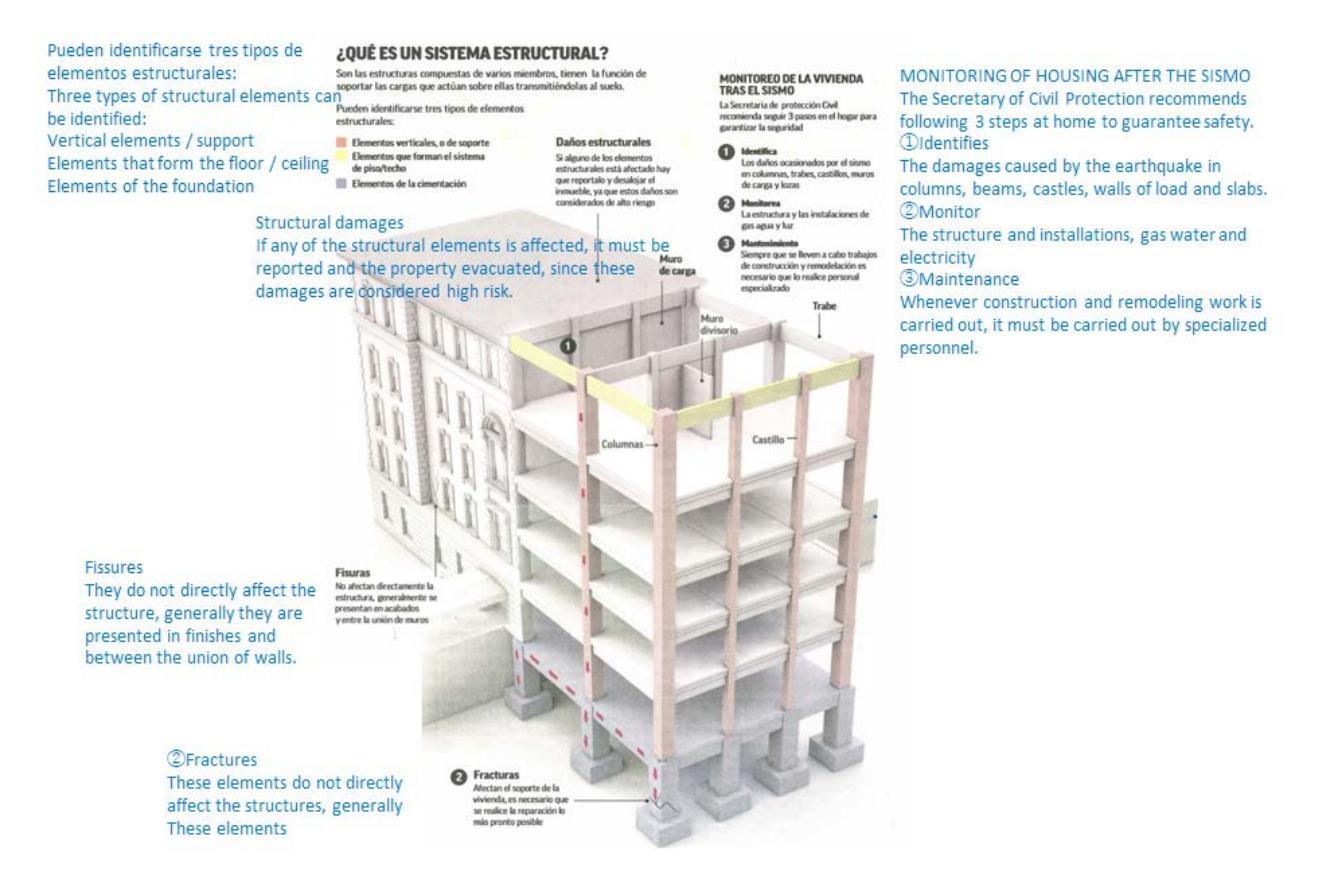
It is important to note whether structures are composed of several elements, and have the function of supporting the loads that act on them seismically, by transmitting them into the ground, such as is shown in Fig. 5.2.

Fig. 5.2 Diagram illustrating the various structural elements in a building (e.g., fissures, fractures, columns) that need to be considered in terms of identifying, monitoring and repairing (courtesy of EL FINANCIERO, September 26, 2017).

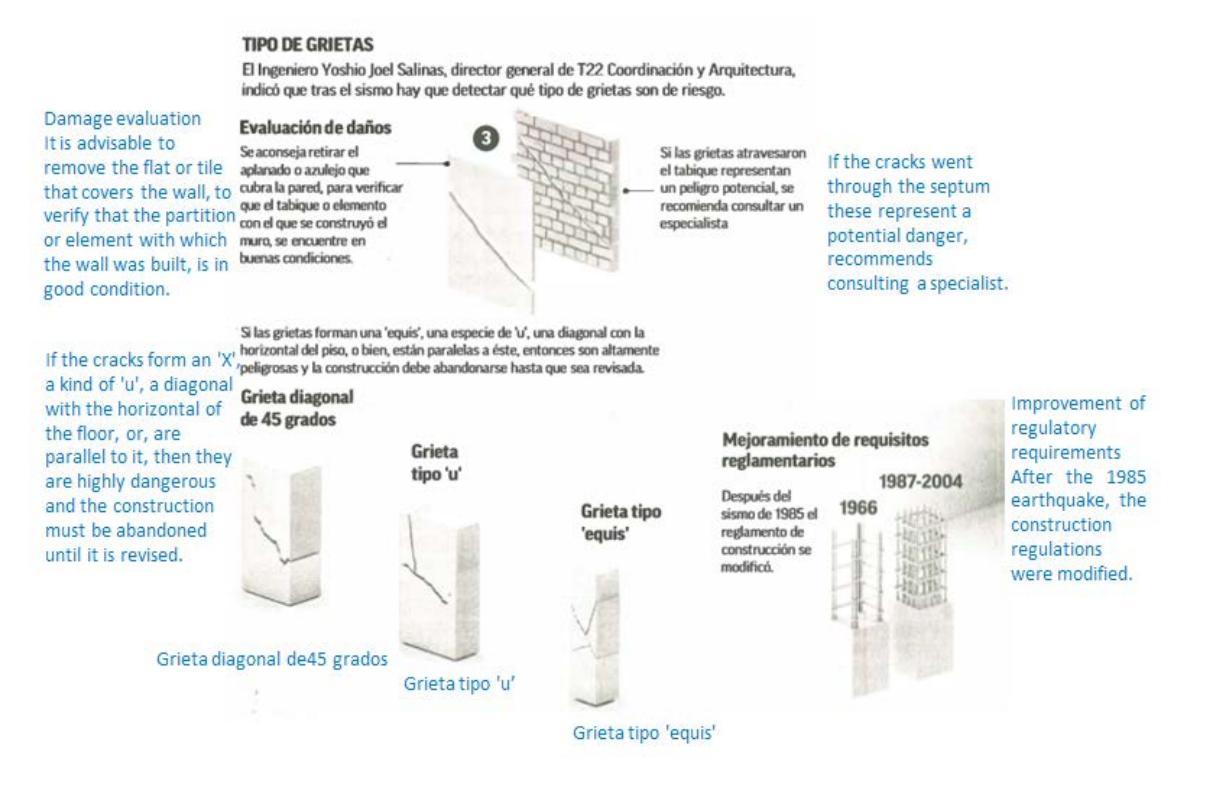
The engineer Yoshio Joel Salinas, general director of T22 Coordination and Architecture, indicated that after the earthquake it is necessary to detect the types of cracks evident in buildings in terms of their relative risk of further failure (**Fig. 5.3**).

Fig. 5.3 Diagram showing the various type of cracks that can occur and should be monitored in a seismically damaged structure (courtesy of EL FINANCIERO, September 26, 2017).
