Landslides in the Appalachian Region

*Field Trip Records and Proceedings of
the 3rd International Conference and Field Workshop on Landslides,
Eastern United States*

Edited by
Masaki Tominaga
Norio Oyagi

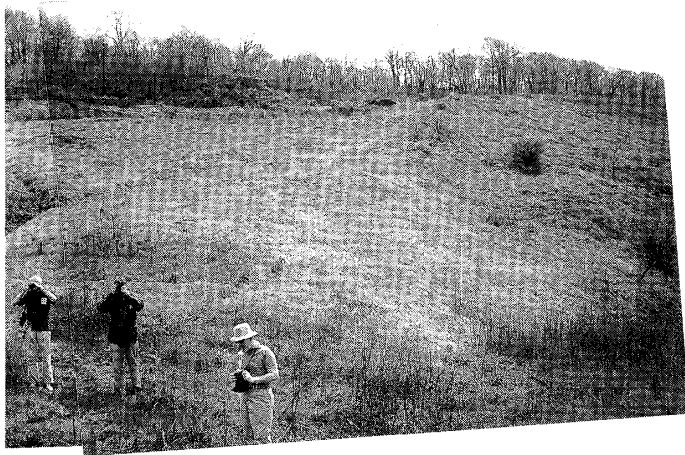
Photo 5 Interstate-79 slide.

Extensive sliding occurred during construction due to undercutting of old slide masses at the stratigraphic level of the Pittsburgh Redbeds (a claystone). See References 6, 7, and 8 (Case History 4).
(from the field trip guide.)

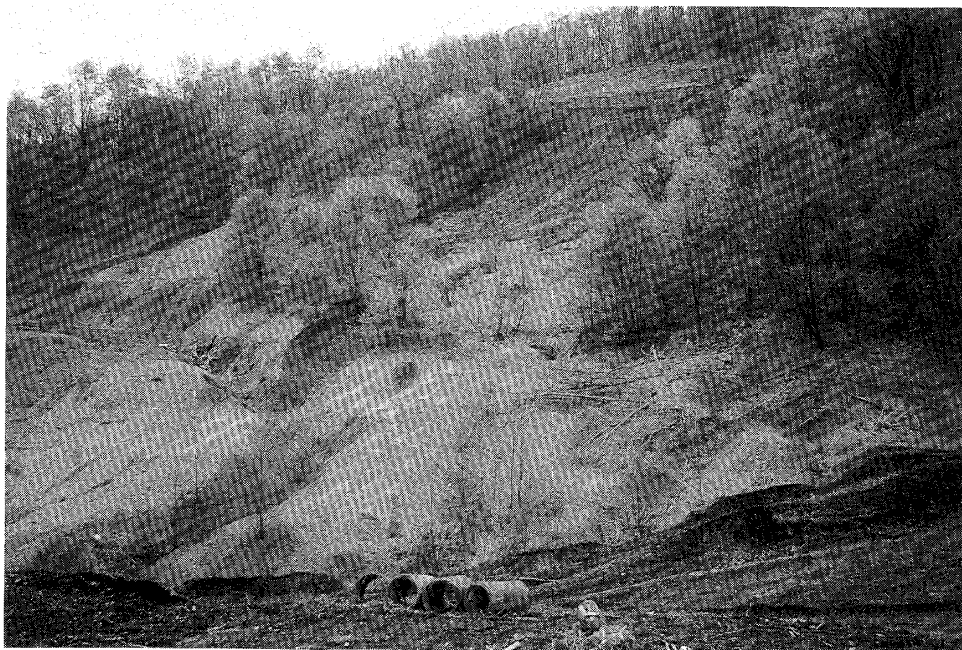
Photo 20 Mrs. Fry's house.

Mrs. Fry's house - Waddles Run. (Photo 20)

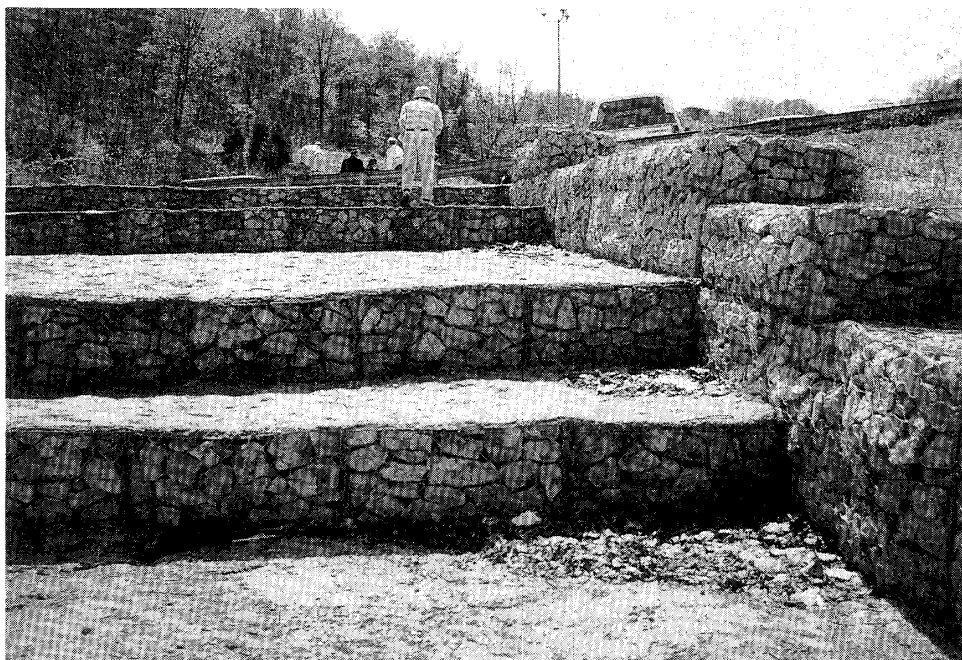
Landslides in Coal Waste. (Photo 21)

Photo 21 Slides in spoil bank of strip mine.

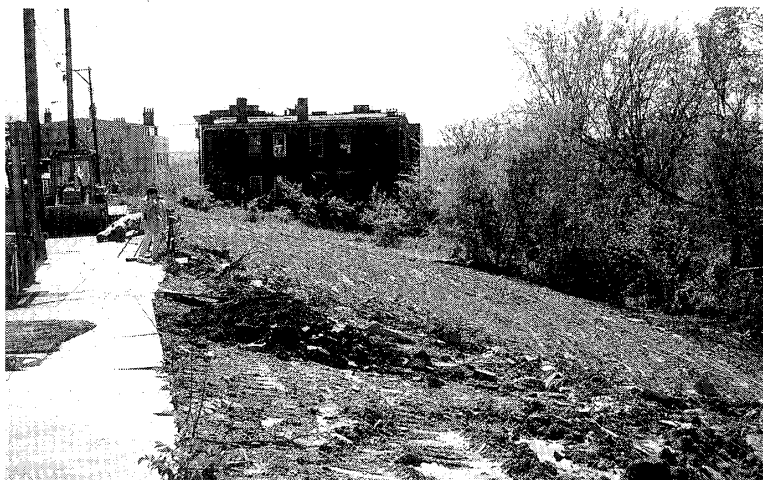
Photo 24 Slide 1 in Fig. 20.

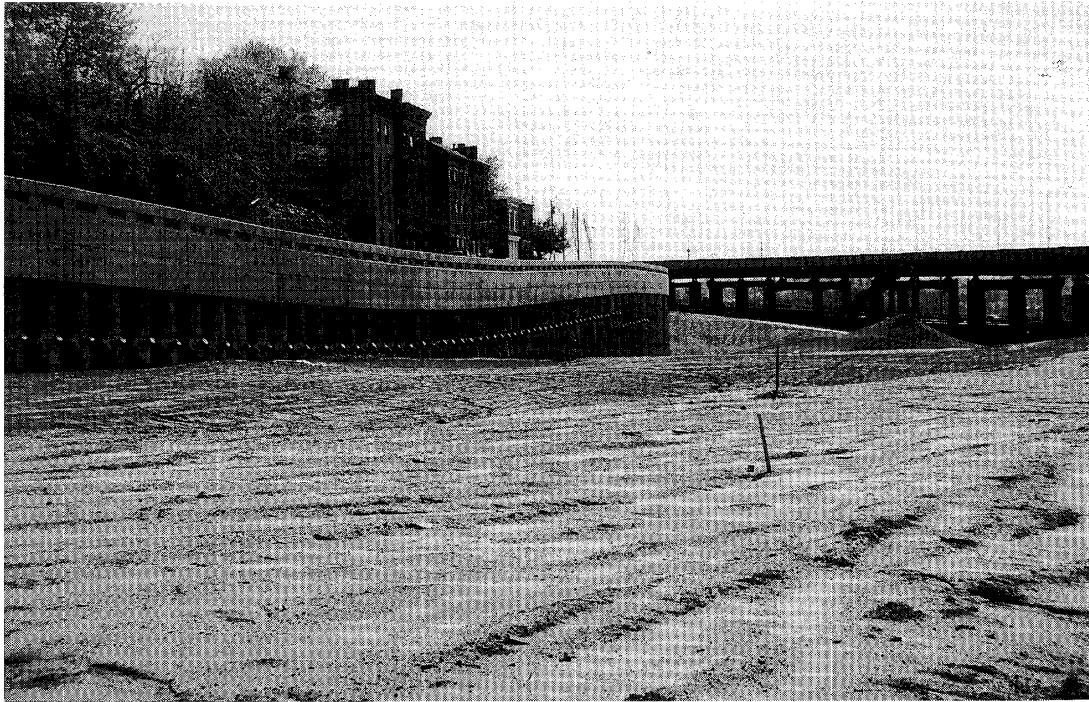
Photo 27 Pier wall, distant view.

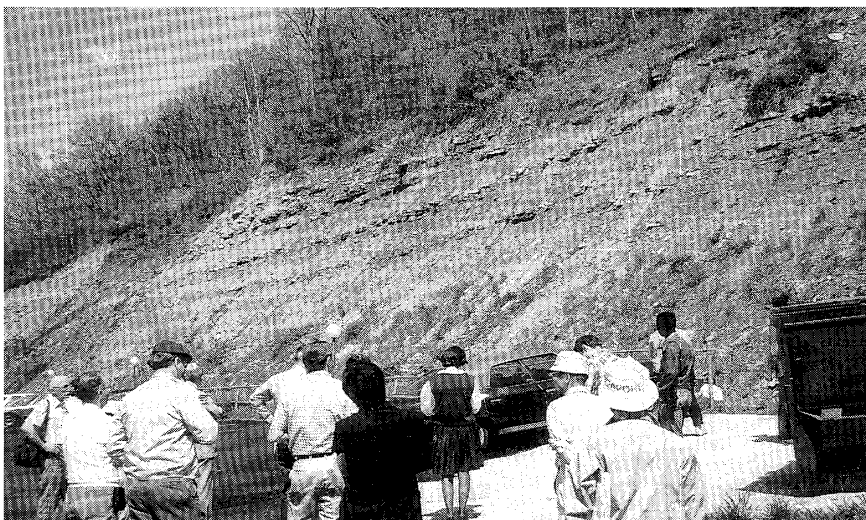
Photo 28 Colluvial slope.

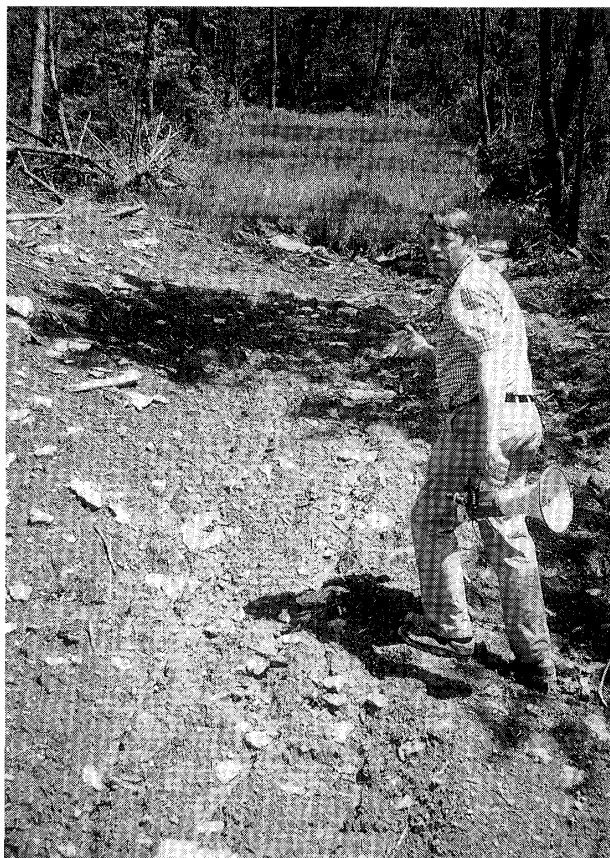
Photo 29 Slide along Delhi Pike.

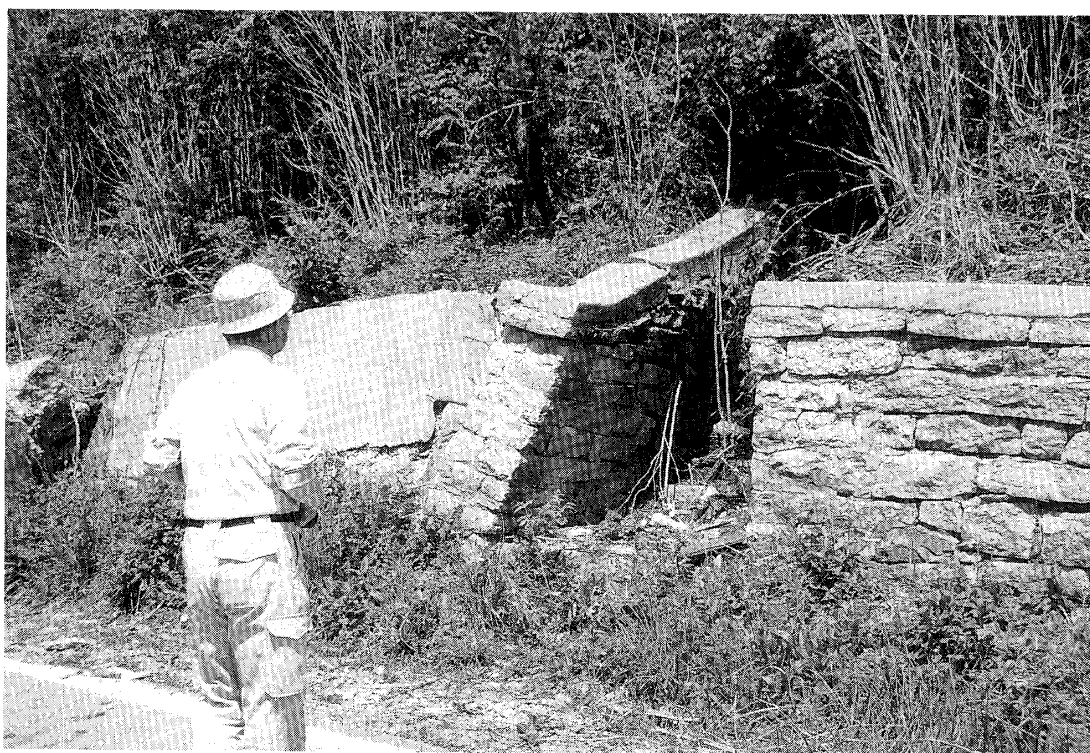
Photo 30 Damaged wall.

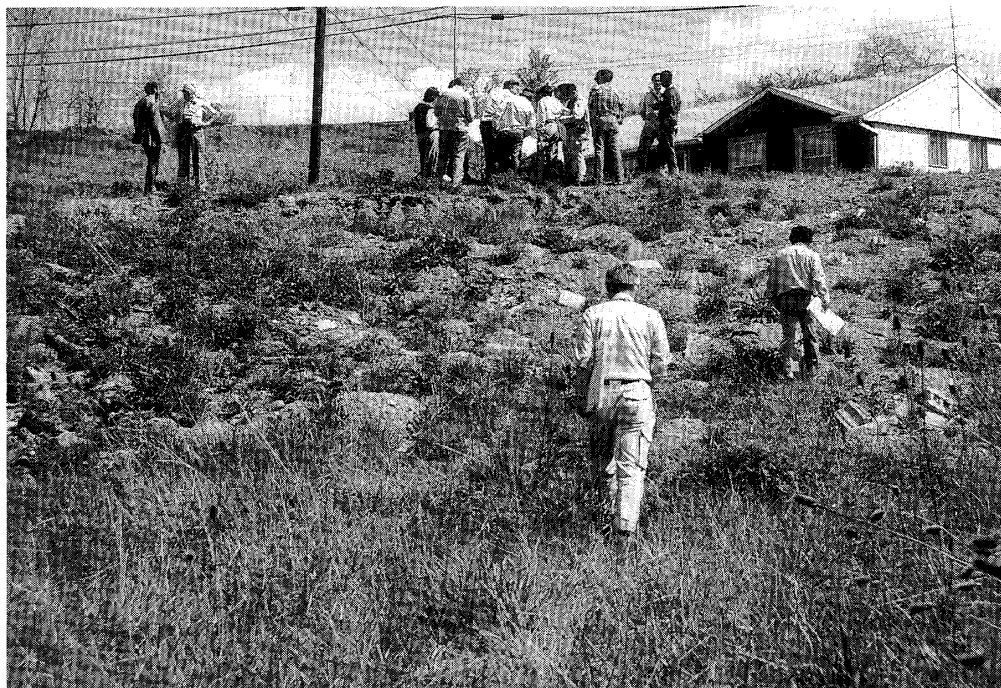
Photo 31 "early 1975" landslide, northeast edge of Huffman Court.

Landsliding also occurred at the eastern end of Huffman Court. In the winter of 1971, a small slide developed in the fill slope between the house at 980 Huffman Court and the county access road along the creek (H.C. Nutting Co., 1979). In early 1975, a larger landslide had begun to develop (Norman Hall, oral comm., 1979 ; H.C. Nutting Co., 1979), damaging the house at 980 Huffman Court and the sidewalk and driveway at 984 Huffman Court. By 1980, the scarp of that landslide had developed to the extent shown in Figure 24, involving lots at 980, 984, 988, and 992 Huffman Court. To date there have been no corrective measures to halt this sliding.

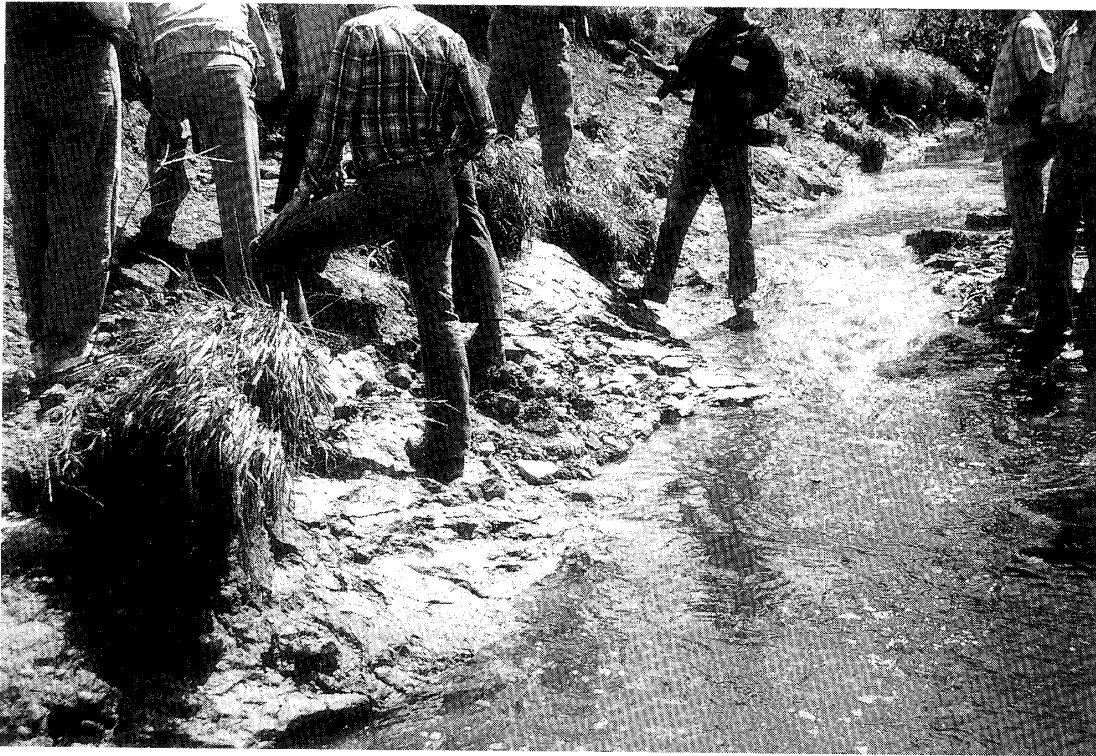
Photo 33 Outcrop of lake clay.

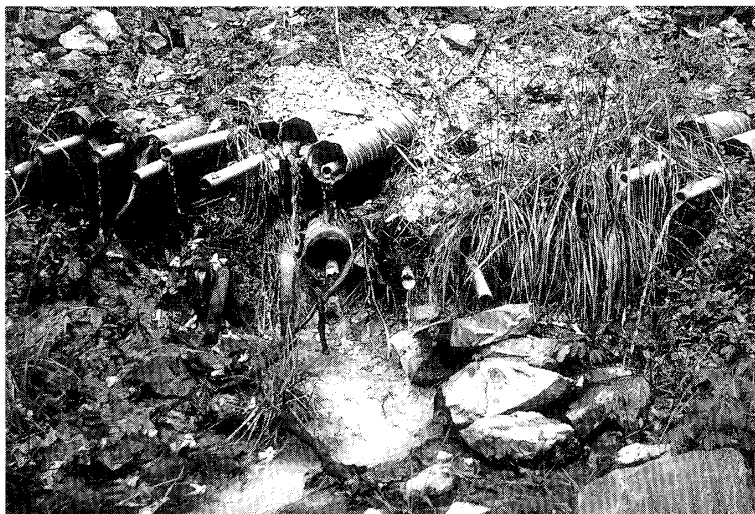
Photo 38 Horizontal drainage.

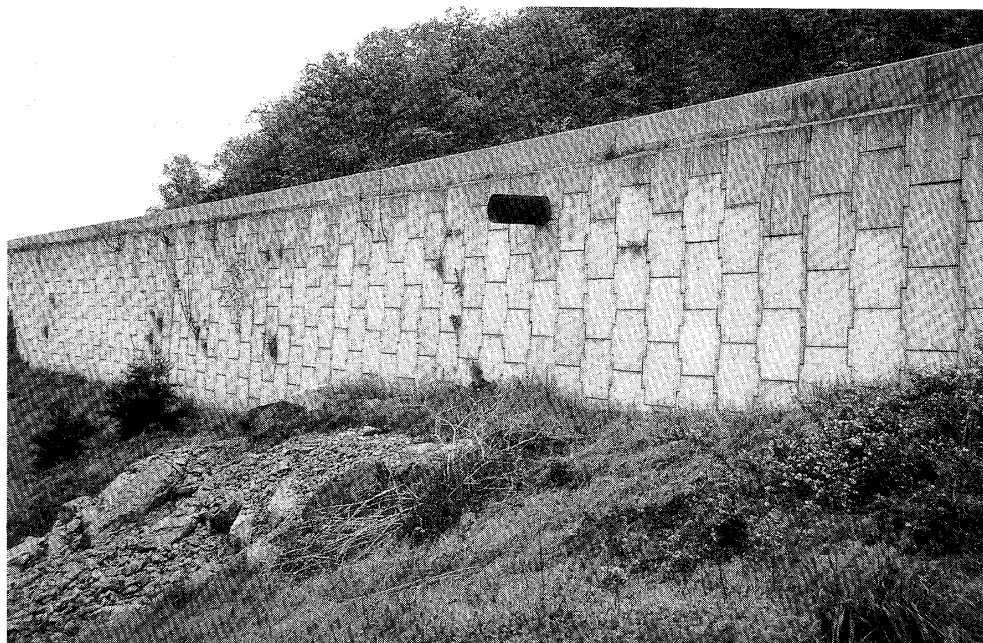
Photo 39

In October 1973, approximately two months after the initial row of concrete panels was set, the first Reinforced Earth structure to be constructed along a highway project in the Southeast was completed. The structure, which is 831 feet long and 39 feet high at its highest point, spans one of the many landslide problem areas along Interstate 40 near Rockwood .

Reinforced
earth wall.

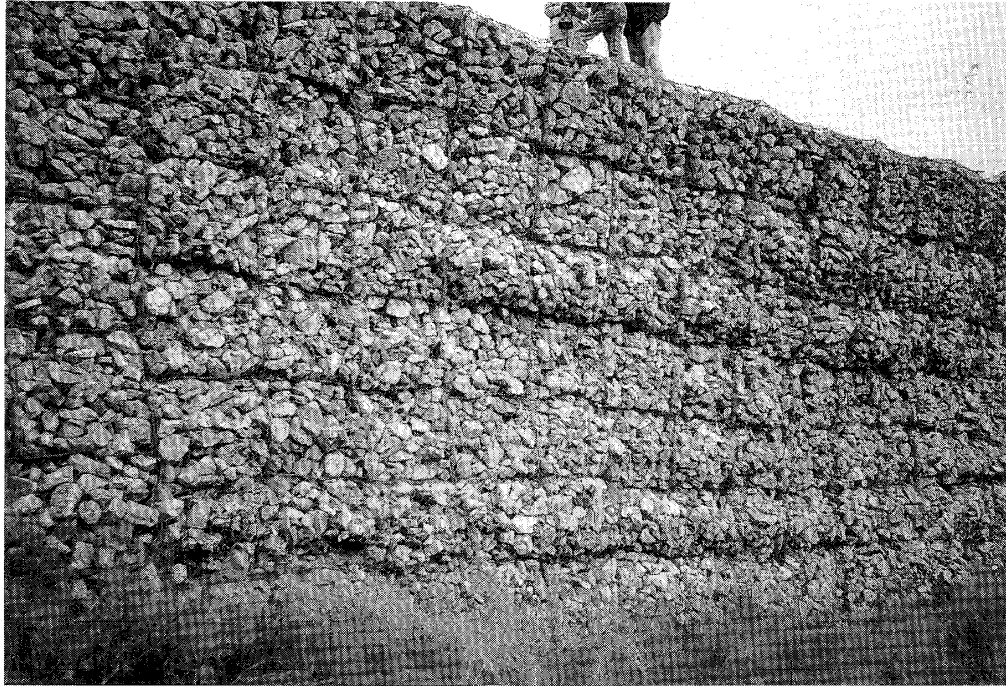
Photo 43 Gabion wall.

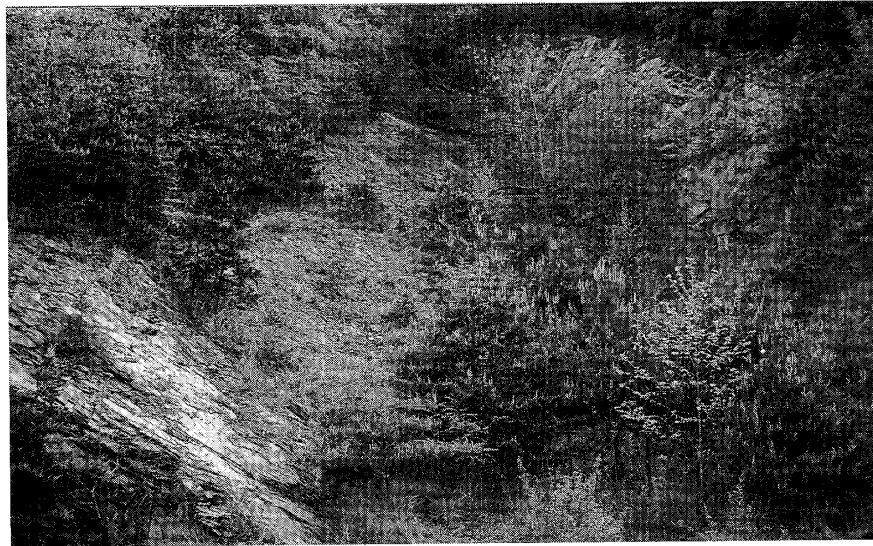
Photo 45 Wedge failure.

Initial cut slopes along this section of I-40 undercut and exposed numerous unstable wedges of rock. These wedges are defined by pattern resulting from the intersection of bedding, joint and cleavage planes. After periods of freeze and thaw, heavy rains usually activate these masses of unstable rock resulting in rock and debris slides. These slides are classically known as wedge failures (Fig. 33).

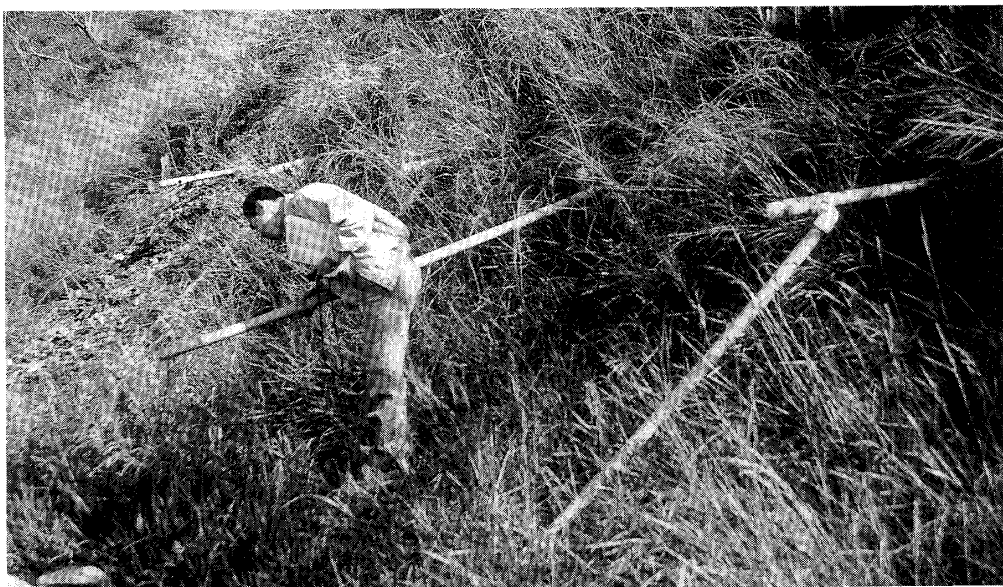
Photo 47 Drainage pipe, Hartford slide.

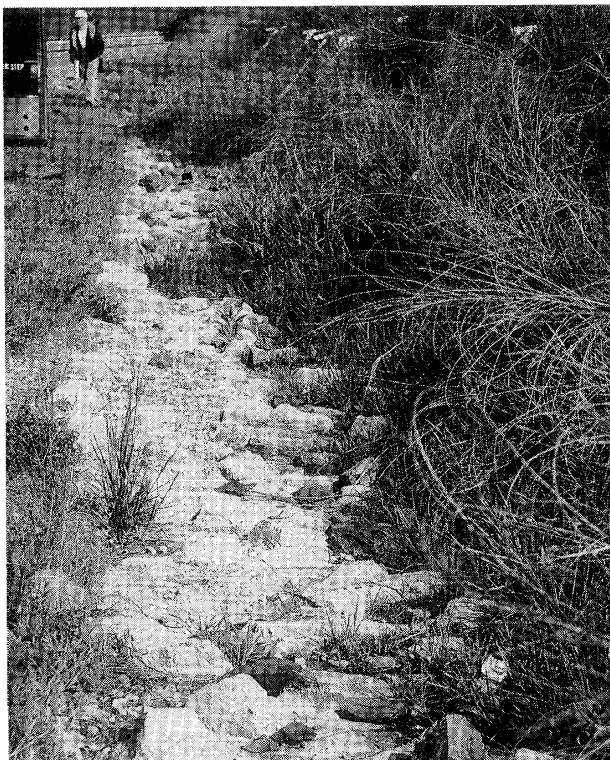
Photo 48 Drainage trough.

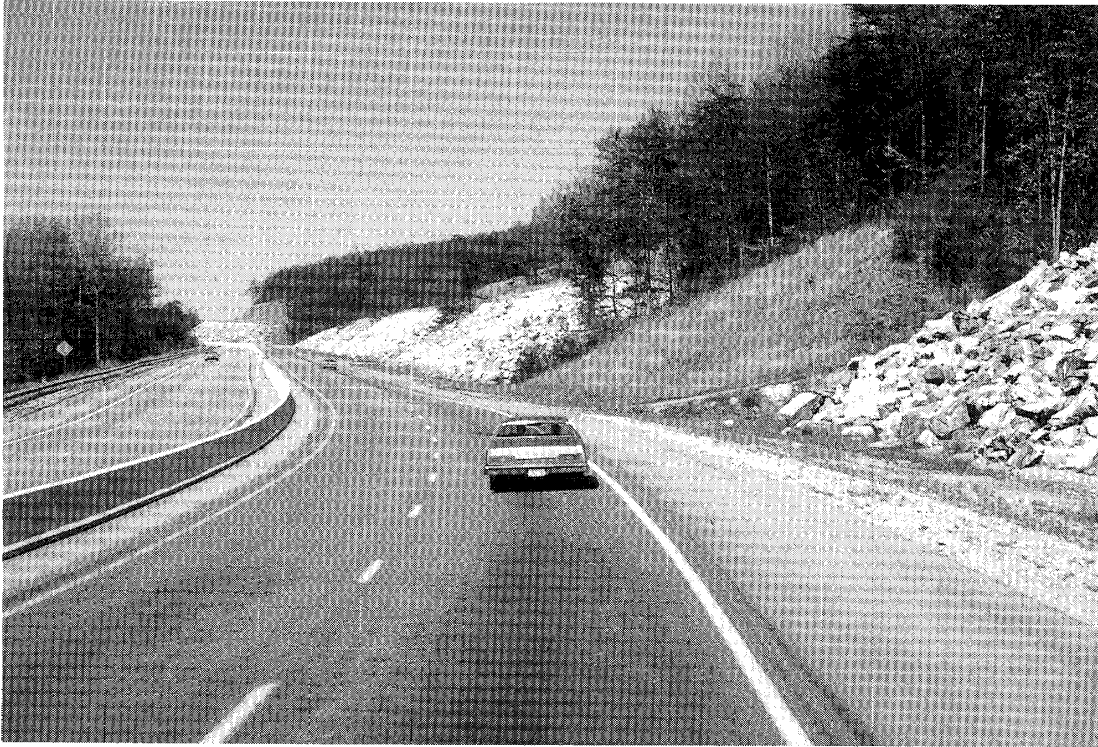
Photo 50 Rock buttresses.

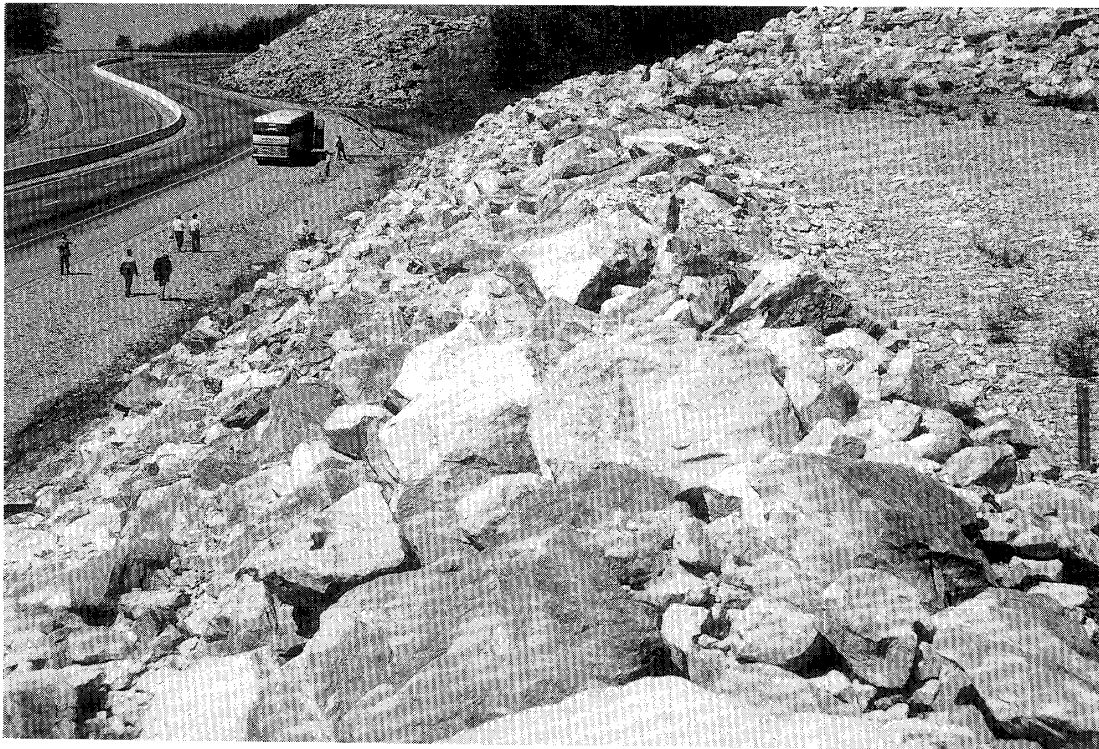
Photo 51 Rock buttresses.

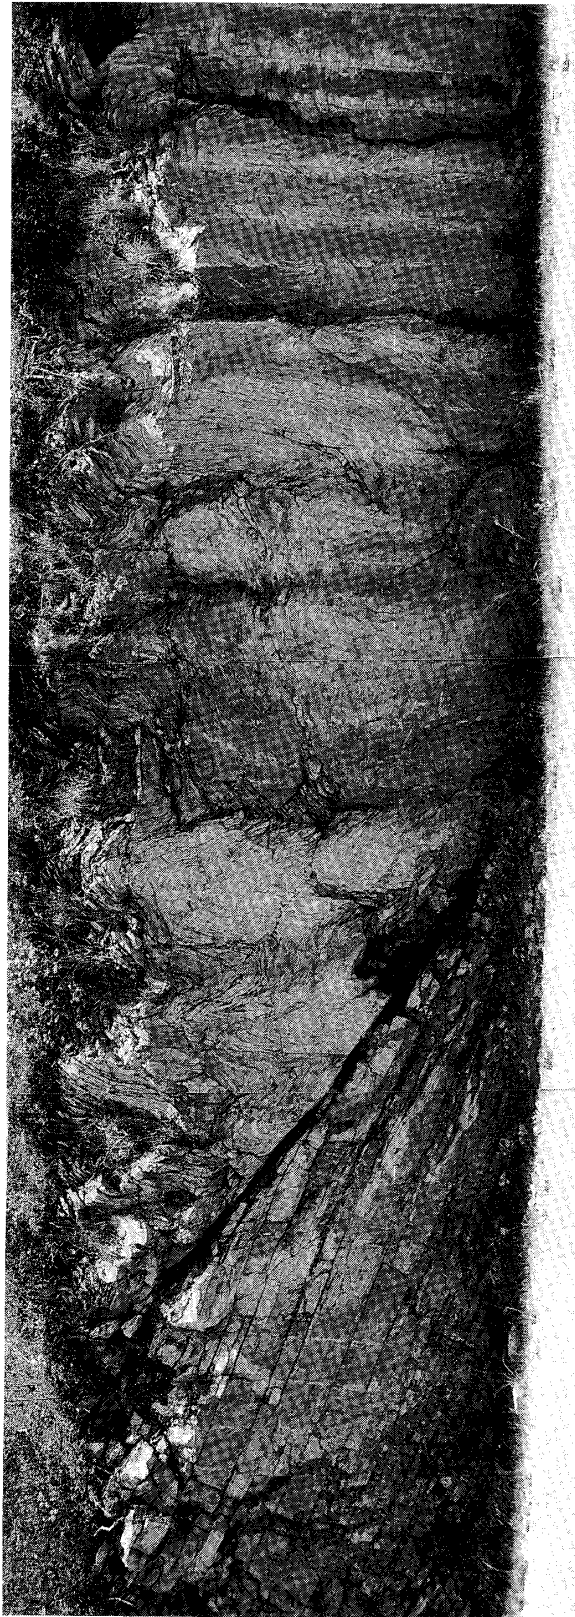
Photo 56 Faulted Martinsburg Strata.

Profile of faulted Martinsburg Strata. (Photo 56)
